Asbestos Building Inspection, Lead-Based Paint Testing, and
Bulk Sampling of Treated Wood

**Vista Water District
Edgehill Road Reservoir
Vista, CA**

**Aurora Industrial Hygiene
San Diego, CA**

Date: March 22, 2019

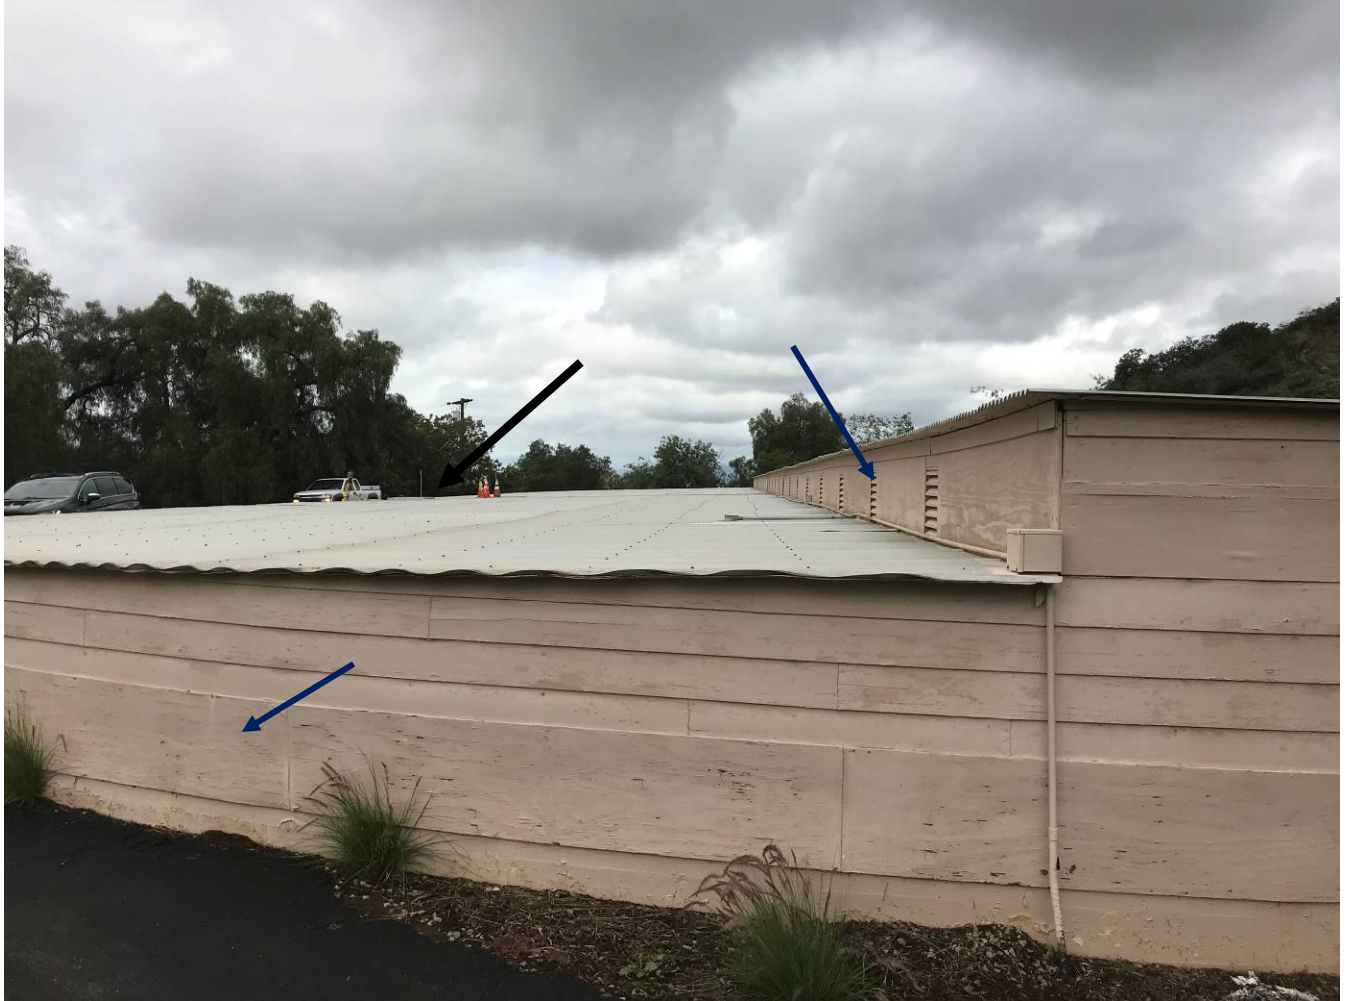
Photo Three: Ground level photo of Edgehill Road Reservoir. The blue arrows point to the plywood over the screens around the perimeter of the tank and the louvers on the center area of roof. The black arrow points toward the access hatch used to enter the tank.

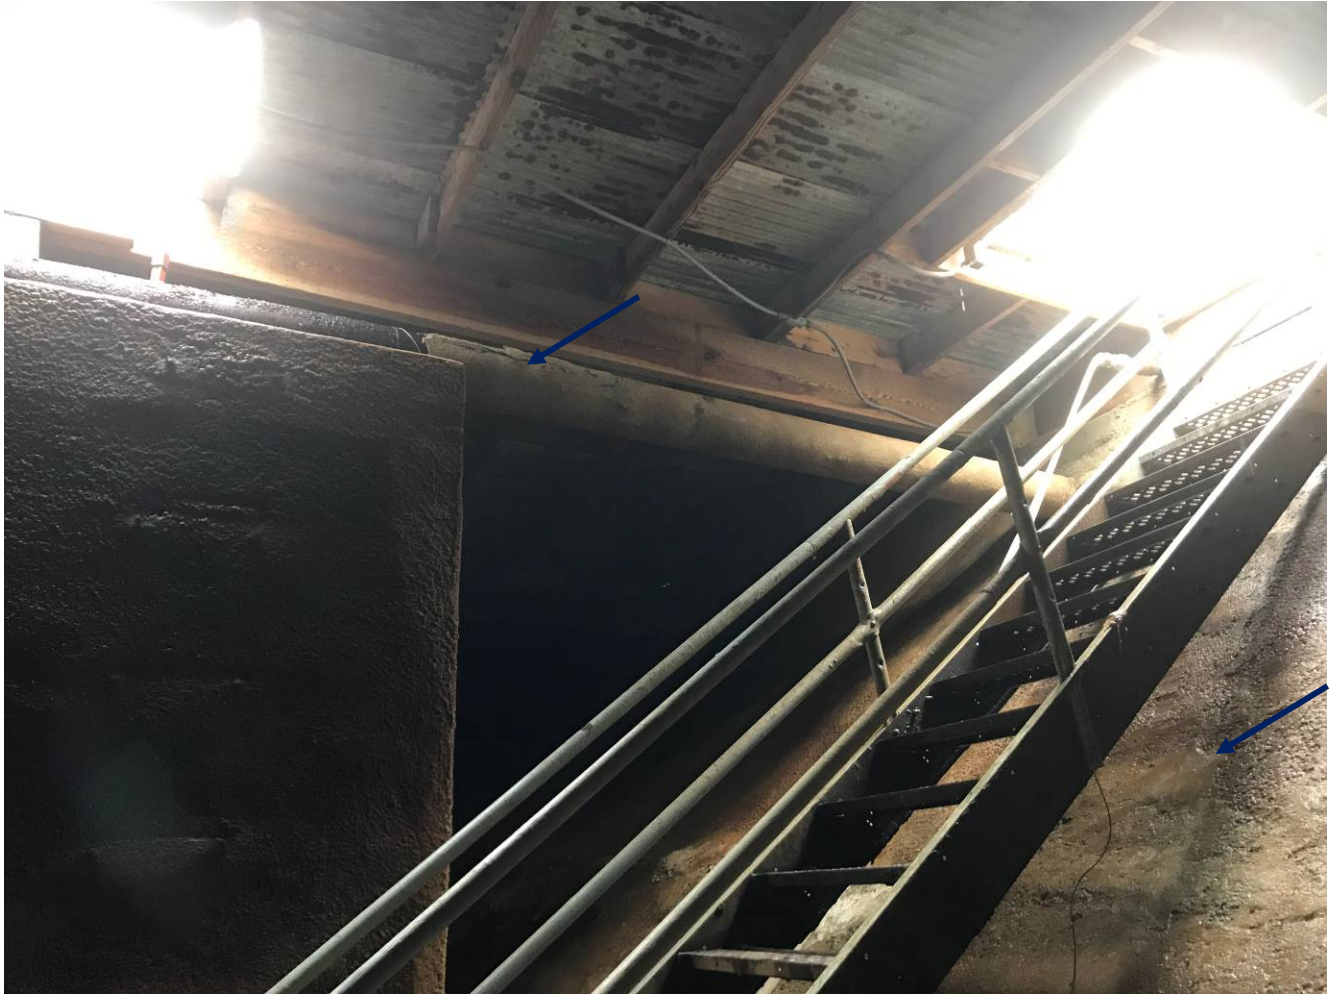
Photo Four: The stairs inside the tank looking towards the access hatch. The arrows point to the inlet pipe and the gunnite on the interior walls,

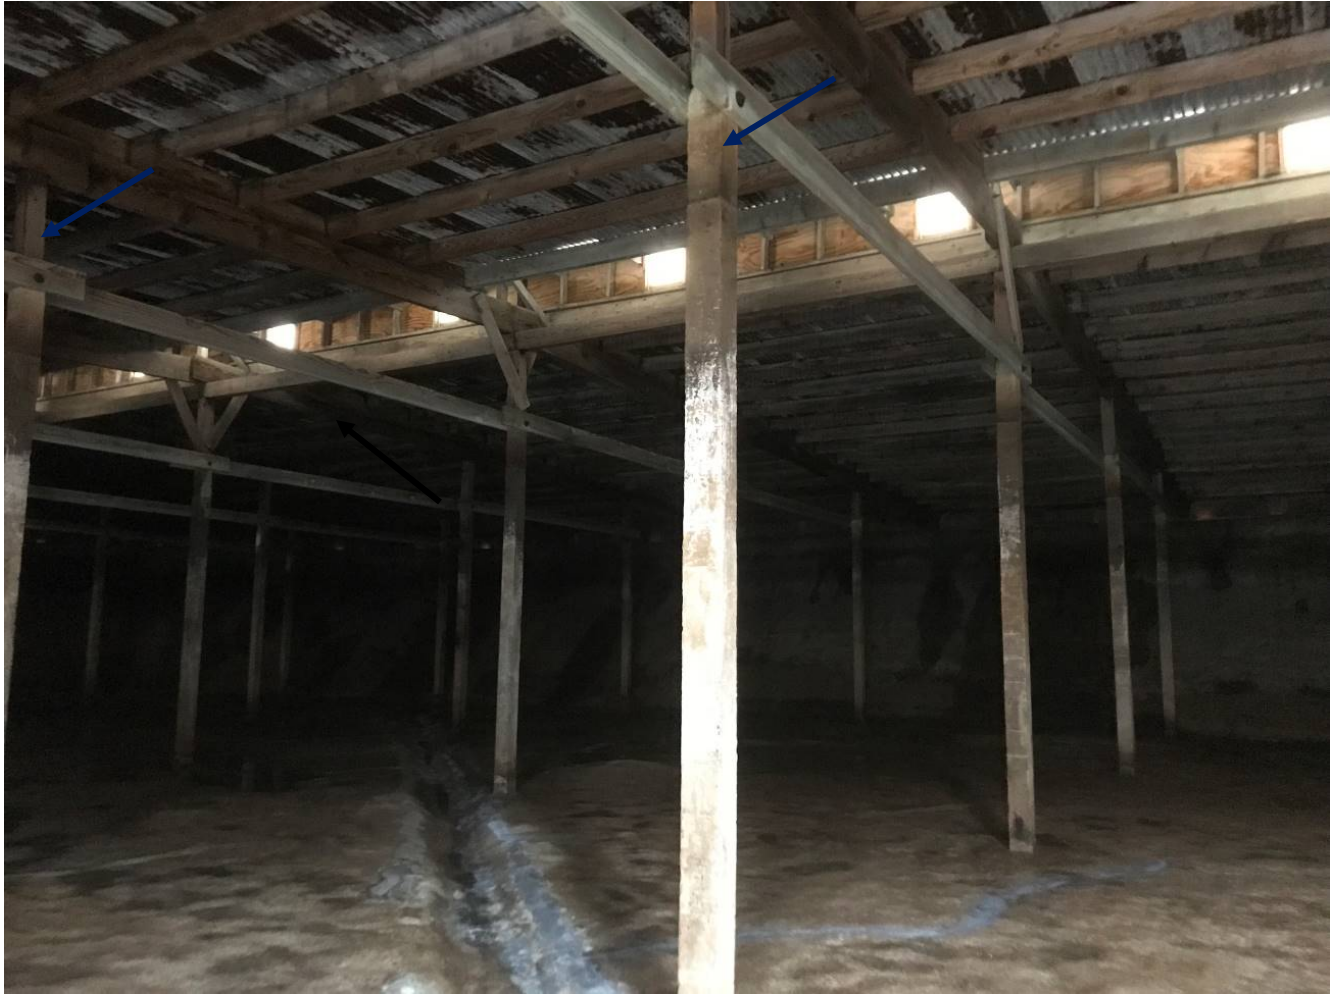
VID-0102-W01, Wood framing above concrete columns inside the tank:

- SVOCs: Benzo (a) pyrene, Benzo (b) fluoranthene, Benzo (g,h,i) perylene, Benzo (k) fluoranthene, Benzyl alcohol, Chrysene, Fluoranthene, Indeno (1,2,3-cd) pyrene, Phenanthrene, and Pyrene; and
- Creosote

Photo Five: The blue arrows point to the wood framing on the interior of the tank above the concrete columns.

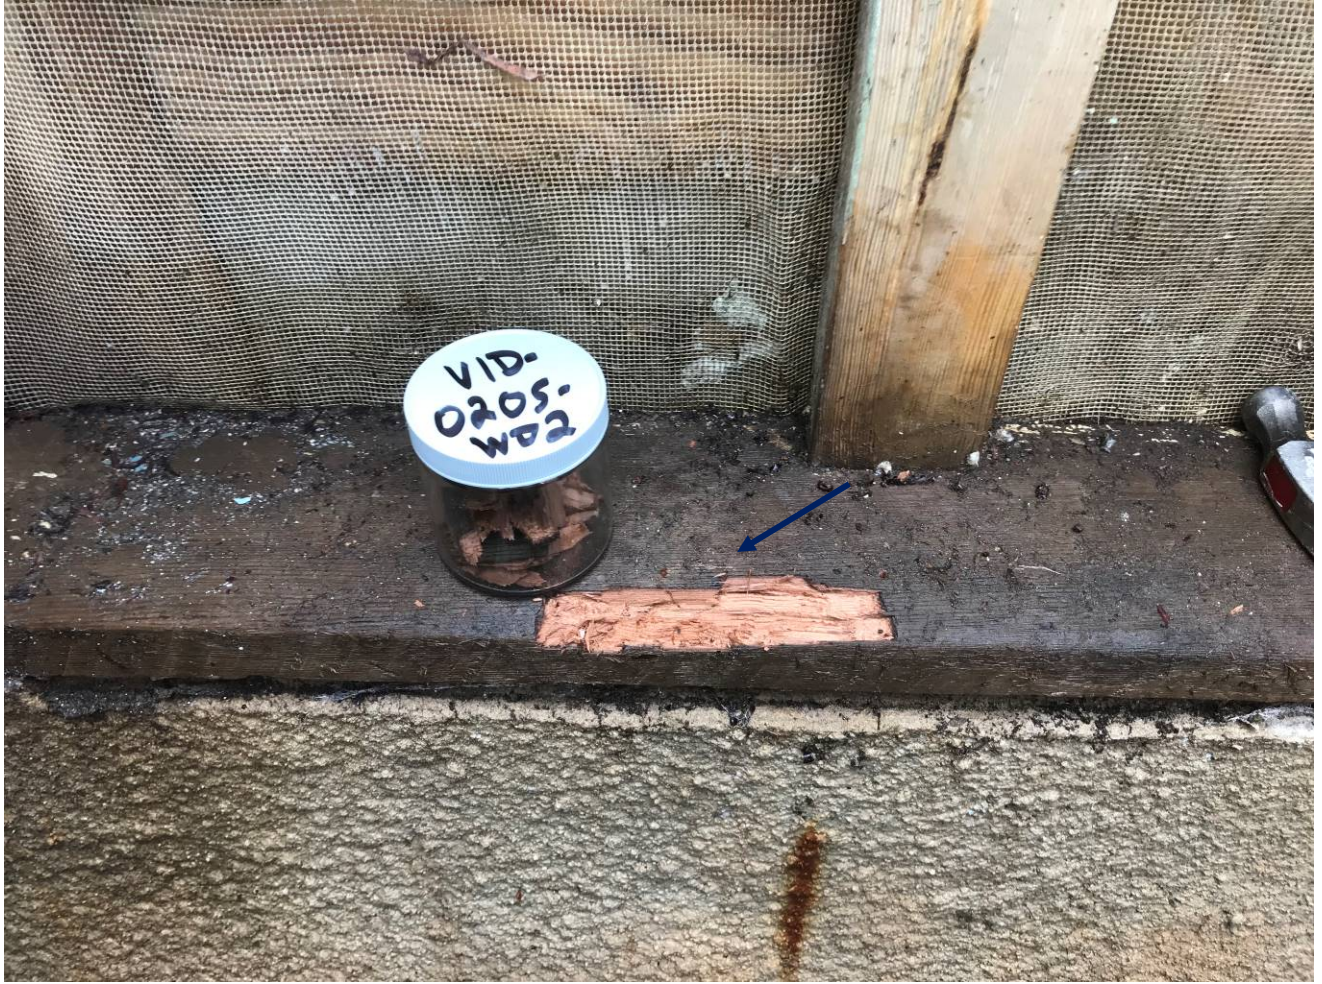
Photo Six: The bottom plate on wall around the perimeter of the tank.

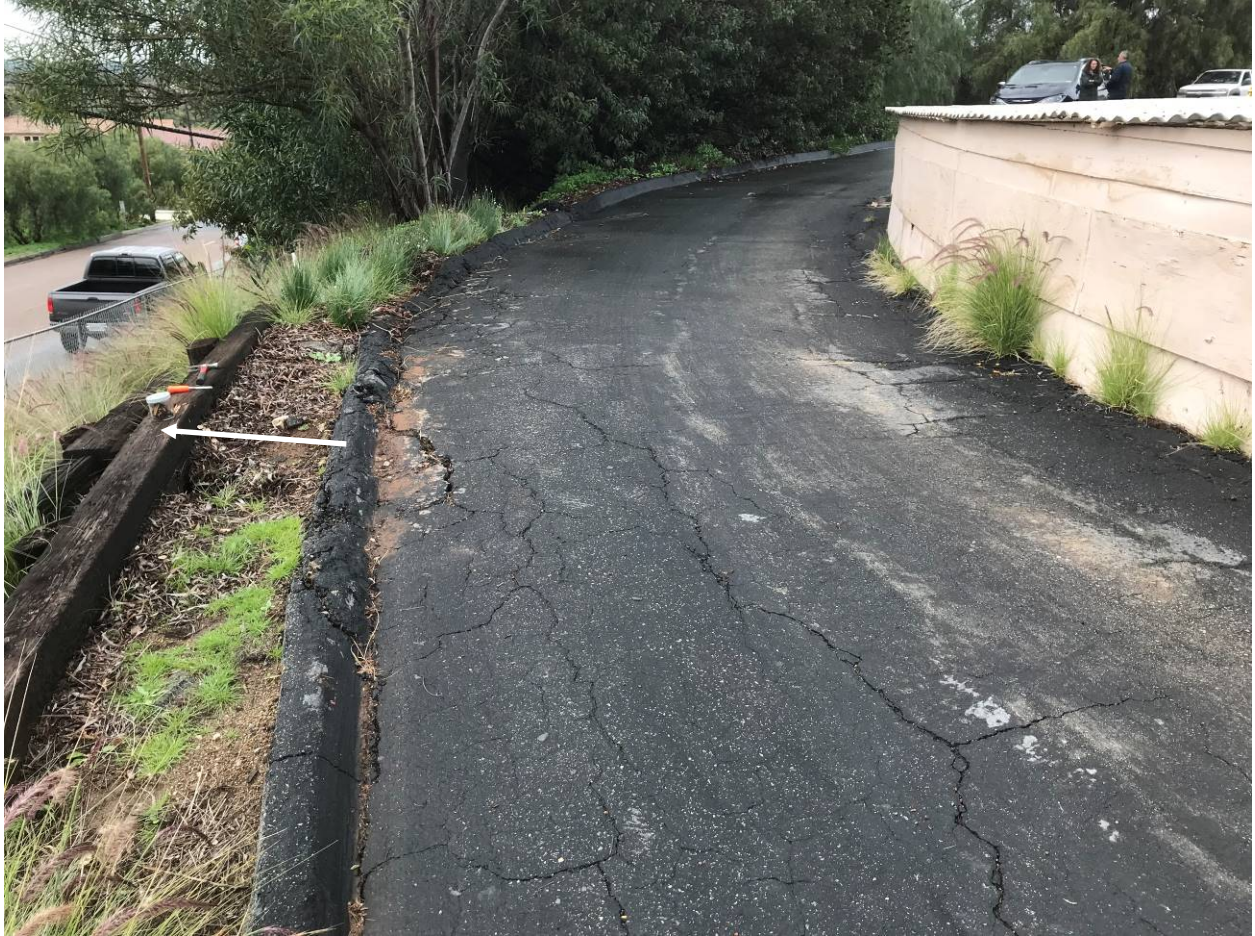
VID-0102-W03, Wood railroad ties outside of the tank within the fenced tank area:

- Chromium
- Copper
- SVOCs – Acenaphthene, Acenaphthylene, Anthracene, Benzo (a) pyrene, Benzo (b) fluoranthene, Benzo (k) fluoranthene, Chrysene, Dibenzofuran, Fluoranthene, Fluorene, 1-Methyl Naphthylene, 2-Methylnaphthalene, Naphthalene, Phenanthrene, and Pyrene; and
- Creosote

Photo Seven: The arrow points to the railroad ties that were tested on the outside of the tank.

Treated wood can be tested prior to disposal to determine whether it is hazardous waste. Alternatively, the California Department of Toxic Substances Control (DTSC) has developed alternative management standards (AMS) for treated wood waste. These standards lessen the storage, accumulation period, shipment, disposal, and testing requirements and allow treated wood waste to be disposed of in a solid waste landfill which has been approved for treated wood waste by the Regional Water Quality Control Board.
