# Potable Water Master Plan

Vista Irrigation District

April 9, 2018

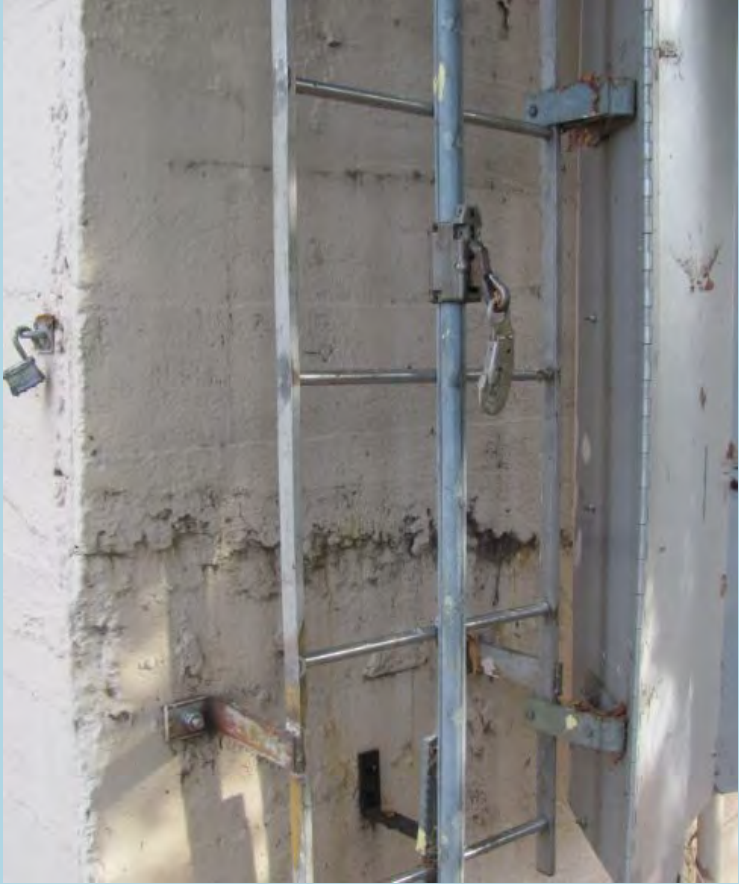
Exterior ladders first step bracket is placed too high (Photo 11).	<p>Photo 11</p>
