# Potable Water Master Plan

Vista Irrigation District

April 9, 2018

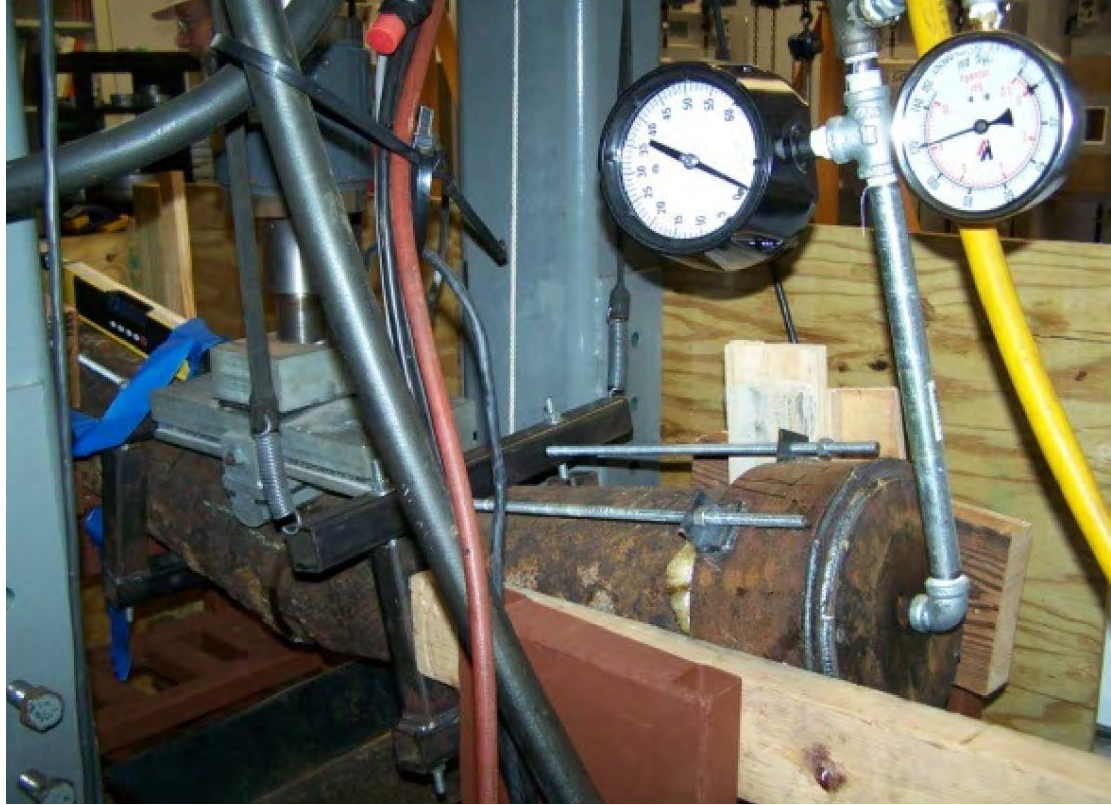
Sanexen, the manufacturer of Aquapipe CIPP lining has conducted a laboratory test to assess the lining’s ability to withstand host pipe failure. The photo below shows a reinforced CIPP liner being tested which appears to demonstrate the ability to survive the fracturing of the host pipe while withstanding 120psi of internal pressure without leakage. However, there are two concerns regarding the test which was performed:

1. The tests were not performed on a sample lined in place; and
2. According to the professor who oversaw the testing, special measures were taken to prevent the lining from bonding to the host pipe in the vicinity of the simulated fracture.

More testing is needed to substantiate the structural value of the lining.

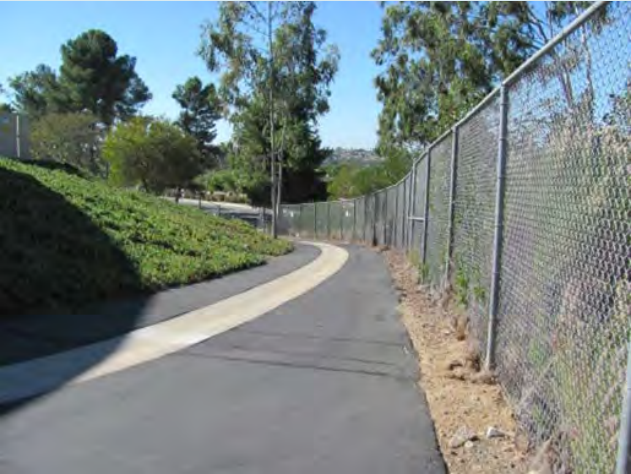
Lupine Hills Civil/Site and Corrosion Observations		Photo
Fence/Gate	Entrance contains a locked gate with VID signage. Fencing surrounding the reservoir and gate were typically in good condition. Fence height surrounding the reservoir varies due to dirt and shrubbery but is at an adequate height to prevent unauthorized entry (Photo 1).	Photo 1

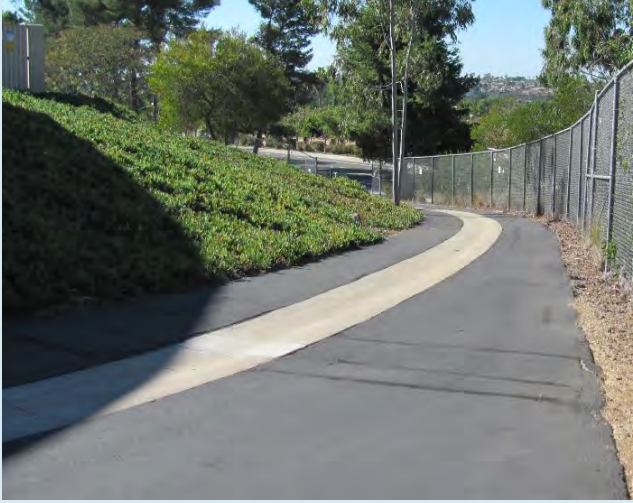
Lupine Hills Civil/Site and Corrosion Observations		Photo
Drainage	Roof drains spill runoff into gutter around perimeter of the access road. Area is clear and observed to be in good condition. Adequate drainage with good slope for runoff (Photo 3).	<p>Photo 3</p>

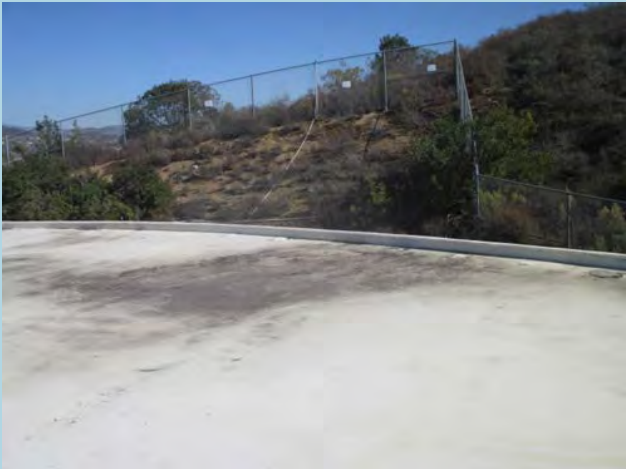
Trees and Vegetation	Trees and shrubbery surrounded the reservoir near the perimeter fence with minimal tree growth on the fence (Photo 4).	<p>Photo 4</p>

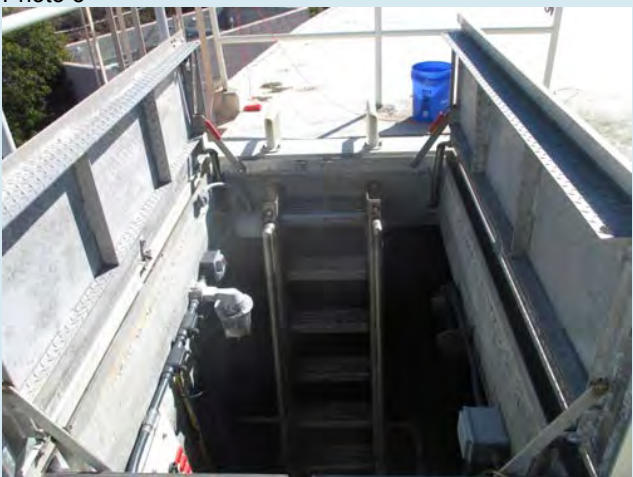
Hatches	Access to the reservoir is through the roof access hatch. Steel screws and the intrusion alarm switch were found to be corroded. The hatch was observed to be in overall good condition (Photo 5).	<p>Photo 5</p>

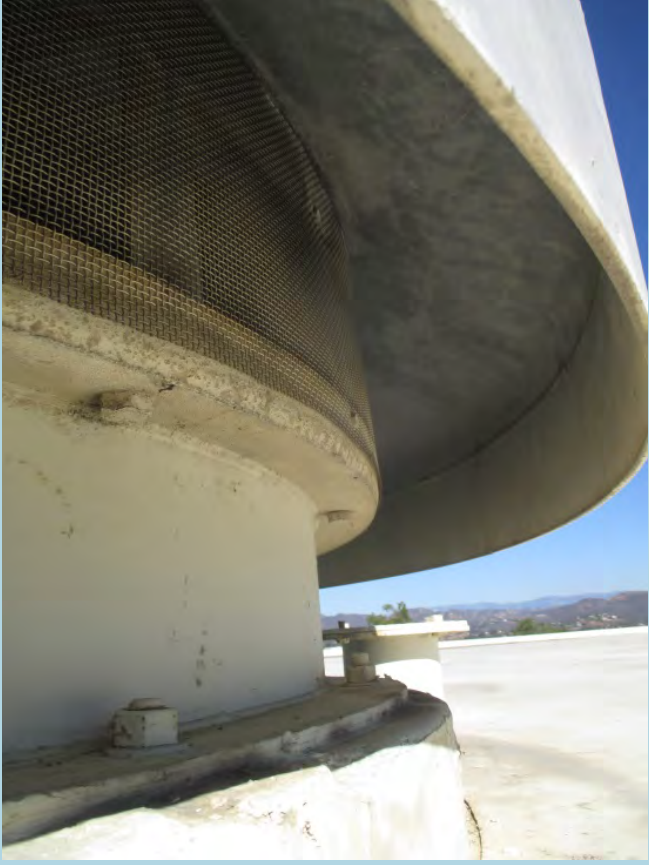
Lupine Hills Civil/Site and Corrosion Observations		Photo
Vents	One roof vent located at the center of the reservoir roof. The conduit penetration plate on top of the vent was found to be corroded. The vent was observed to be in overall good condition with minor rusting (Photo 6).	Photo 6

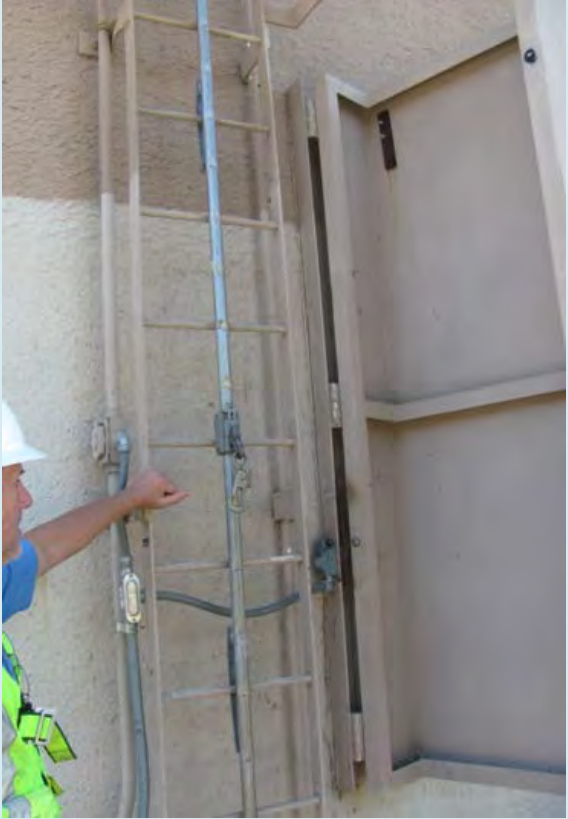
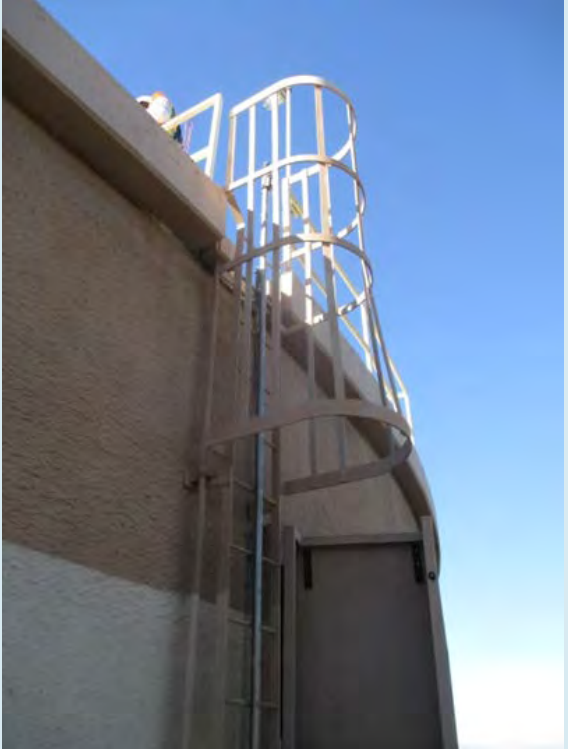
Lupine Hills Civil/Site and Corrosion Observations	Photo
<p>Ladders</p> <p>Exterior ladder is painted carbon steel with a cage and anti-climb door. The U-shaped frame on the top of the anti-climb door has coating loss and surface rusting. Anchor bolts supporting the ladder in the shotcrete on the reservoir side are intact and appear to be in good condition. Ladder top supports are welded to guardrails cast into the reservoir roof. Extensive corrosion and metal loss on the guardrail supports have resulted in failure directly above the embedment locations (Photo 7 and Photo 8).</p>	<p>Photo 7</p>

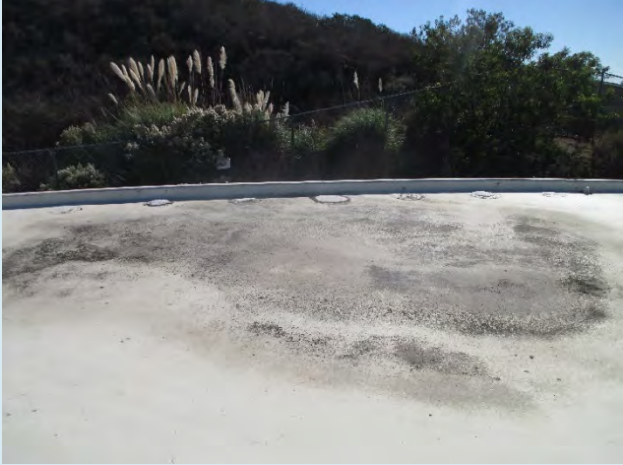
Lupine Hills Structural Exterior Observations		Photo
Roof	Typical evidence of ponding at low points between roof drains at the outside edge of the roof (approximately 10 locations) (Photo 1).	Photo 1

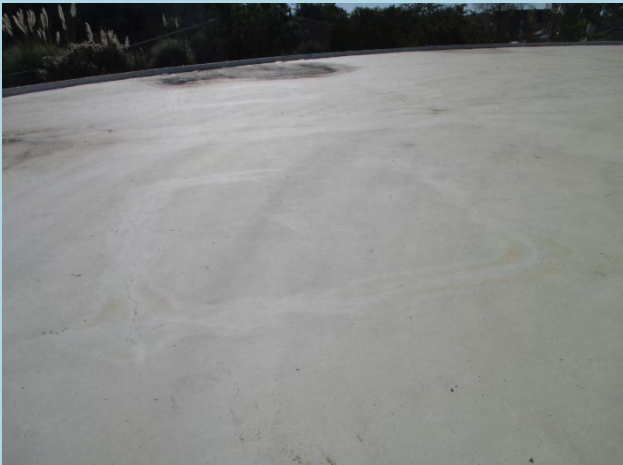
Roof	Typical cracking on concrete roof, concentrated over column caps (Photo 2).	Photo 2

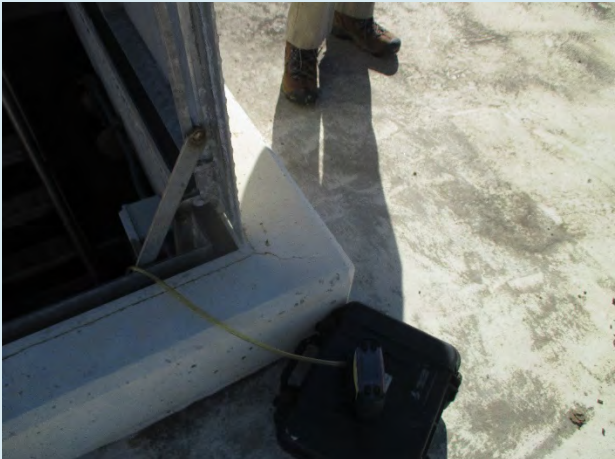
Roof	Typical cracking at the corners of the concrete curb around the access hatch (Photo 3).	Photo 3

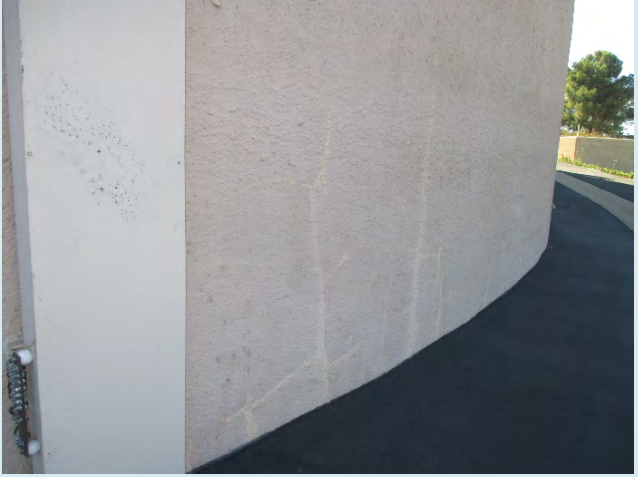
Lupine Hills Structural Exterior Observations		Photo
Wall	Cracking in gunite finish. This condition was only observed at the low end of the access road. The cracking is concentrated on the lower 1/3 of the wall height and does not appear to have any moisture seepage (Photo 7).	Photo 7

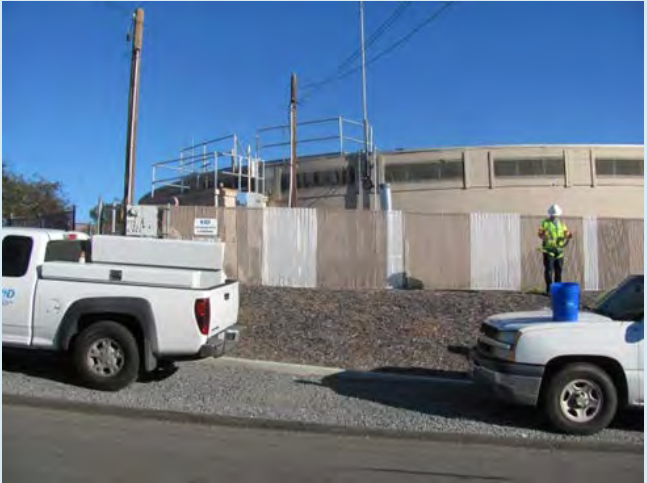
A Reservoir Civil/Site and Corrosion Observations		Photo
Fence/Gate	<p>Full access of the surrounding fence at A Reservoir requires entry and re-entry through two separate fencing areas. Figure 3-2 displays the additional fence on the east side entrance.</p> <p>Paved access road has adequate space for field crews and multiple vehicles (Photo 1).</p>	<p>Photo 1</p>

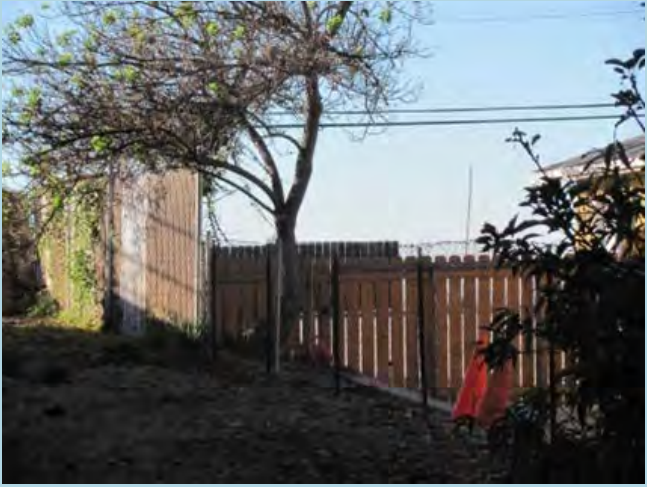
Access Road	<p>Approximately half of the surrounding fencing is shared between the reservoir and the adjacent properties. The fence in the back area is damaged due to the neighboring homes property, displayed in Figure 3-3 (Photo 2).</p>	<p>Photo 2</p>

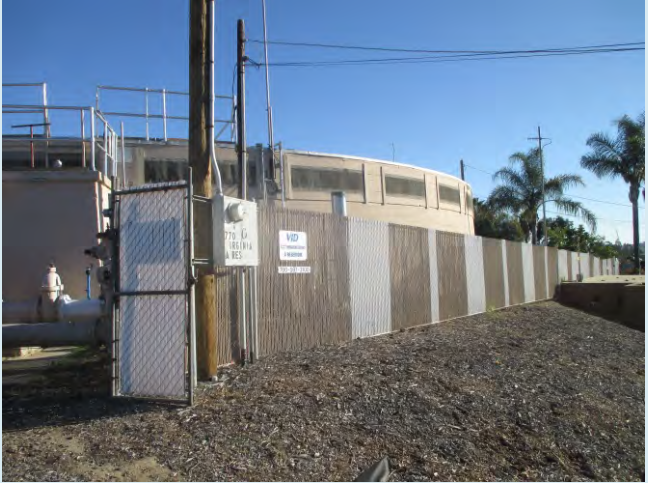
A Reservoir Civil/Site and Corrosion Observations		Photo
<p>Drainage</p>	<p>Roof drains spill runoff into gravel slope that leads down to the street below (Photo 3).</p> <p>VID staff mentioned past complaints from adjacent properties regarding runoff; problems have since been alleviated.</p>	<p>Photo 3</p>

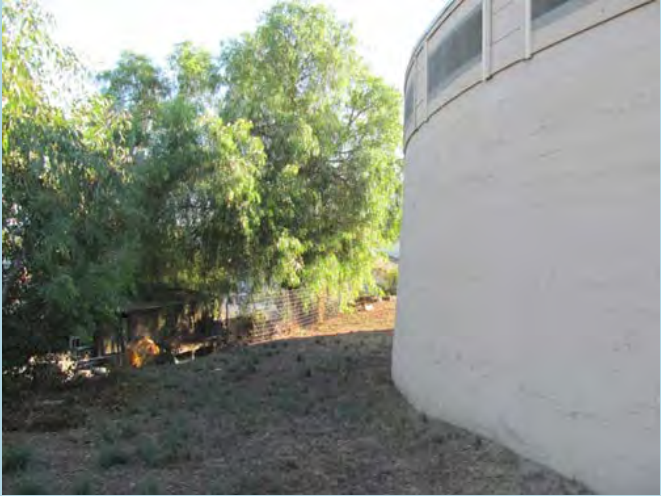
<p>Trees and Vegetation</p>	<p>Typical trees and vegetation from adjacent properties surrounding reservoir. Instances of minimal tree growth on the surrounding fence (Photo 4).</p>	<p>Photo 4</p>

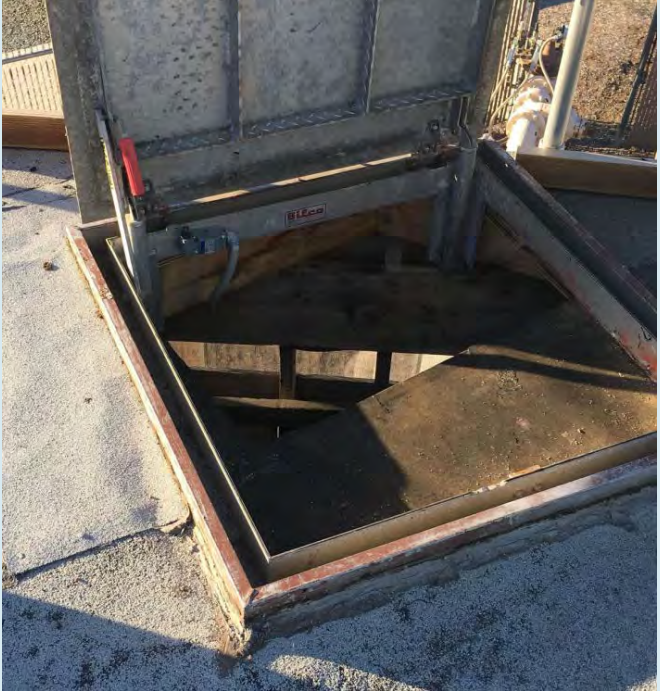
A Reservoir Civil/Site and Corrosion Observations		Photo
Hatches	<p>Access to the reservoir is through the roof access hatch. The hatch showed surface corrosion on the lock cover but was in overall good condition (Photo 5).</p>	<p>Photo 5</p>

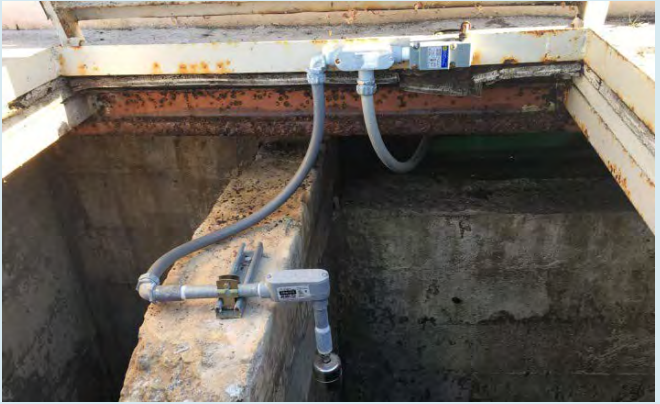
<p>The float box hatch was found to be in good condition with some paint degradation and minor surface rusting. Coating loss and pitting was observed on the support beam inside the float box (Photo 6).</p>	<p>Photo 6</p>

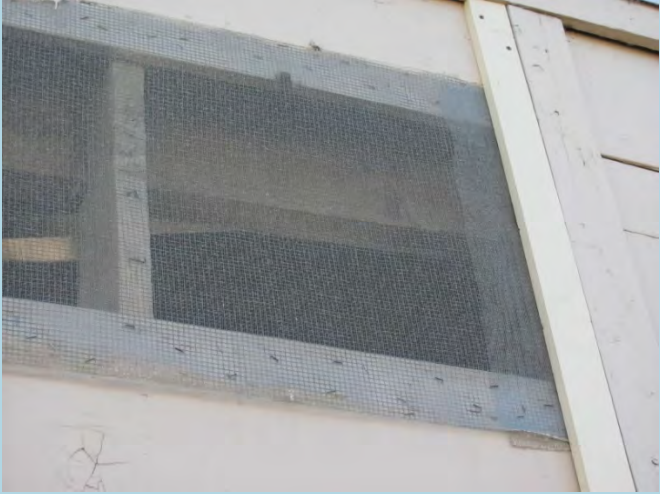
A Reservoir Civil/Site and Corrosion Observations		Photo
Vents	Side vents are located around the perimeter of the reservoir every few feet apart. Vents contain a mesh covering and wood frame on each side. Vents were observed to be in good condition (Photo 7).	<p>Photo 7</p>

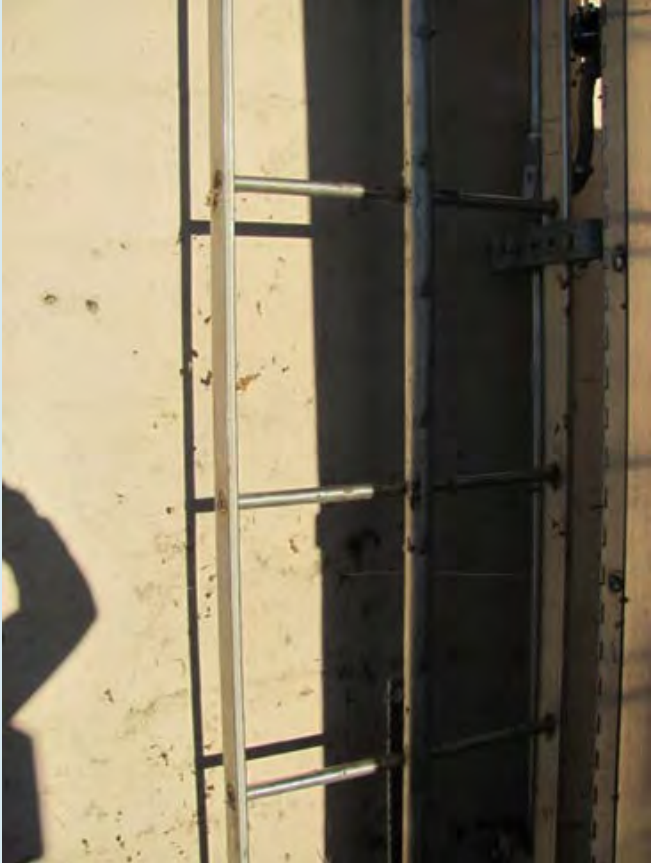
Ladders	Typical surface rusting observed on exterior ladder, overall good condition (Photo 8).	<p>Photo 8</p>

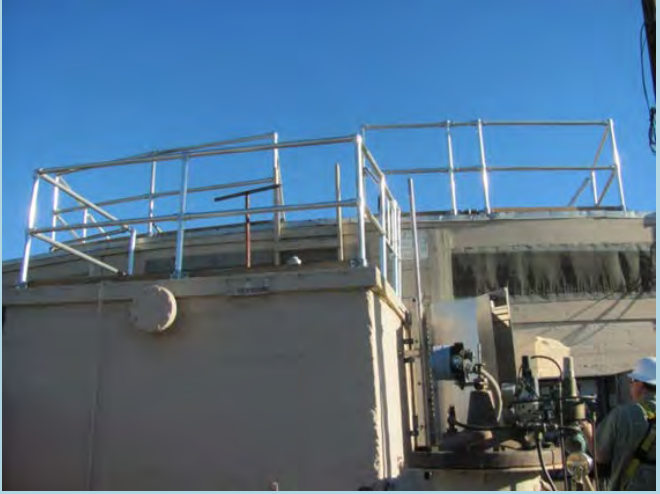
A Reservoir Civil/Site and Corrosion Observations		Photo
Handrails, and Guardrails	Aluminum guardrails located at roof hatch and float box areas were in good condition (Photo 9).	<p>Photo 9</p>

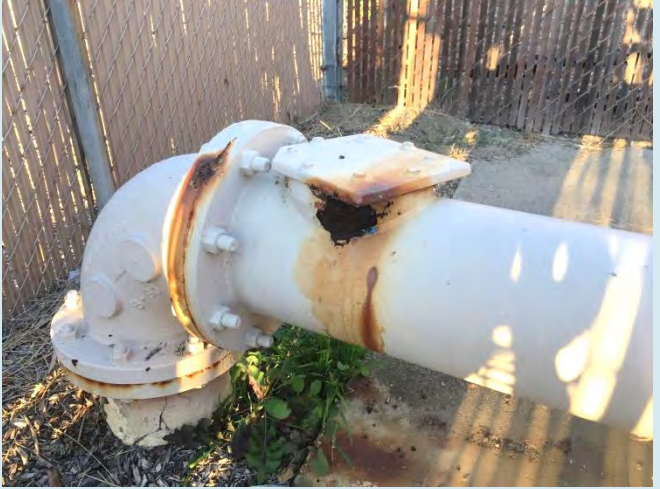
Pipes and Appurtenances	Corrosion and localized metal loss observed on the exterior pipe riser (Photo 10).	<p>Photo 10</p>

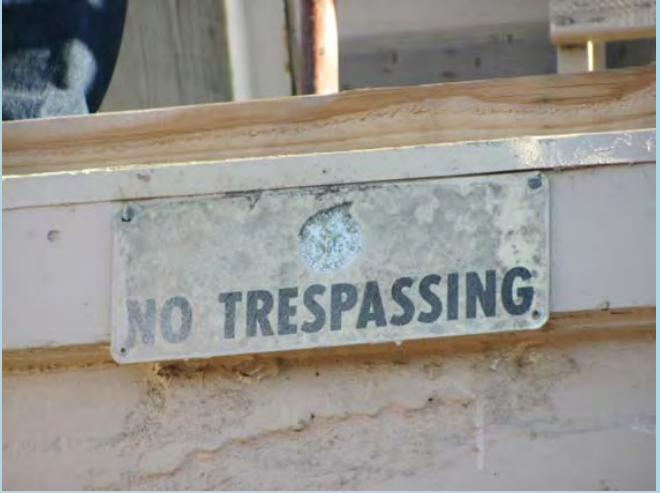
Signage	Signage observed to be in faded and poor condition. Replacement is necessary (Photo 11).	<p>Photo 11</p>

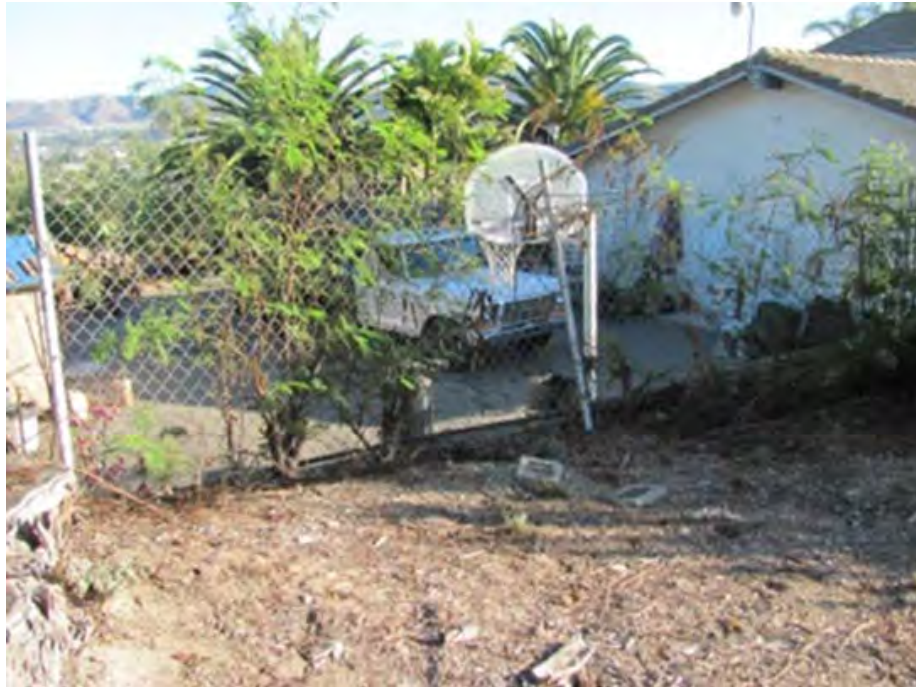
**Figure 3-4. Damaged Fence**

- Neighboring property shared chain link fence in the back area is damaged due to the neighboring homes property, see Figure 3-4.
- Surrounding trees and vegetation out of vicinity of site operation and maintenance at the time of inspections but could potentially obstruct if not maintained periodically.

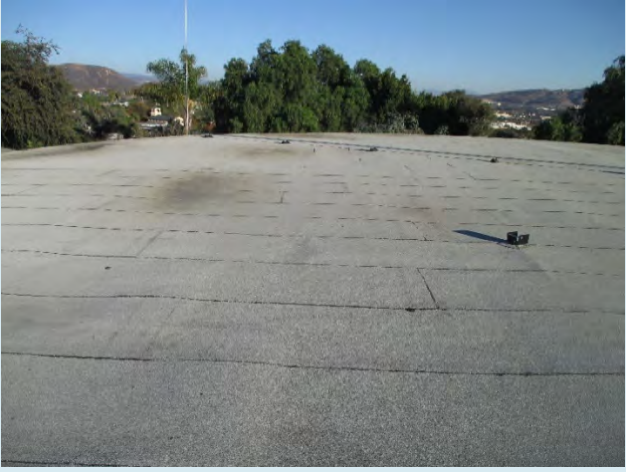
A Reservoir Structural Exterior Observations		Photo
Roof	Visible sagging of the roof paneling between the supports with evidence of ponding (throughout entire roof area). Vertical deflection of the roof system felt while walking the roof (Photo 1).	<p>Photo 1</p>

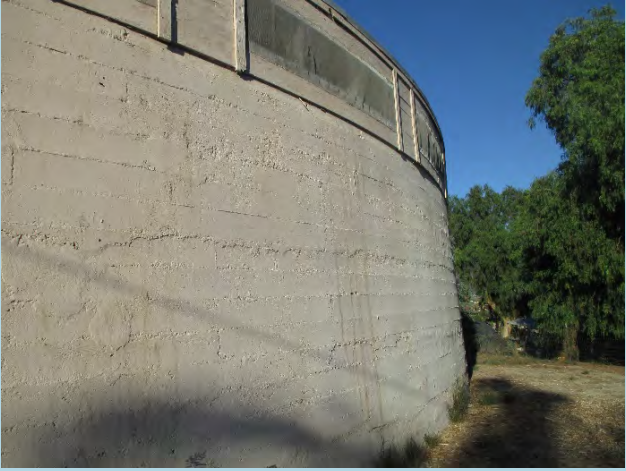
Wall	Typical staining of exterior wall surface from roof/wall interface (Photo 2).	<p>Photo 2</p>

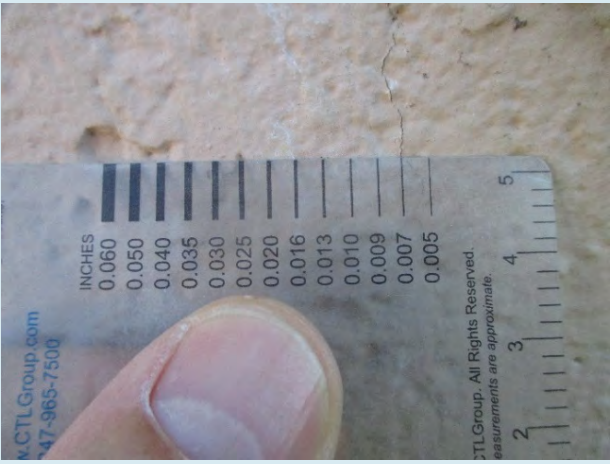
Wall	Typical full-height cracking in exterior face of concrete wall. This condition was observed along the entire perimeter of the reservoir at approximately 8-foot spacing. There does not appear to be any moisture seepage (Photo 3).	<p>Photo 3</p>

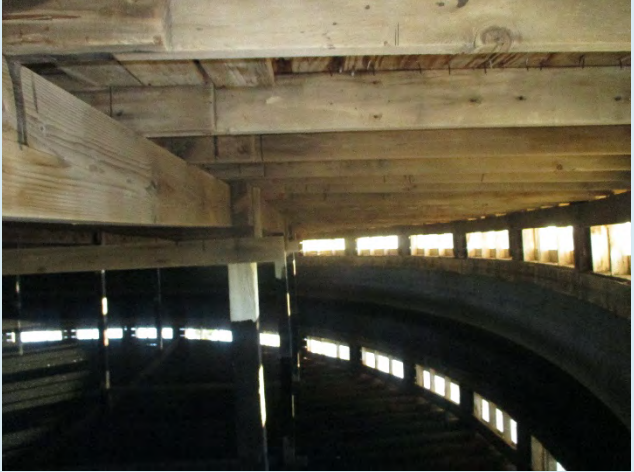
A Reservoir Structural Interior Observations		Photo
Roof	Typical condition of interior roof framing and support (Photo 1).	Photo 1

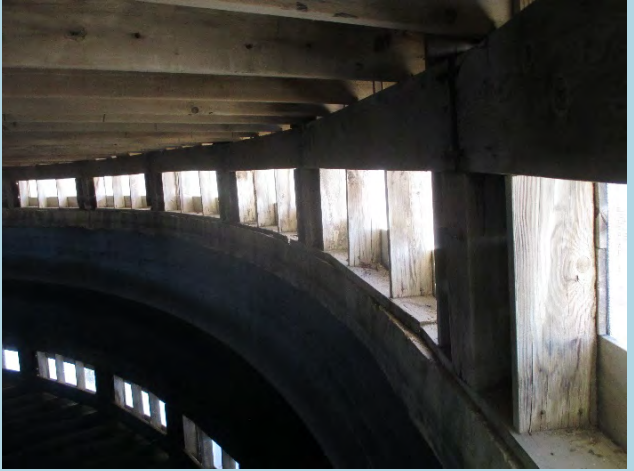
Roof/Wall	Typical condition of roof structure connection to reservoir wall (Photo 2).	Photo 2

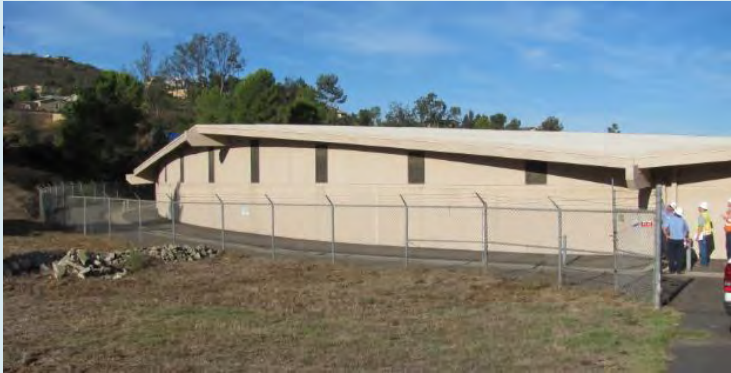
Pechstein Reservoir Civil/Site and Corrosion Observations		Photo
Fence/Gate	The perimeter of the reservoir is enclosed by a chain link fence with 3 rows of barbed wire on top. The fence and gate were observed to be in good condition with minor rusting (Photo 1).	<p>Photo 1</p>

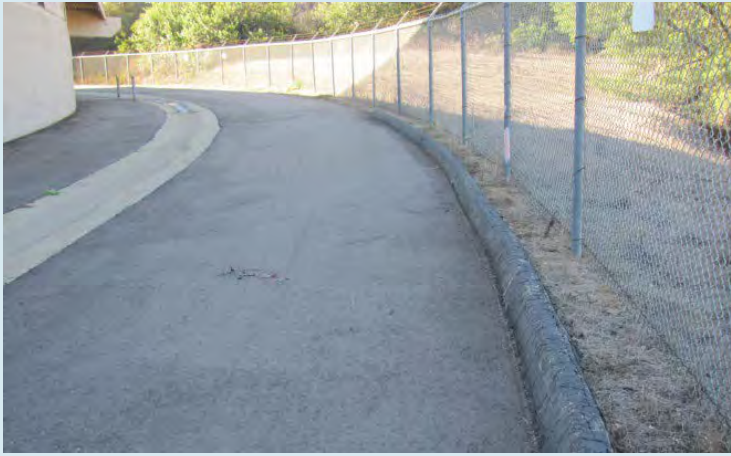
Access Road	Paved access road provides adequate space for field crews and multiple vehicles. The access road was observed to have minor cracking, displayed in Figure 4-3, but is in overall good condition (Photo 2).	<p>Photo 2</p>

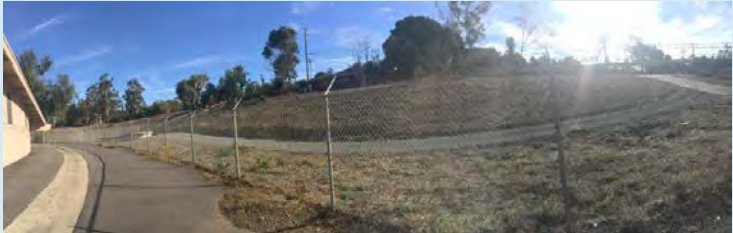
Trees and Vegetation	Typical trees and vegetation outside of the site fence (Photo 4).	<p>Photo 4</p>

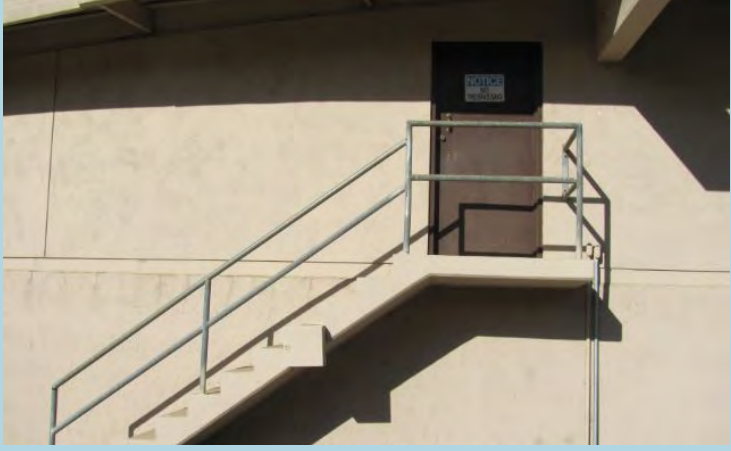
Pechstein Reservoir Civil/Site and Corrosion Observations		Photo
Entrance/Stairs	Access to the inside of Pechstein Reservoir is done through stairs located at the front entrance. Localized corrosion was observed on the interior door surface (Photo 5).	Photo 5

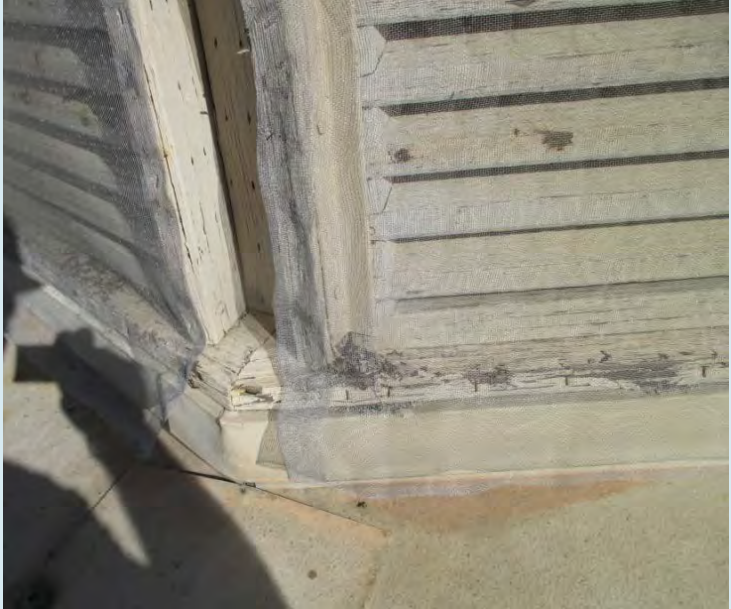
Pechstein Reservoir Civil/Site and Corrosion Observations		Photo
<p>Vents</p>	<p>One roof vent is located at the center of the reservoir roof. The roof vent had areas of rusting and loose mesh observed from a distance (Photo 6).</p> <p>Side vents are located around the perimeter every few feet apart. Vents have a mesh covering. Vents were observed to be in good condition with minor rusting (Photo 7).</p>	<p>Photo 6</p>

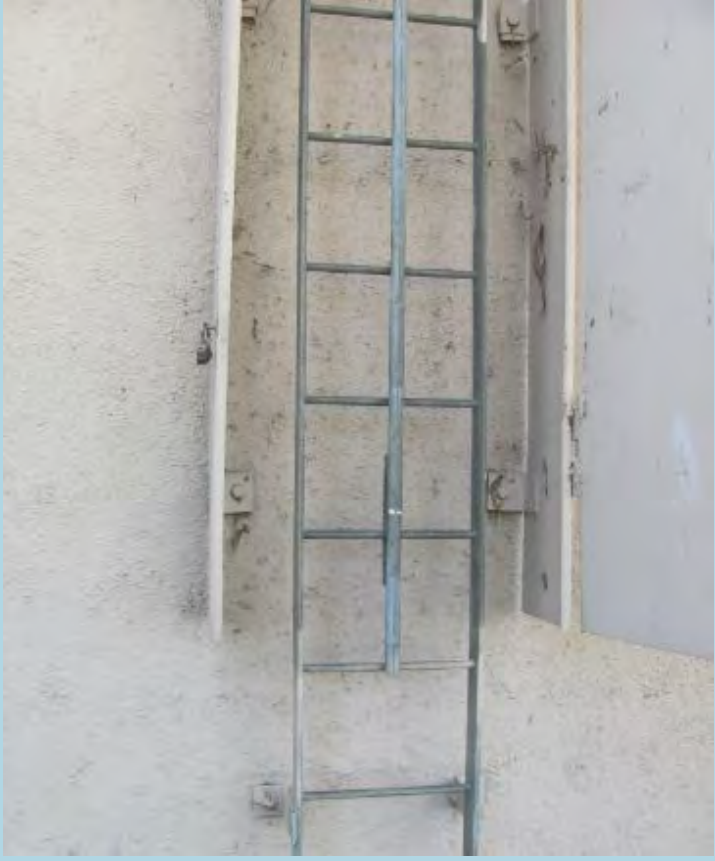
Pechstein Reservoir Civil/Site and Corrosion Observations		Photo
Ladders	Typical surface rusting on exterior ladder, overall in good condition (Photo 8).	Photo 8

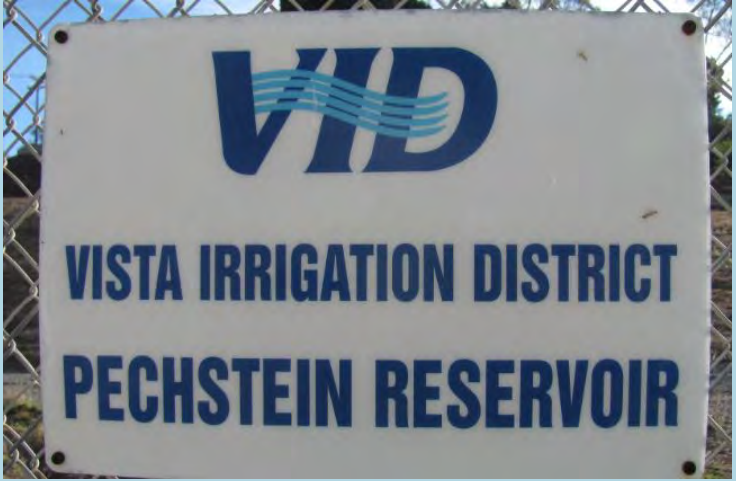
Pechstein Reservoir Civil/Site and Corrosion Observations		Photo
Signage	Site signage includes signs located on the entrance gate and along the fence. All signage typically in good condition (Photo 11).	Photo 11

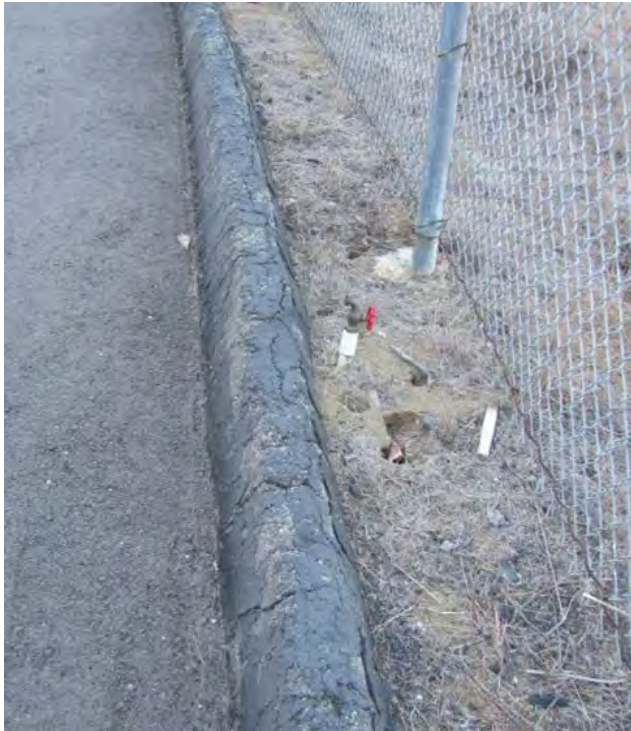
Figure 4-3. Pavement Cracks

- Continuous cracks along pavement surrounding Pechstein Reservoir is not currently of concern but should be monitored, see Figure 4-3.
- Evidence of ponding in channel surrounding Pechstein Reservoir coming from roof gutters is not currently of concern but should be monitored.
- Roof vent observed to have areas of rusting and loose mesh.
- Hatches contain rust spots and the access door interior contains areas of chipped off paint.
- No confined space signage installed at the roof hatch location.

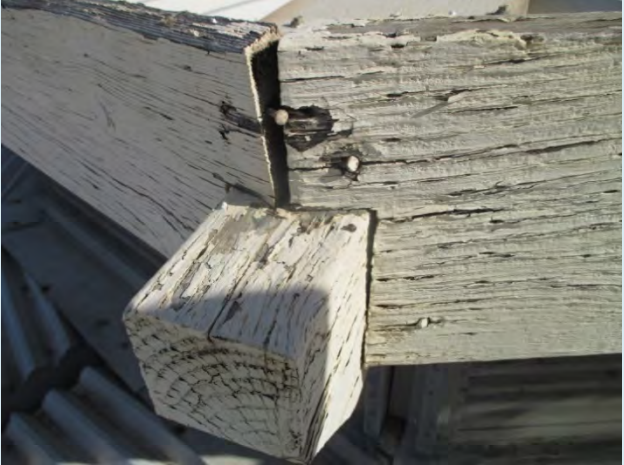
Pechstein Reservoir Structural Exterior Observations		Photo
Roof	Typical deterioration of exposed wood at center vent (Photo 1).	<p>Photo 1</p>

- The observed condition of the exposed wood at the center vent is expected of the age of its construction and does not appear to be affecting its function. All exposed wood should be recoated and, if necessary, replaced to ensure functionality of the vent structure.

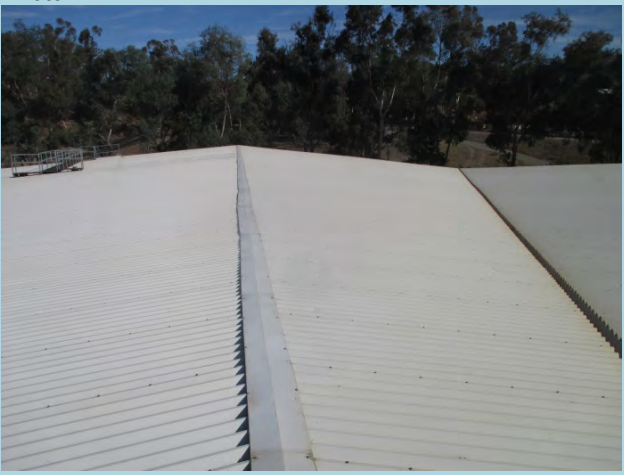
Roof	Typical condition of roof deck. Evidence of damage due to thermal movement including missing and replaced fasteners. Isolated locations where roof deck is not adequately supported due to damaged or displaced underlying roof framing members. Missing foam insulation (Photo 2).	<p>Photo 2</p>

- Damage due to thermal movement is typical of this type of roof deck. The deck connections to all supports should be routinely inspected and, if necessary, replaced, for safety and to ensure its functionality.

- Roof deck loading should be limited until all missing roof deck supports are replaced and deck attachments secured.
- All missing foam insulation should be replaced to restore weather-tightness of the reservoir.

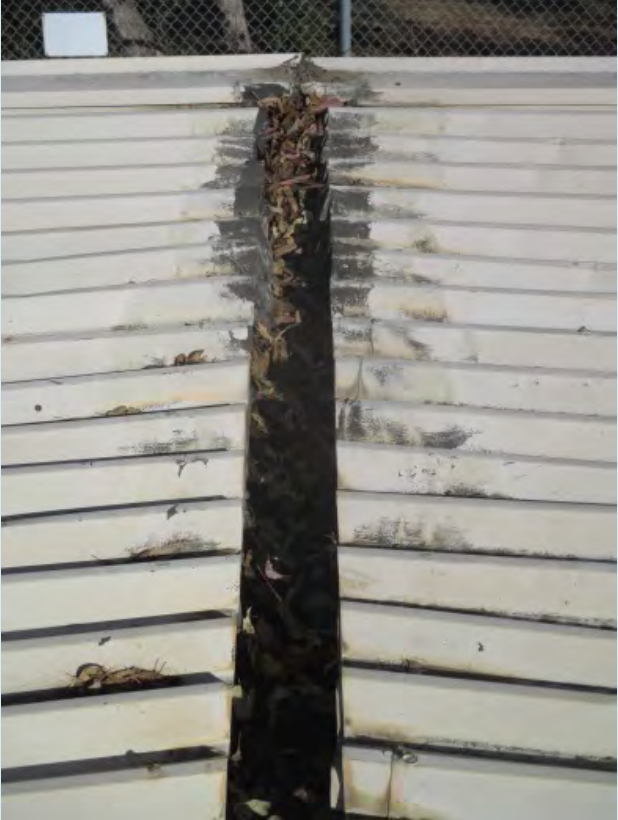
Pechstein Reservoir Structural Exterior Observations		Photo
Roof Drains	<p>Typical accumulation of debris at roof drains.</p> <p>Concentrated roof deck damage at these locations due to retained moisture.</p> <p>Evidence of prior repairs with isolated damage to adjacent roof deck due to workers walking on deck at these locations (Photo 3).</p>	<p>Photo 3</p>

- Current design of the roof drains allows accumulation of debris and moisture at the low points, leading to deterioration of the roof system at these locations. Leaking of the gutters is also contributing to the active moisture and damage observed at the valley girders. The roof drains should be redesigned to prevent these conditions.

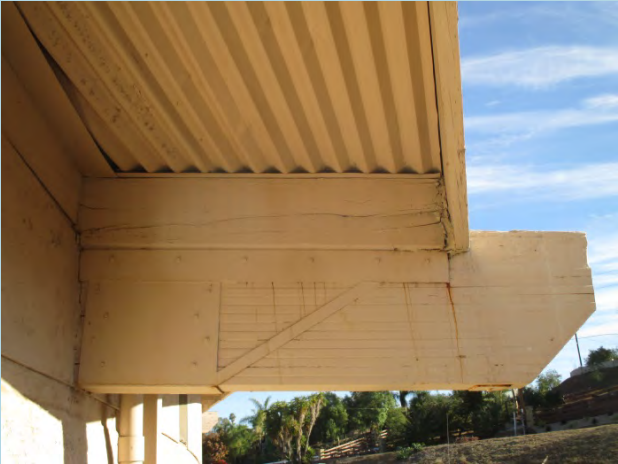
Roof	<p>Repaired valley girder at southeast quadrant (clockwise from access doorway). Active moisture with corrosion of painted metal components (Photo 4).</p>	<p>Photo 4</p>

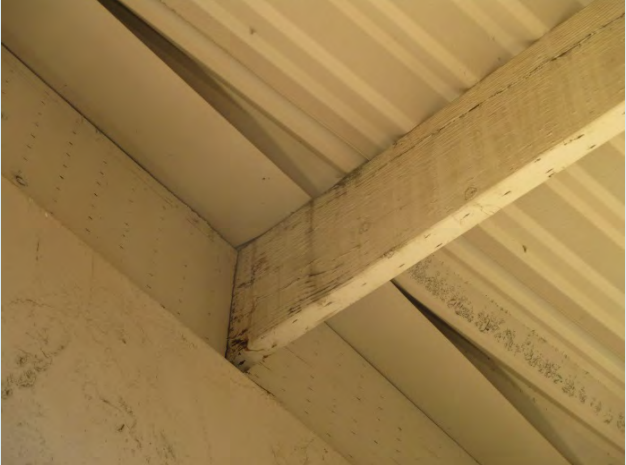
Pechstein Reservoir Structural Exterior Observations		Photo
Roof	<p>Typical condition of wood framing at top of masonry wall.</p> <p>Active moisture with visible wood deterioration (Photo 5).</p>	<p>Photo 5</p>

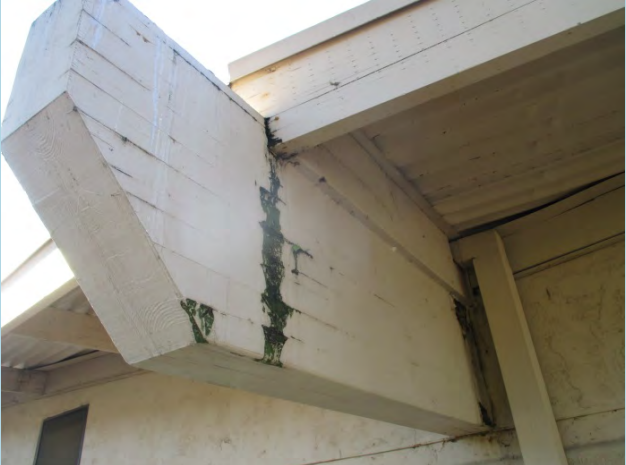
Roof	<p>Typical condition of valley girder.</p> <p>Deterioration and delamination of glu-lam beam with active moisture and staining visible (Photo 6).</p>	<p>Photo 6</p>

- The major contributor to the deterioration of the roof framing is the lack of ventilation inside the reservoir. This lack of ventilation allows condensation to form on the roof components. The condensation accumulates as it travels from ridge to valley, causing progressively more severe damage with accumulation. The observed deterioration caused by this condition includes; deterioration of the rafters and valley girders with active moisture and staining (Table 4-2, Photos 4 – 6), cracking of the masonry wall stucco with active moisture and staining at the intermediate girder bearings (Table 4-2, Photo 8), corrosion and failure of wood connections at the interior of the reservoir (Table 4-3, Photos 1 – 2, and as described by VID staff). Previous repairs to the valley girders, to mitigate this deterioration, were observed. Without improvements to the ventilation, the observed deterioration will continue.

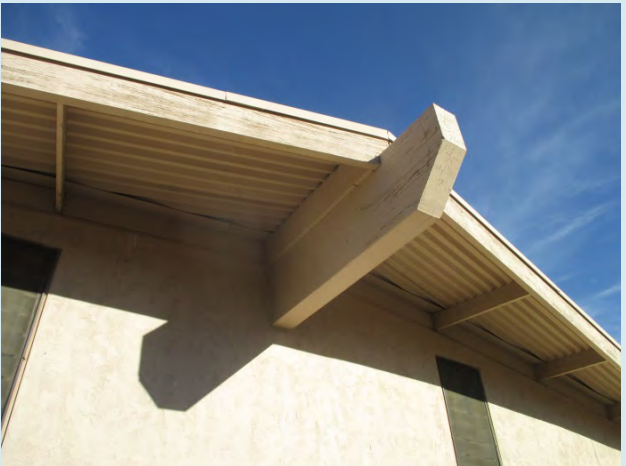
Roof	<p>Typical condition of ridge girder.</p> <p>Deterioration and delamination of glu-lam beam with no active moisture visible (Photo 7).</p>	<p>Photo 7</p>

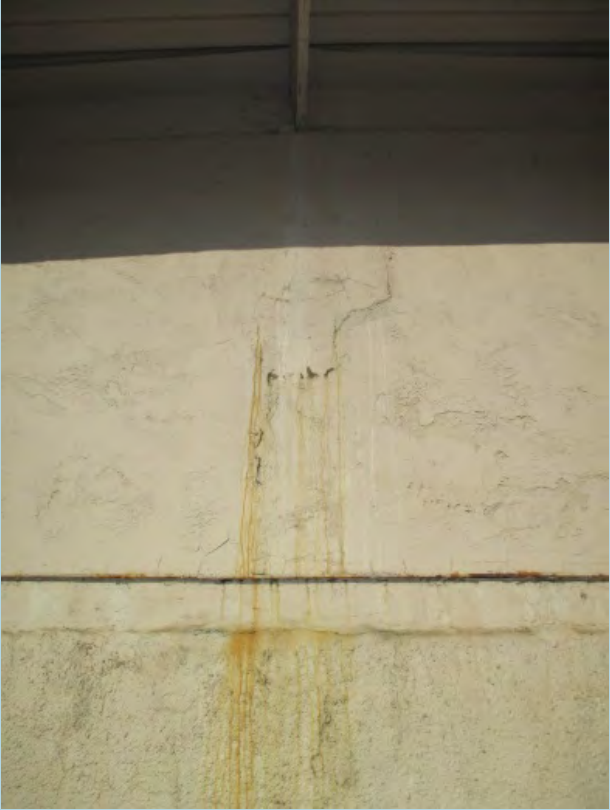
Pechstein Reservoir Structural Exterior Observations		Photo
Wall	<p>Typical condition of masonry wall at intermediate girder bearing (between ridge and valley girders).</p> <p>Cracking of stucco finish with active moisture and staining visible (Photo 8).</p>	<p>Photo 8</p>

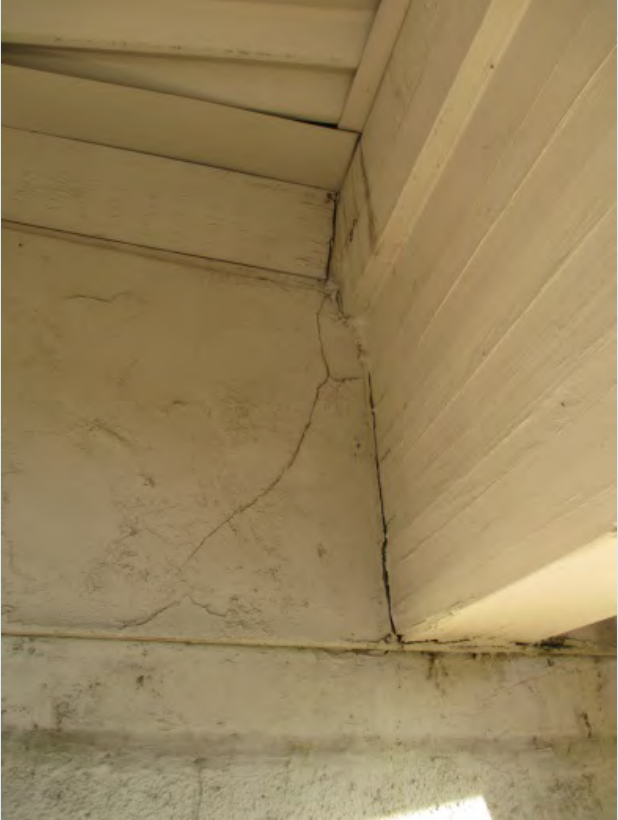
Pechstein Reservoir Structural Exterior Observations		Photo
Wall	Typical cracking in stucco finish at ridge and valley girder penetrations on masonry wall (Photo 9).	Photo 9

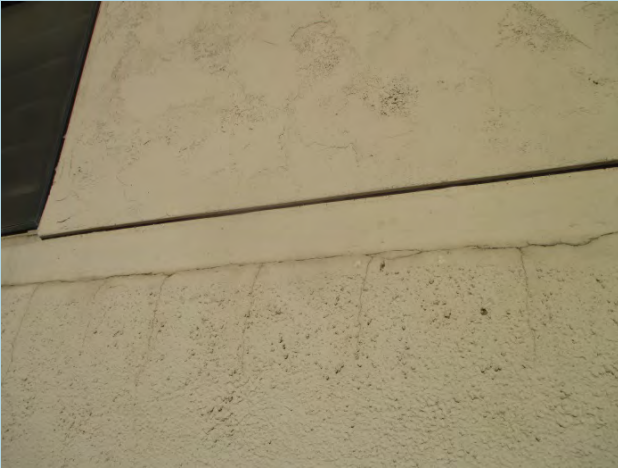
Wall	Typical vertical cracking in gunite finish at concrete/masonry wall transition with continuous horizontal crack at joint between wall types (Photo 10).	Photo 10

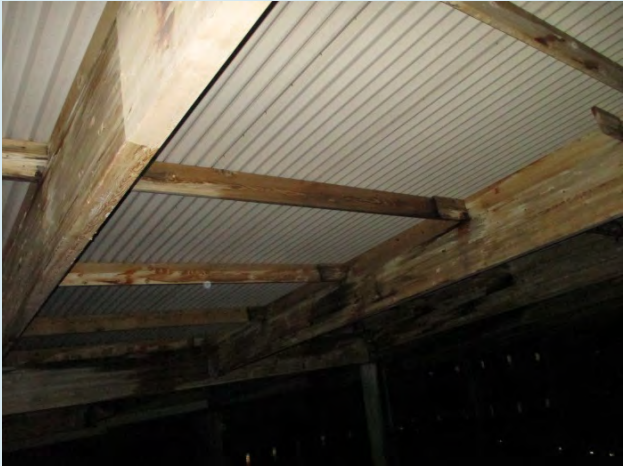
Pechstein Reservoir Structural Interior Observations		Photo
Roof	Typical condition of interior roof framing and support. Progressively more severe moisture accumulation (condensation) and corrosion of framing connections moving from ridge to valley (Photo 1).	<p>Photo 1</p>

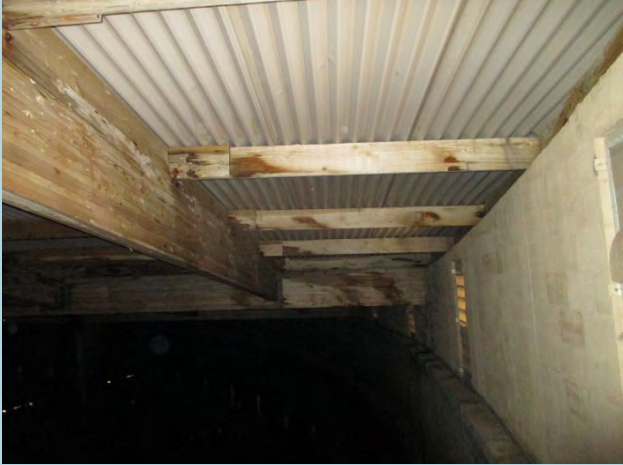
Pechstein Reservoir Structural Interior Observations		Photo
Roof/Wall	Typical condition of roof structure connection to reservoir wall (Photo 2).	Photo 2

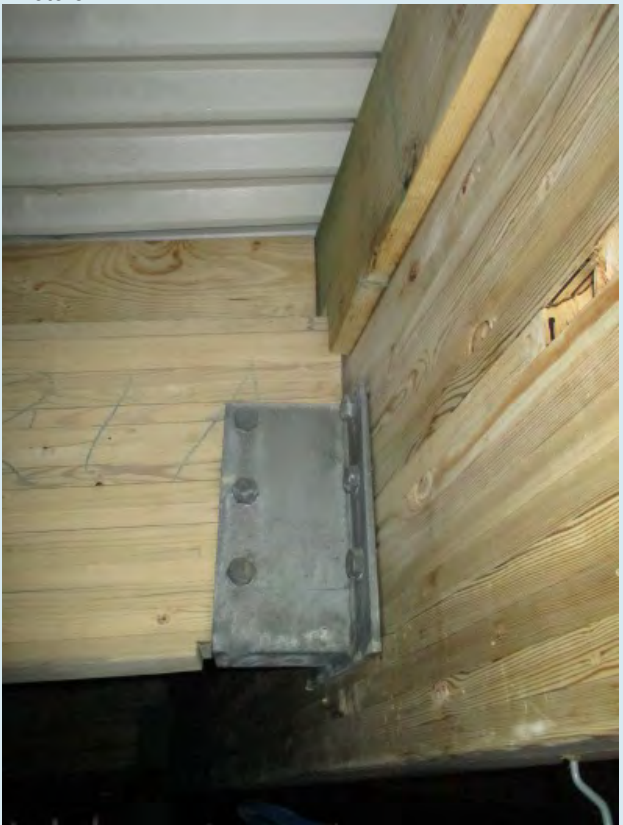
A photograph showing the interior of a structure, likely a reservoir, focusing on the roof structure. The roof is supported by wooden joists and rafters. The walls are made of corrugated metal. The lighting is dim, and the overall appearance is that of a well-maintained but somewhat aged structure.
Roof	Girder to Girder connection in good condition at ridge girder near access platform (Photo 3).	Photo 3

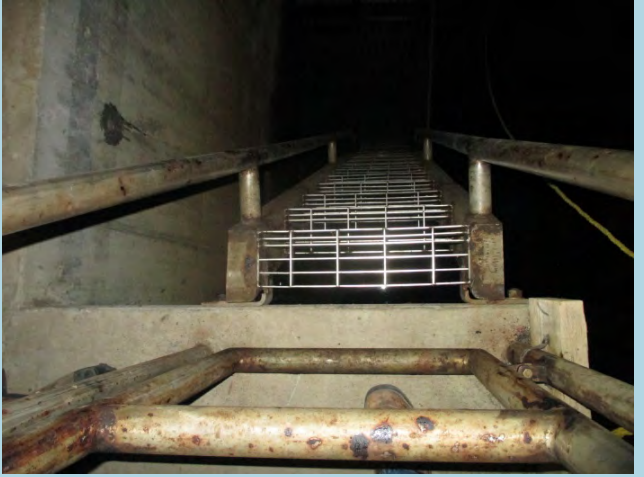
Pechstein Reservoir Structural Interior Observations		Photo
Access Stairs	Typical surface corrosion of interior metals (Photo 4).	Photo 4
