# Potable Water Master Plan

Vista Irrigation District

April 9, 2018

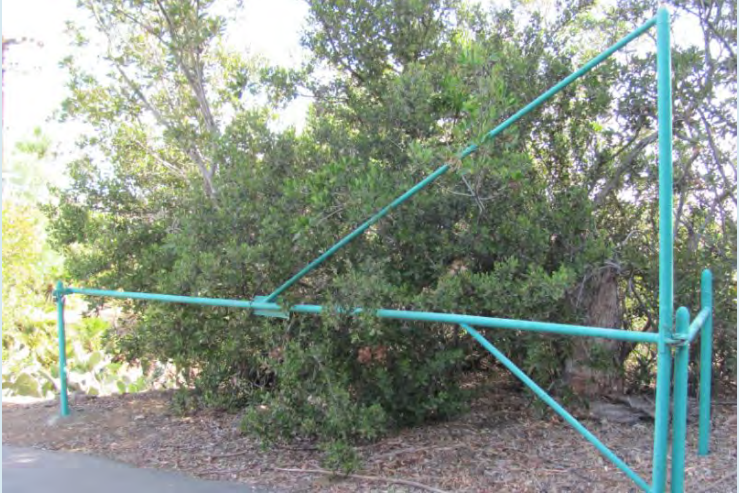
HB Reservoir Civil/Site and Corrosion Observations		Photo
Fence/Gate	<p>Access gate consists of a single swing gate and lock. Gate is observed to be in good condition (Photo 1).</p> <p>No VID fence surrounding the perimeter of the reservoir. West side of reservoir contains fencing from adjacent property (Photo 5).</p>	<p>Photo 1</p>

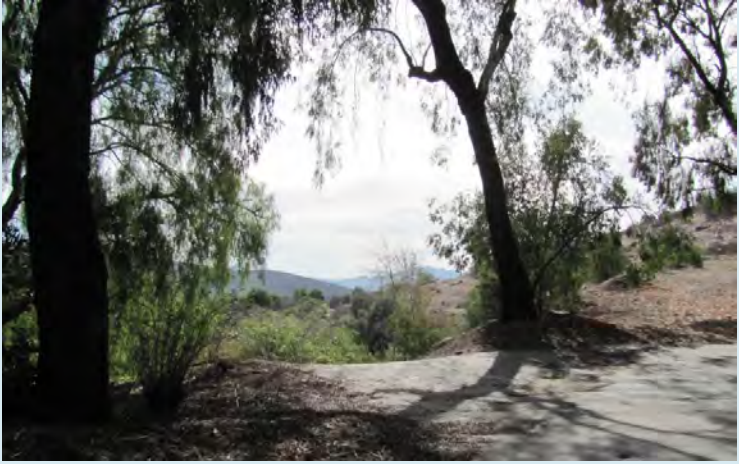
Access Road	<p>Paved access road leading up to and surrounding reservoir. Access road on north west side of entrance is completely accessible from the outside (Photo 2).</p>	<p>Photo 2</p>

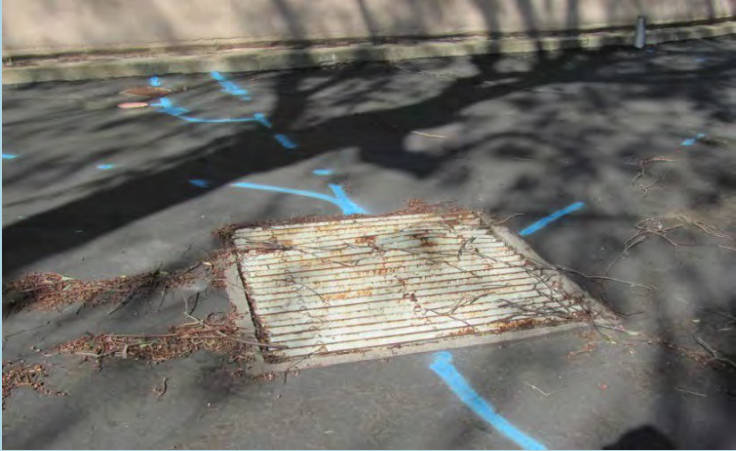
HB Reservoir Civil/Site and Corrosion Observations		Photo
Drainage	Roof drains located throughout perimeter of reservoir. Good slope for runoff into drain and surrounding vegetation (Photo 3).	<p>Photo 3</p>

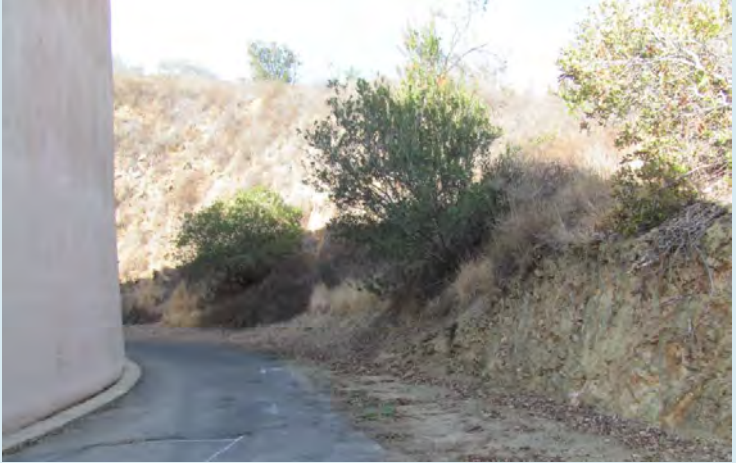
Trees and Vegetation	Typical trees and vegetation surrounding reservoir do not impose interference but could interfere with accessibility if not periodically maintained (Photo 4).	<p>Photo 4</p>

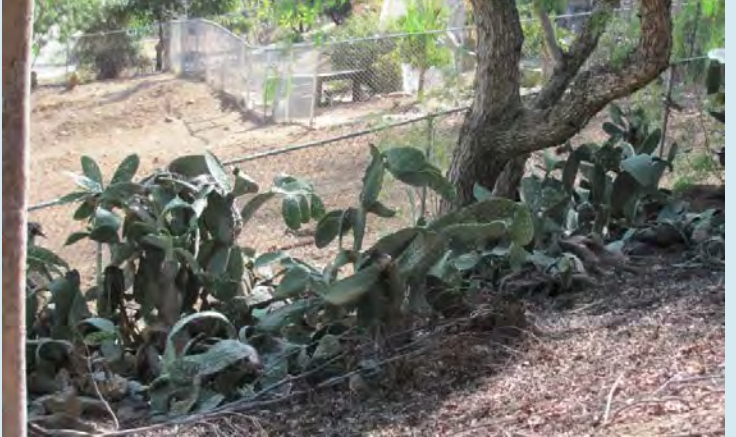
Trees and cactus located on west side of entrance along adjacent property (Photo 5).	<p>Photo 5</p>

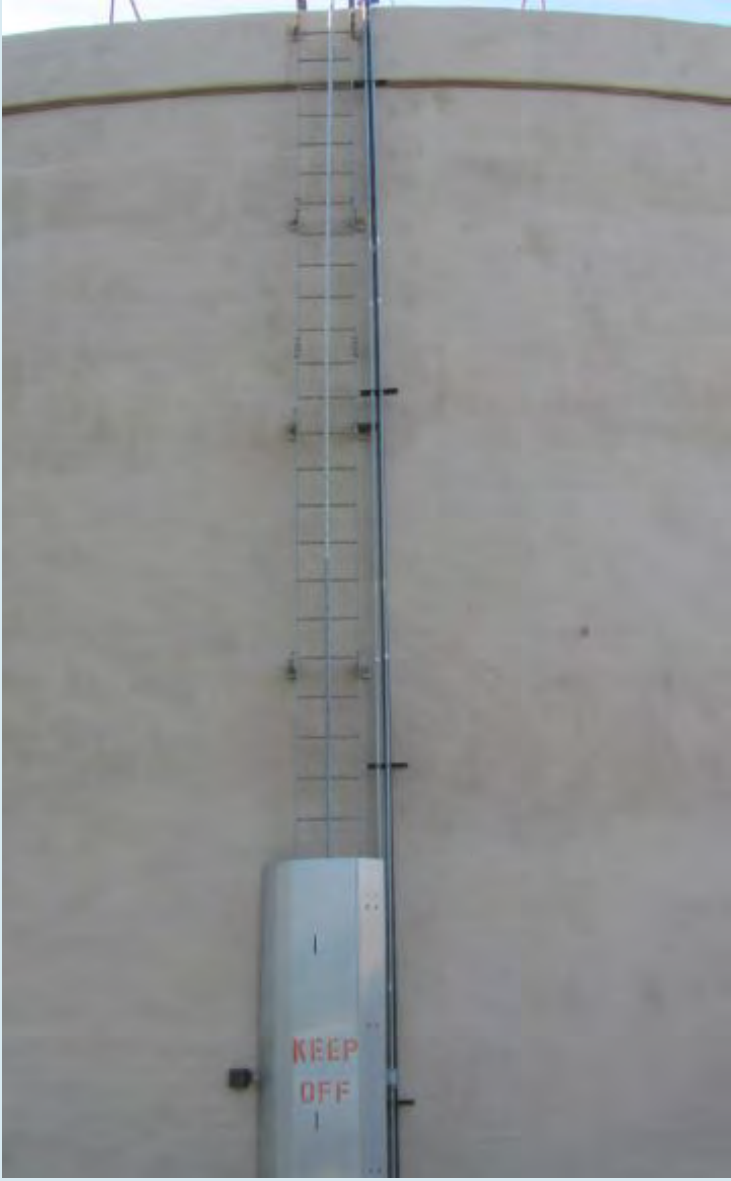
HB Reservoir Civil/Site and Corrosion Observations		Photo
Ladders	<p>Typical exterior ladder observed to be in overall good condition (Photo 8).</p> <p>Exterior ladder at the time of inspections is scheduled to be replaced.</p> <p>Interior ladder was observed to have significant corrosion at anchor brackets due to galvanic coupling with stainless anchor bolts.</p>	<p>Photo 8</p>

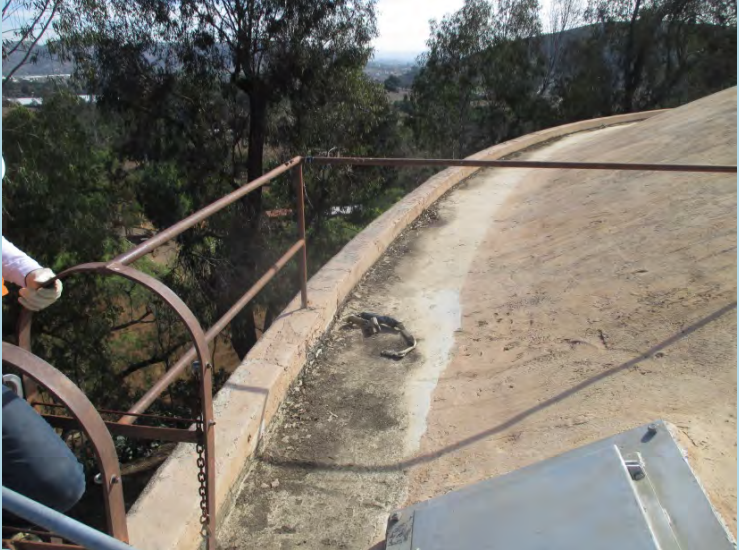
HB Reservoir Civil/Site and Corrosion Observations		Photo
Handrails, and Guardrails	<p>Handrail and guardrail located at the reservoir were observed to be in good condition. Minor rusting on guardrail. (Photo 9)</p> <p>Handrail and guardrail at the time of inspections is scheduled to be replaced.</p>	<p>Photo 9</p>

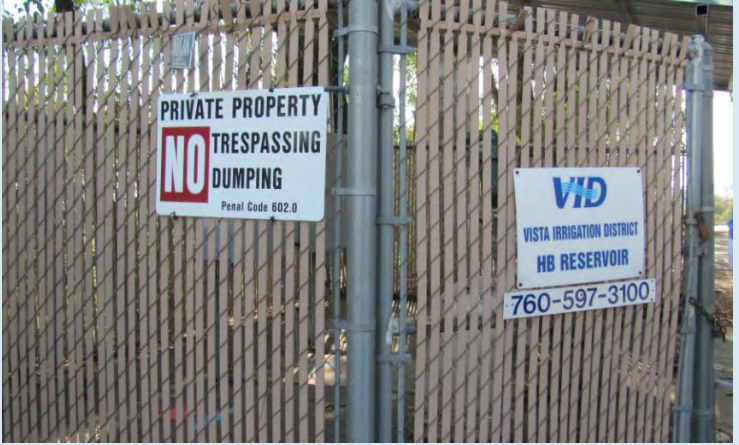
Signage	<p>Site signage includes signs located on the entrance gate. No signage located along the perimeter of the reservoir. Signage observed to be in good condition (Photo 10).</p>	<p>Photo 10</p>

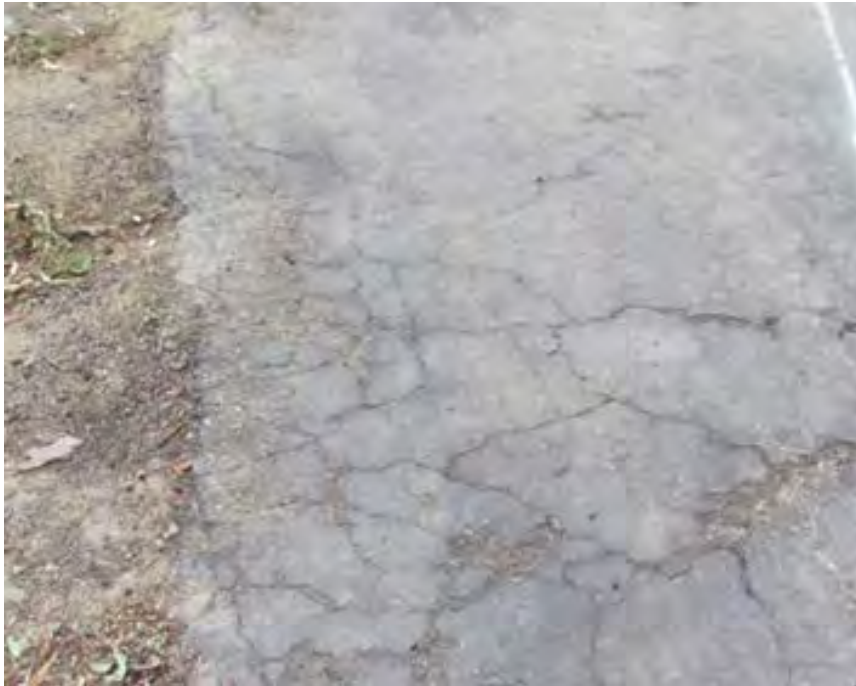
**Figure 5-4. Pavement Cracking**

- No confined space signage installed at the roof hatch location.
- The access road pavement is in good condition with minor cracking observed, displayed in Figure 5-4. Minor cracking is not currently a concern.
- Surrounding trees and vegetation out of vicinity of site operation and maintenance at the time of inspections but overgrown bushes could become an obstruction if not maintained periodically.
- Interior ladder has significant corrosion and metal loss at bracket locations.
- External pipe riser and blow-off in enclosure near site gate have surface rusting.

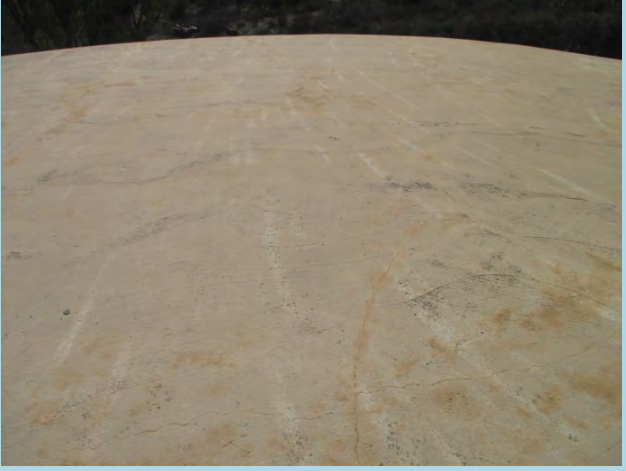
Roof	Typical cracking on concrete roof. Horizontal and vertical cracking uniform over entire roof area (Photo 2).	<p>Photo 2</p>

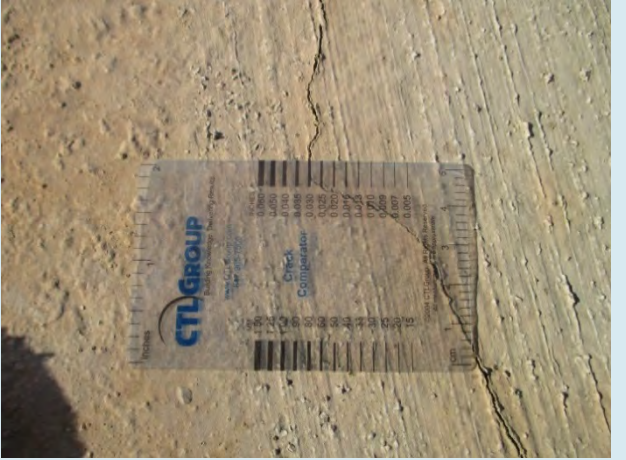
Roof	Typical crack width on concrete roof (Photo 3).	<p>Photo 3</p>

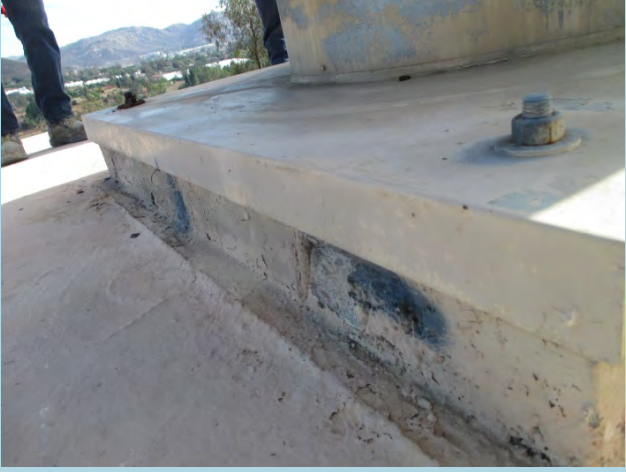
HB Reservoir Structural Exterior Observations		Photo
Roof	Exposed reinforcing at concrete curb at center vent (Photo 4).	<p>Photo 4</p>

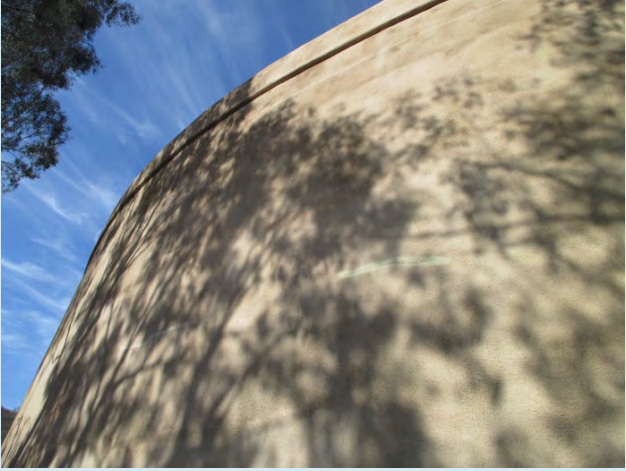
Wall	<p>Previously repaired horizontal cracking in shotcrete finish at east side of reservoir (approximately 5 locations).</p> <p>No evidence of moisture seepage or corrosion of underlying prestressed reinforcing (Photo 5).</p>	<p>Photo 5</p>

- The cracking of the shotcrete finish is not currently a structural concern, but should be monitored for corrosion of the embedded circumferential prestressed reinforcing. This condition likely indicates leaking in the reservoir's existing hypalon membrane liner.

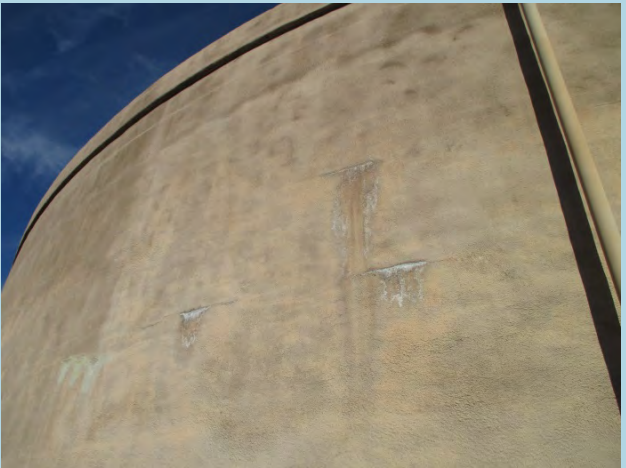
Wall	<p>Horizontal cracking in shotcrete finish with active moisture seepage at southwest and southeast reservoir quadrants (approximately 10 locations).</p> <p>No evidence of corrosion of underlying prestressed reinforcing (Photo 6).</p>	<p>Photo 6</p>

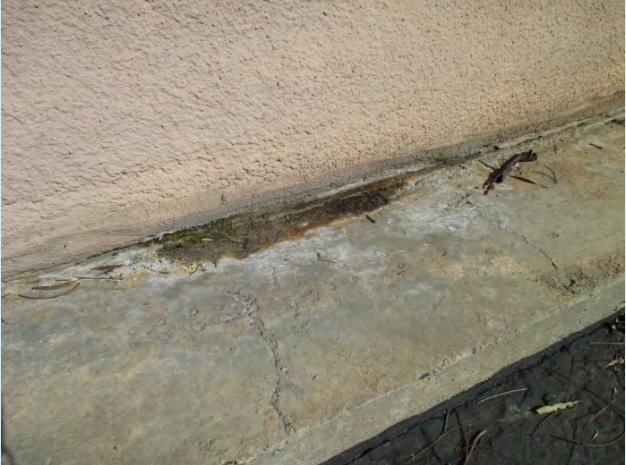
HB Reservoir Structural Exterior Observations		Photo
Wall Foundation	<p>Active moisture seepage at wall/foundation joint at south end of reservoir.</p> <p>Radial cracking in concrete foundation. This condition was observed along the entire perimeter of the reservoir at approximately 4-foot spacing (Photo 7).</p>	<p>Photo 7</p>

- The cracking of the concrete foundation appears to have been present since construction, but should be addressed to prevent long-term damage to the concrete and embedded steel reinforcing due to moisture infiltration.

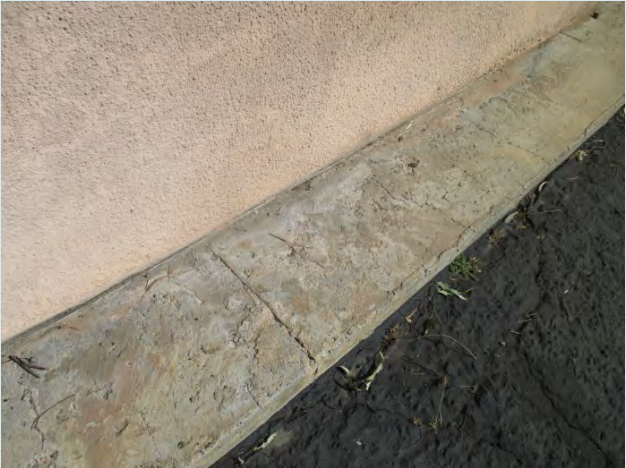
Foundation	<p>Typical crack width in concrete foundation (Photo 8).</p>	<p>Photo 8</p>  
Foundation	<p>Typical scaling of top surface of concrete foundation (Photo 9).</p>	<p>Photo 9</p>

- The scaling of the concrete foundation is indicative of poor finishing methods of the concrete during construction. This is not currently a structural concern, but should be addressed to prevent more severe long-term damage to the concrete.

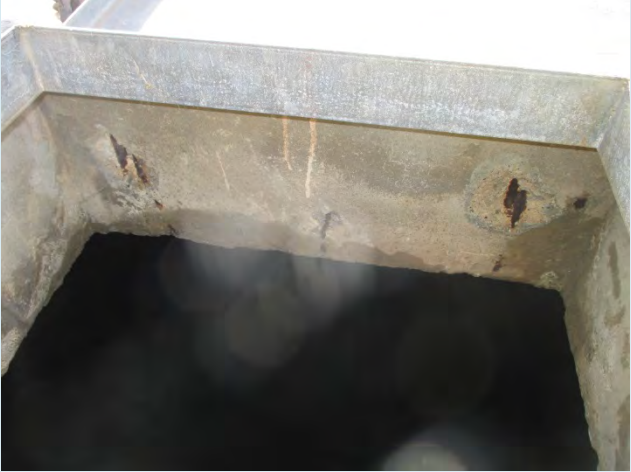
HB Reservoir Structural Interior Observations		Photo
Access Hatch	Exposed corroded reinforcing at roof opening (Photo 1).	Photo 1

- The exposed corroded reinforcing in the concrete at the roof hatch opening is the result of insufficient concrete cover over the reinforcing during construction. This should be repaired to prevent long-term damage to the concrete.

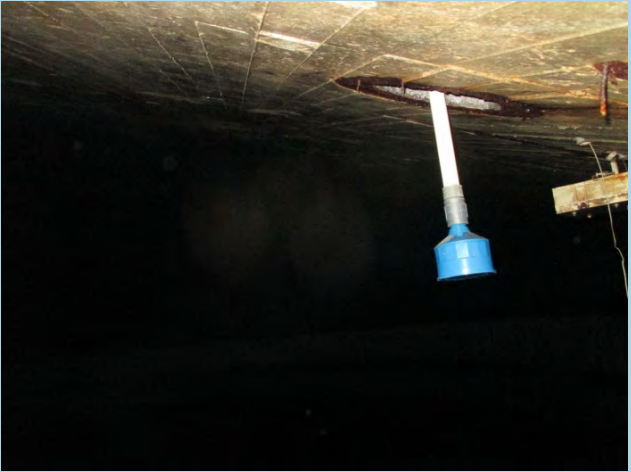
Roof	Typical severe corrosion of interior metals (Photo 2).	Photo 2

- The severe corrosion of the interior metals should be addressed to maintain long-term serviceability of the metal components and the adjacent concrete.

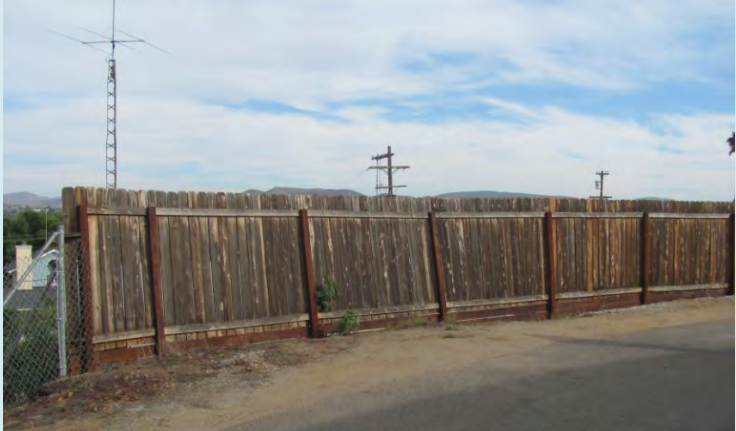
C Reservoir Civil/Site and Corrosion Observations		Photo
Fence/Gate	<p>No VID main site access gate.</p> <p>VID fence does not surround entire perimeter of reservoir. Partial wood fence owned by homeowner separates adjacent properties (Photo 1).</p> <p>Perimeter fence would deny access to homeowners on the west side.</p>	<p>Photo 1</p>

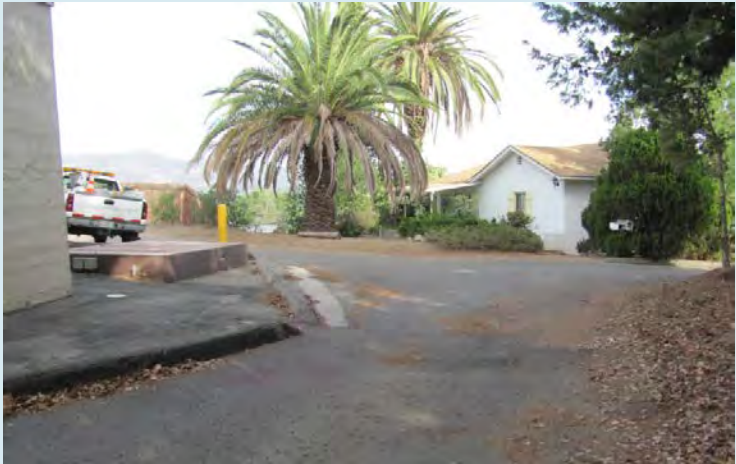
Access Road	<p>Paved access road provides adequate space for inspection teams and their vehicles (Photo 2).</p> <p>Paved access road contains areas of uneven surface and minor cracks.</p>	<p>Photo 2</p>

- The paved access road pavement contains areas of uneven surface and minor cracks.

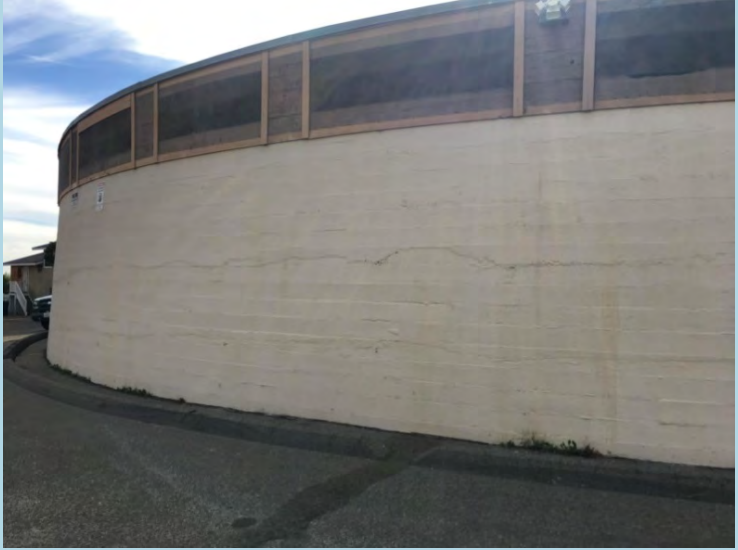
C Reservoir Civil/Site and Corrosion Observations		Photo
Drainage	<p>Paved gutter around perimeter of reservoir observed to be clear and good condition. Runoff slopes away from reservoir (Photo 3).</p>	<p>Photo 3</p>

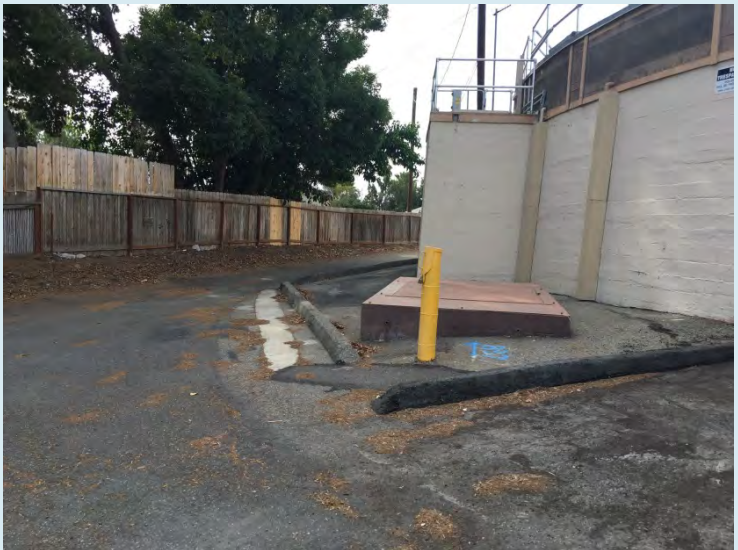
Trees and Vegetation	<p>Typical trees and vegetation along adjacent properties. No imposing accessibility interference (Photo 2).</p> <p>Minor shrubbery around perimeter of reservoir (Photo 4).</p>	<p>Photo 4</p>

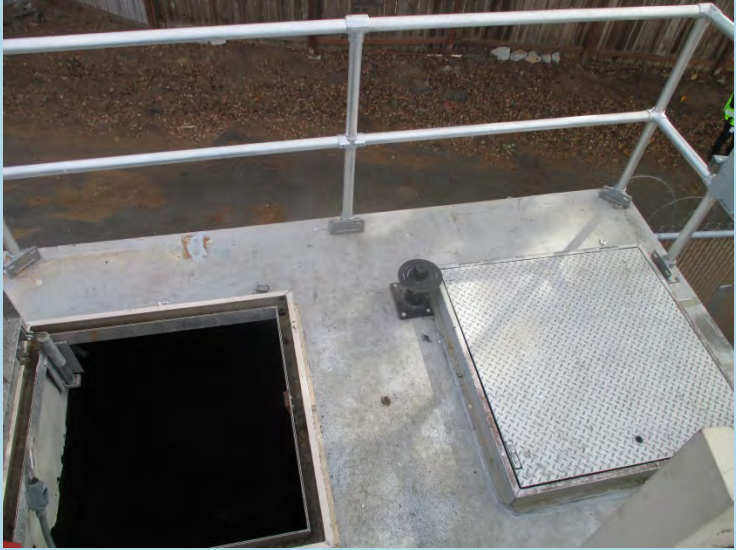
C Reservoir Civil/Site and Corrosion Observations		Photo
Hatches	Minor corrosion on interior of aluminum hatch on reservoir roof. Float box hatches found to be in good condition. Support beam inside float box found to be wrapped with tar tape (Photo 5).	Photo 5

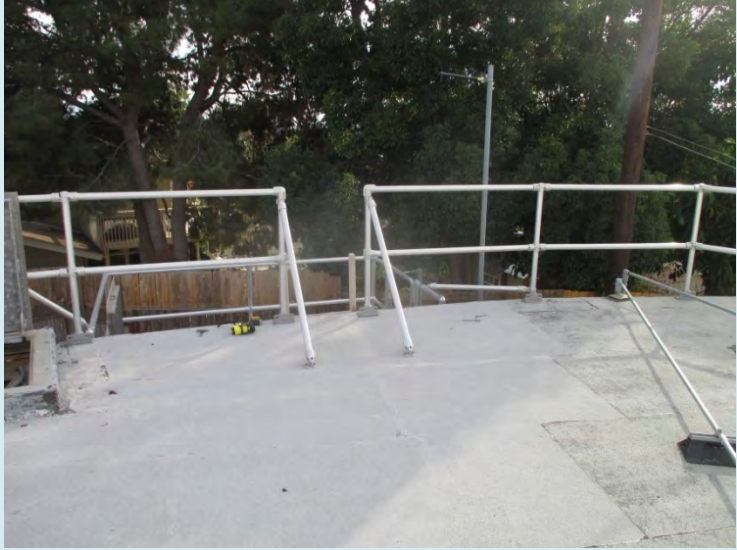
C Reservoir Civil/Site and Corrosion Observations		Photo
Handrails, and Guardrails	Guardrail is located on the reservoir roof at the hatch. Toe board is missing. The aluminum guardrails were observed to be in overall good condition (Photo 10).	<p>Photo 10</p>

- The fixed exterior ladders are not OSHA compliant and require further modification.
- Toe board missing, aluminum guardrail observed to be in good condition.

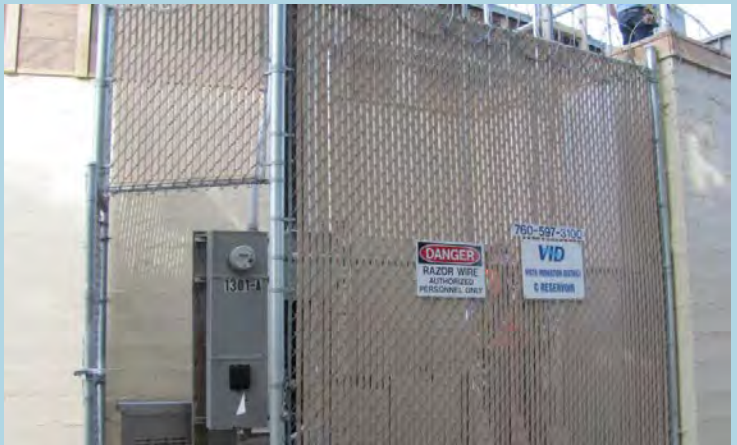
Signage	Site signage includes signs located on the fence surrounding ladder. No trespassing sign located along reservoir. All signage observed to be in good condition (Photo 11).	<p>Photo 11</p>

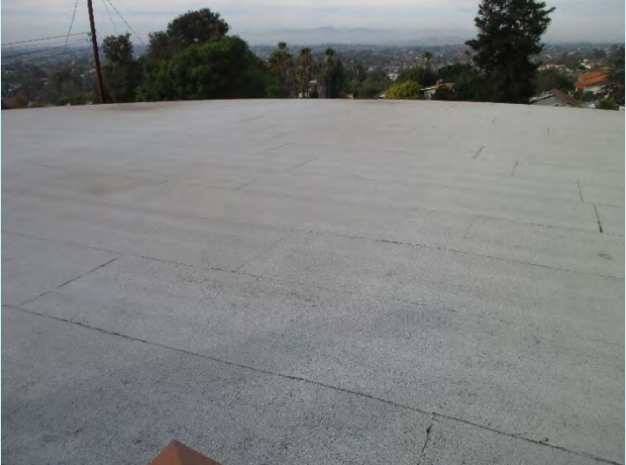
C Reservoir Structural Exterior Observations		Photo
Roof	Visible sagging of the roof paneling between the supports with evidence of ponding along the roof edge. Minor vertical deflection of the roof system felt while walking the roof (Photo 1).	<p>Photo 1</p>

- The sagging and evidence of ponding observed on the roof is expected of age and type of construction. Roof loading should be limited and roof condition monitored regularly for safety.
- The staining of the exterior wall surface is not a structural concern.
- The wall cracking appears to have been present since construction and is not a structural concern.
- Despite the age of the roof framing, it is in fair condition and appears to be functioning properly. As stated previously, the roof system is not in compliance with the current seismic code and should be monitored regularly for safety.

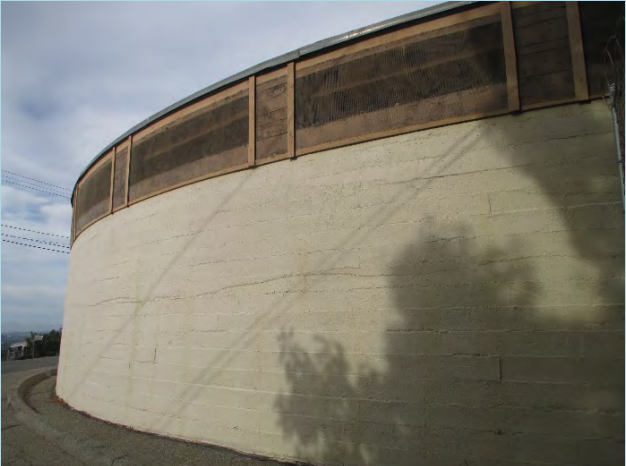
Wall	Typical staining of exterior wall surface from roof/wall interface (Photo 2).	<p>Photo 2</p>

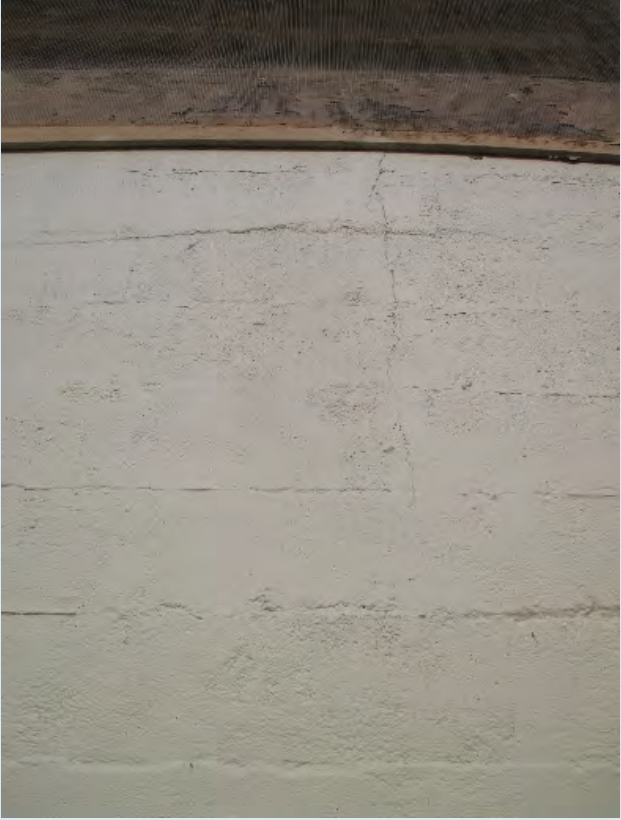
C Reservoir Structural Exterior Observations		Photo
Wall	Typical full-height cracking in exterior face of concrete wall. This condition was observed along the entire perimeter of the reservoir at approximately 8-foot spacing. There does not appear to be any moisture seepage (Photo 3).	Photo 3

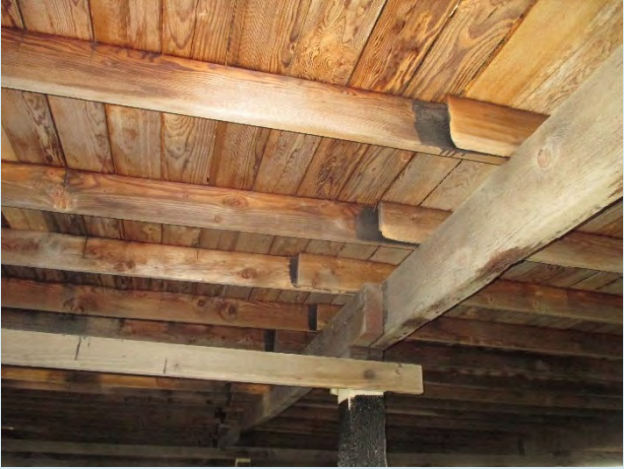
C Reservoir Structural Interior Observations		Photo
Roof	Typical condition of interior roof deck, roof framing, and support (Photo 1).	<p>Photo 1</p>

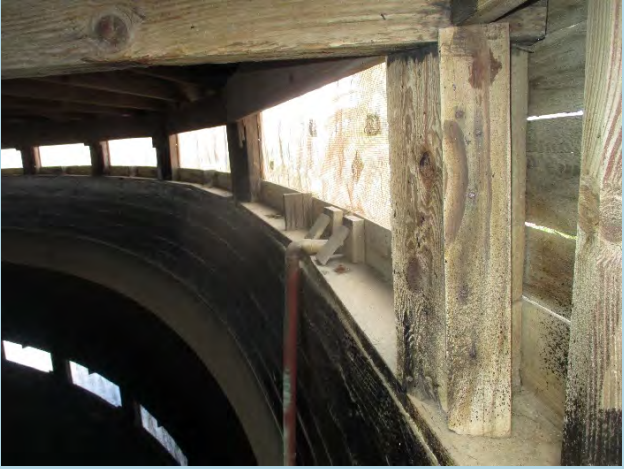
Roof/Wall	Typical condition of roof structure connection to reservoir wall (Photo 2).	<p>Photo 2</p>

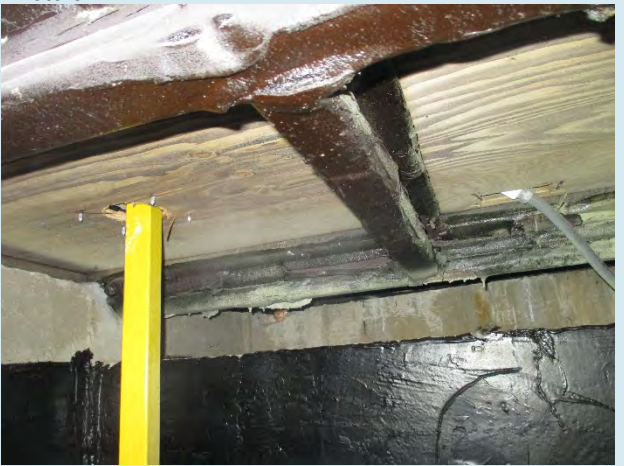
Control Box Roof	Typical condition of interior roof framing and underside of roof deck (Photo 3).	<p>Photo 3</p>

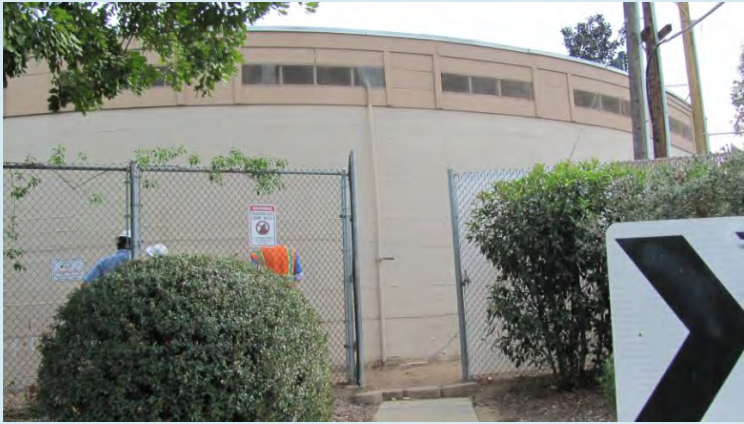
E1 Reservoir Civil/Site and Corrosion Observations		Photo
Fence/Gate	Typical VID chain link fence surrounds entire perimeter of reservoir. Fence and gate observed to be in good condition (Photo 1).	<p>Photo 1</p>

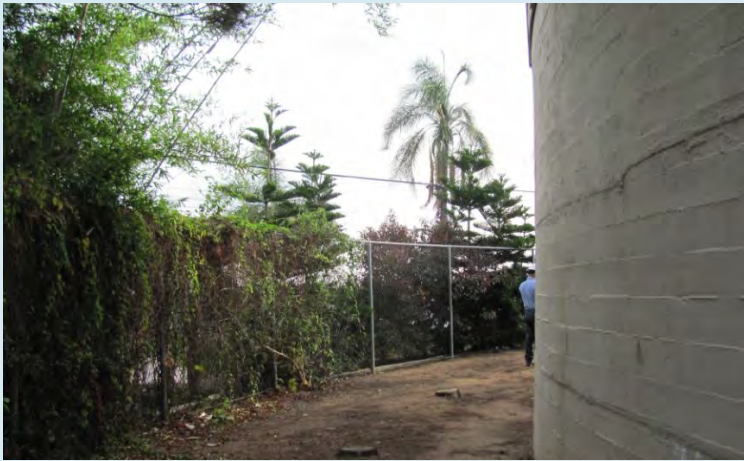
Access Road	<p>Tree growth along fence observed (Photo 2 and Photo 4).</p> <p>Paved access road and a set of stairs lead to the reservoir entrance. Dirt surrounds boundary of reservoir (Photo 2).</p> <p>Adequate space for inspection teams and their vehicles is located on paved access road.</p>	<p>Photo 2</p>

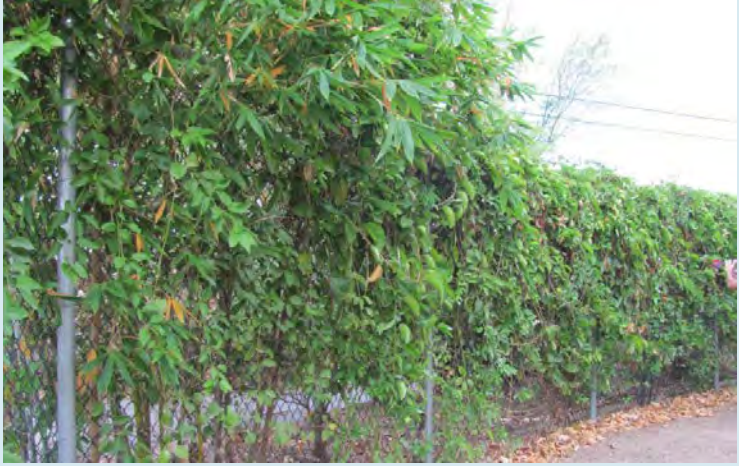
E1 Reservoir Civil/Site and Corrosion Observations		Photo
Trees and Vegetation	Tree growth over a majority of the fence all along west side. Imposing accessibility interference (Photo 4).	<p>Photo 4</p>

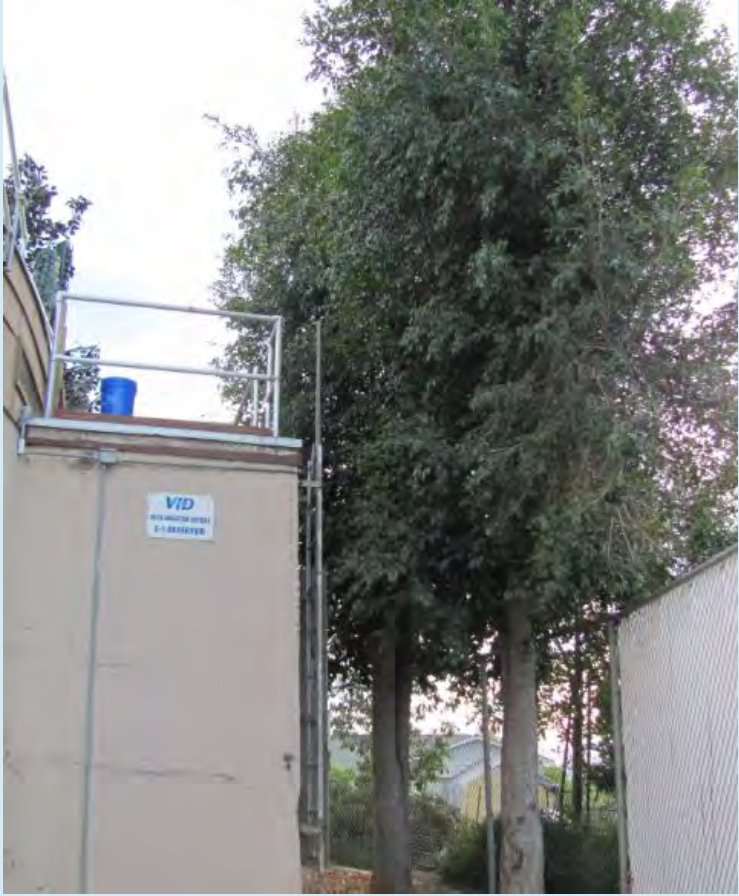
Two large trees located within five feet of reservoir and exterior ladder on the east side (Photo 5).	<p>Photo 5</p>

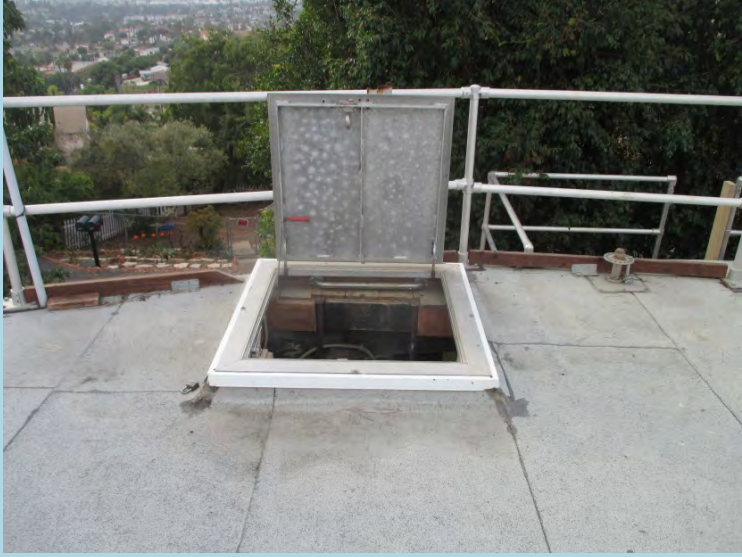
E1 Reservoir Civil/Site and Corrosion Observations		Photo
Hatches	Surface rusting observed on lock cover of roof hatch. Corroded screws on latch mechanism. Minor staining on interior of aluminum hatch (Photo 6).	Photo 6

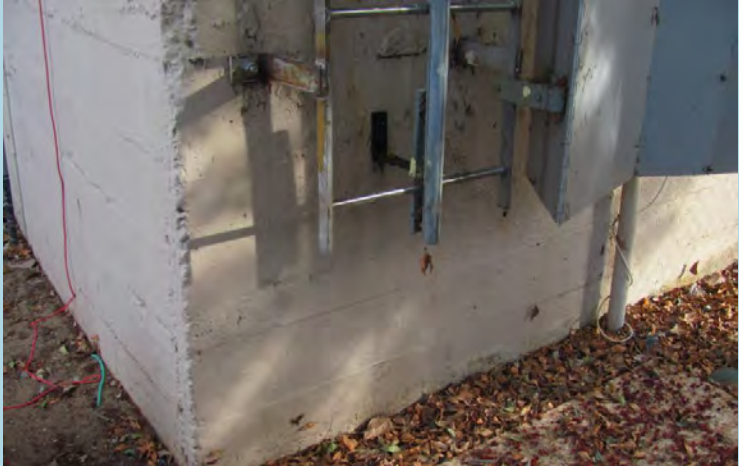
Exterior ladders first step bracket is placed too high (Photo 11).	<p>Photo 11</p>

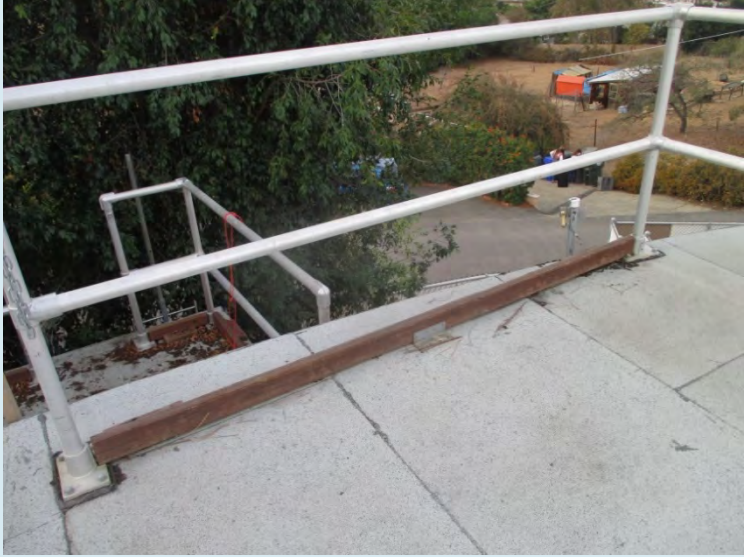
E1 Reservoir Civil/Site and Corrosion Observations		Photo
Handrails, and Guardrails	Guardrail is located on the reservoir roof at the hatch. Missing toe boards on roof (Photo 12).	<p>Photo 12</p>

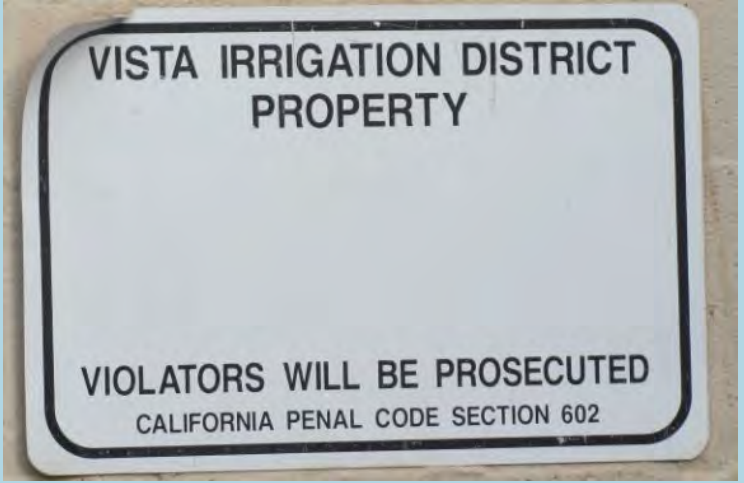
Signage	<p>Site signage includes signs located on the fence and along reservoir.</p> <p>Red text from signs has completely faded (Photo 13).</p>	<p>Photo 13</p>

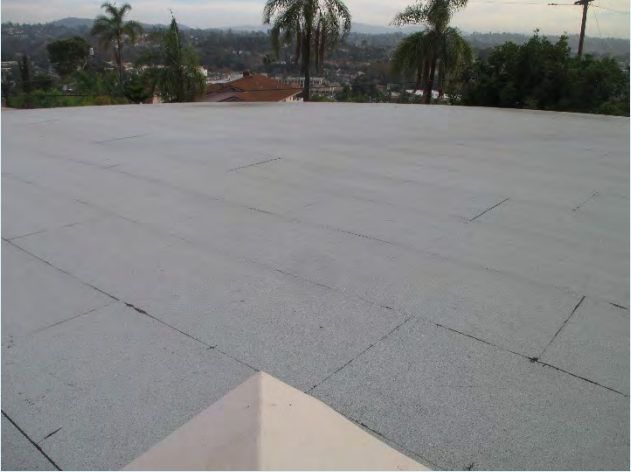
E1 Reservoir Structural Exterior Observations		Photo
Roof	Visible sagging of the roof paneling between the supports with evidence of ponding along the roof edge. Minor vertical deflection of the roof system felt while walking the roof (Photo 1).	<p>Photo 1</p>

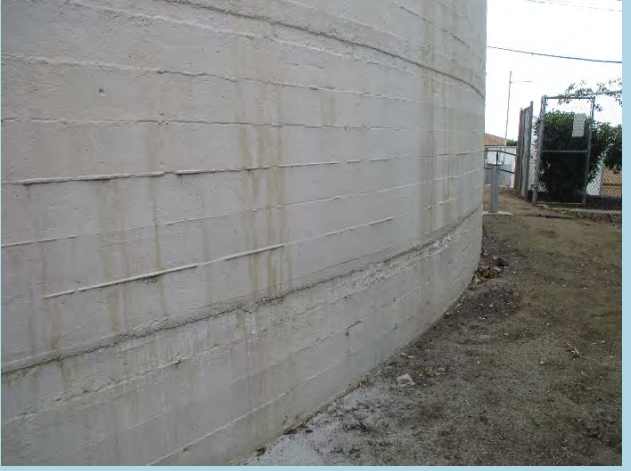
Wall	Typical staining of exterior wall surface from roof/wall interface (Photo 2).	<p>Photo 2</p>

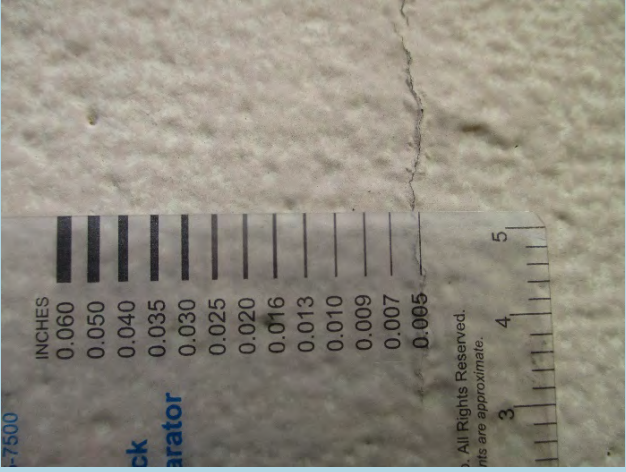
E1 Reservoir Structural Exterior Observations		Photo
Wall	<p>Typical full-height cracking in exterior face of concrete wall. This condition was observed along the entire perimeter of the reservoir at approximately 8-foot spacing. There does not appear to be any moisture seepage (Photo 4).</p>	<p>Photo 4</p>

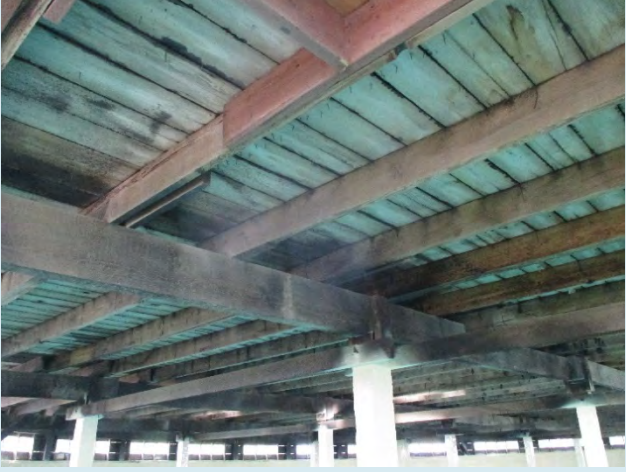
E1 Reservoir Structural Interior Observations		Photo
Roof	Typical condition of interior roof deck, roof framing, and support (Photo 1).	<p>Photo 1</p>

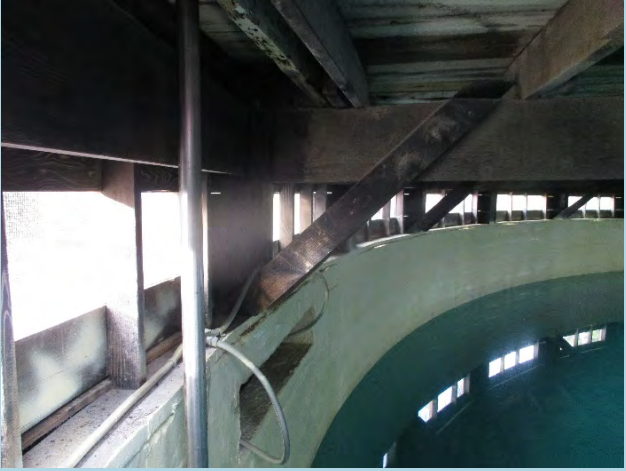
Roof/Wall	Typical condition of roof structure connection to reservoir wall (Photo 2).	<p>Photo 2</p>

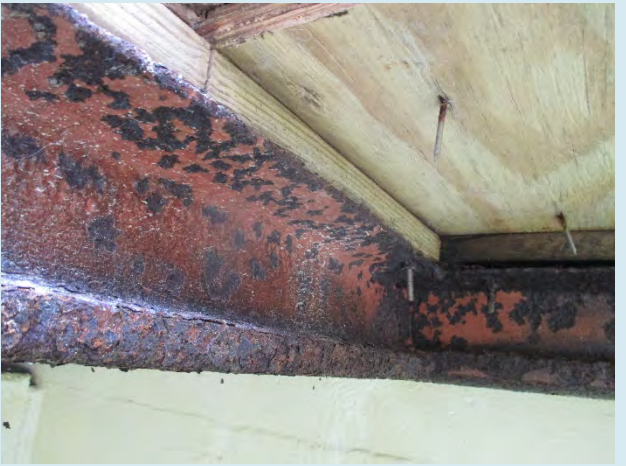
Control Box Roof	Typical condition of interior roof framing and underside of roof deck. Severe corrosion with section loss on interior framing (Photo 3).	<p>Photo 3</p>

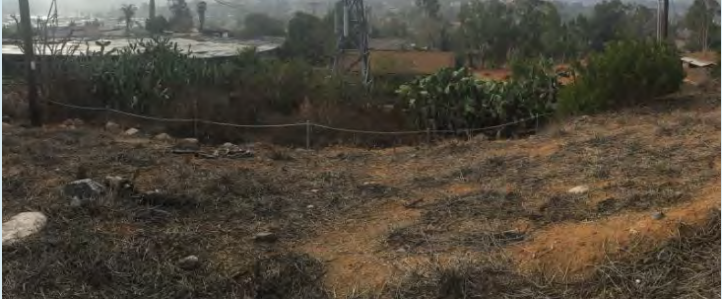
San Luis Rey Reservoir Civil/Site and Corrosion Observations		Photo
Fence/Gate	Typical chain link gate located at entrance in good condition. Fence partially surrounding perimeter of reservoir (Photo 1).	<p>Photo 1</p>

- Consider installation of VID security fence surrounding perimeter of reservoir.
- Remove all vegetation in close proximity to the reservoir fence and signage and clear sediment and debris from the site structures.
- Replace faded VID signage. Black text signage is recommended as red text fades in due time.
- Replace corroded hardware on both hatches including prop bar, hinge screws, and lock cover screws.

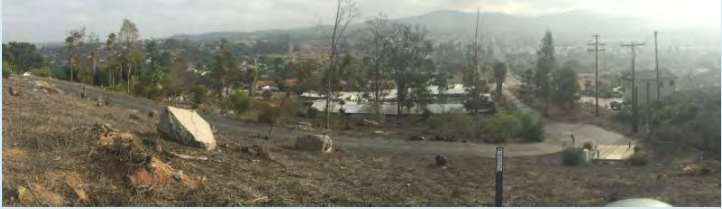
Access Road	<p>Paved access road following entrance leads up to reservoir (Photo 2).            Access road area contains sufficient space for inspection teams and multiple vehicles</p>	<p>Photo 2</p>

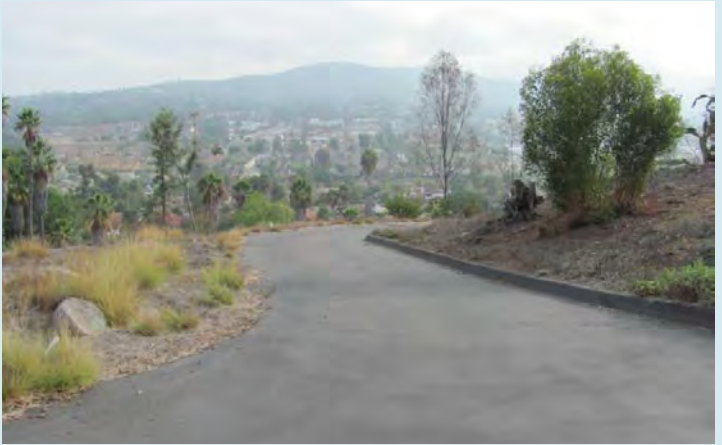
<p>Access road has areas of minor cracking along pavement but was observed to be in overall good condition (Photo 3).</p>	<p>Photo 3</p>

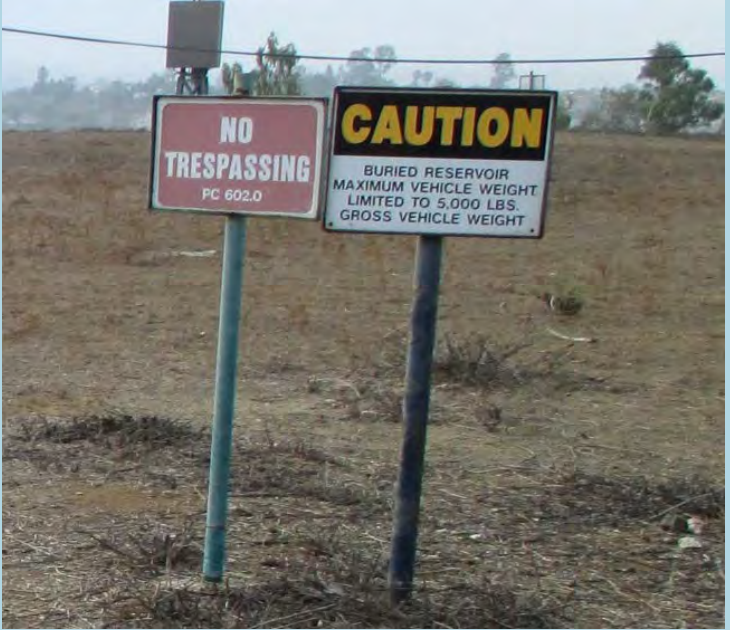
San Luis Rey Reservoir Civil/Site and Corrosion Observations		Photo
Signage	Signage on site included no trespassing and caution signs (Photo 7).  Private Property sign faded and illegible (Photo 8).	<p>Photo 7</p>

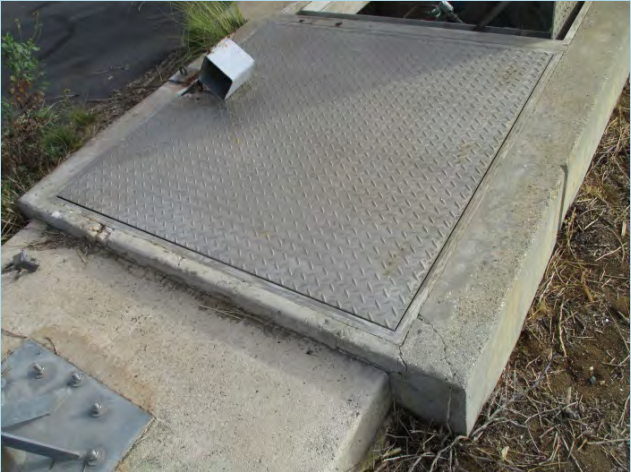
San Luis Rey Reservoir Structural Exterior Observations		Photo
General	Typical exterior view of reservoir (Photo 1).	Photo 1  
Roof	Typical cracking at the corners of the concrete curb around the access hatch (Photo 2).	Photo 2

- The concrete cracking around the access hatch appears to have been present since construction and is not a structural concern.
- The corrosion of the abandoned anchors in the concrete should be addressed to prevent long-term damage to the concrete and embedded steel reinforcing due to moisture infiltration.
- The minor corrosion of the interior metals is not currently a structural concern, but should be addressed to maintain long-term serviceability of the metal components.

- Seal all cracking in the concrete around the access hatch to prevent long-term damage to the concrete and embedded steel reinforcing due to moisture infiltration.
- Repair or remove corroding abandoned anchors to prevent long-term damage to the concrete and reinforcing due to moisture infiltration.
- Clean all corrosion of the interior metal components.

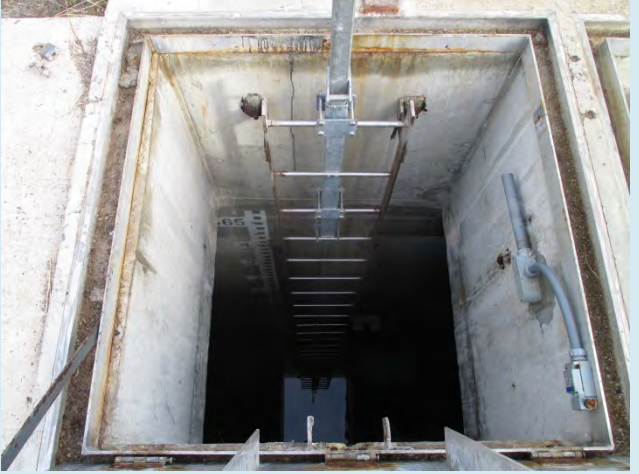
San Luis Rey Reservoir Structural Interior Observations		Photo
Access Hatch	Typical interior view of access hatch. Corrosion of abandoned anchors in concrete. Surface corrosion of interior metals. Efflorescence observed at joint between roof concrete and hatch riser (Photo 1).	<p>Photo 1</p>

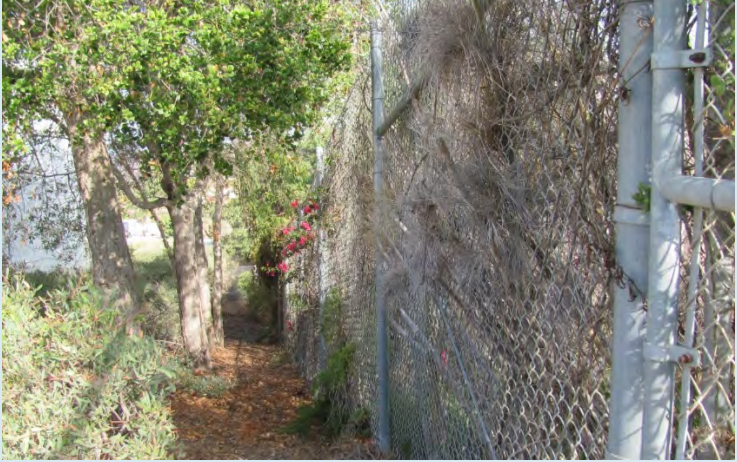
H Reservoir Civil/Site and Corrosion Observations		Photo
Trees and Vegetation	Tree growth over fence all along NE side. Shrubbery and weeds intertwined into links of fence (Photo 4).	<p>Photo 4</p>

- The chain link fence contains tree growth over fence all along NE side of reservoir. Shrubbery and weeds are intertwined into links of fence.
- Access road surrounding reservoir has several areas of uneven pavement and cracking displayed in Figure 9-3 and Figure 9-4.
- Minor sediment and debris built up in concrete lined ditch. Clear ditch allows for adequate run off flow.
- Stairway on NE side of reservoir entrance is missing inner handrail.
- Corrosion on conduit fittings on roof and inside access hatch.
- Spot corrosion was observed on the interior overflow structure.
- No confined space signage installed at the roof hatch location.

- Remove all vegetation in close proximity to the reservoir, fence, and other structures. Remove all shrubbery and weeds intertwined into links of fence.
- Repair uneven pavement and pavement cracking in surrounding access road. Cracking and uneven pavement displayed in Figure 9-1 and Figure 9-3.
- Clear minor sediment and debris built up in concrete lined ditch.
- Install missing inner handrail on exterior stairs.
- Replace corroded conduit fittings on roof and inside access hatch.
- Remove corrosion and repair coating on interior overflow structure.
- Install confined space signage on roof hatch. Use black text on signage to prevent fading.

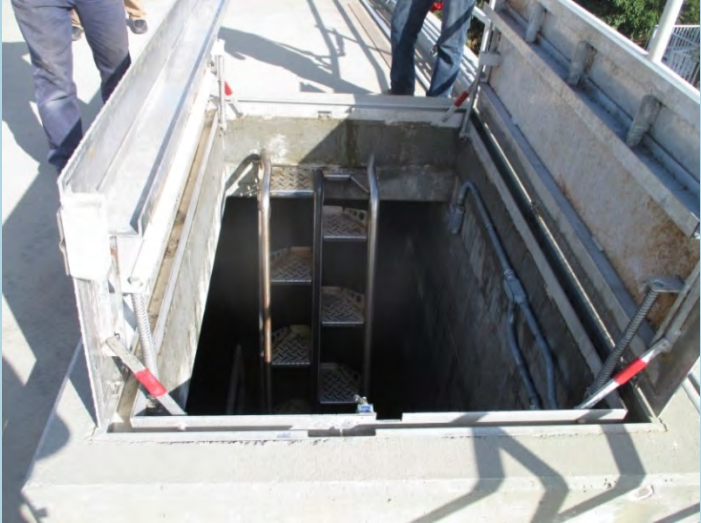
Hatches	Hatches interior conduit brackets were found to be corroded. Hatch observed to be in overall good condition (Photo 5).	<p>Photo 5</p>
