# Potable Water Master Plan

Vista Irrigation District

April 9, 2018

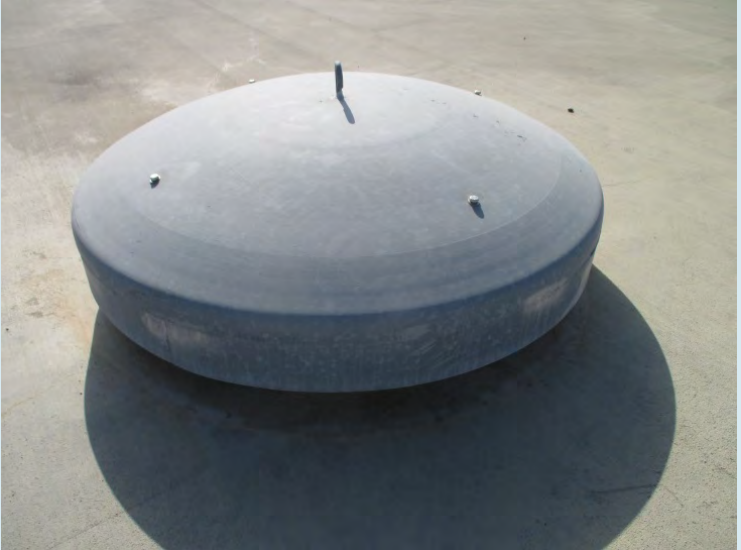
H Reservoir Civil/Site and Corrosion Observations		Photo
Vents	One roof vent located at the center of the reservoir roof. Center vent assembly was observed to be in good condition (Photo 6 and Photo 7).	<p>Photo 6</p>

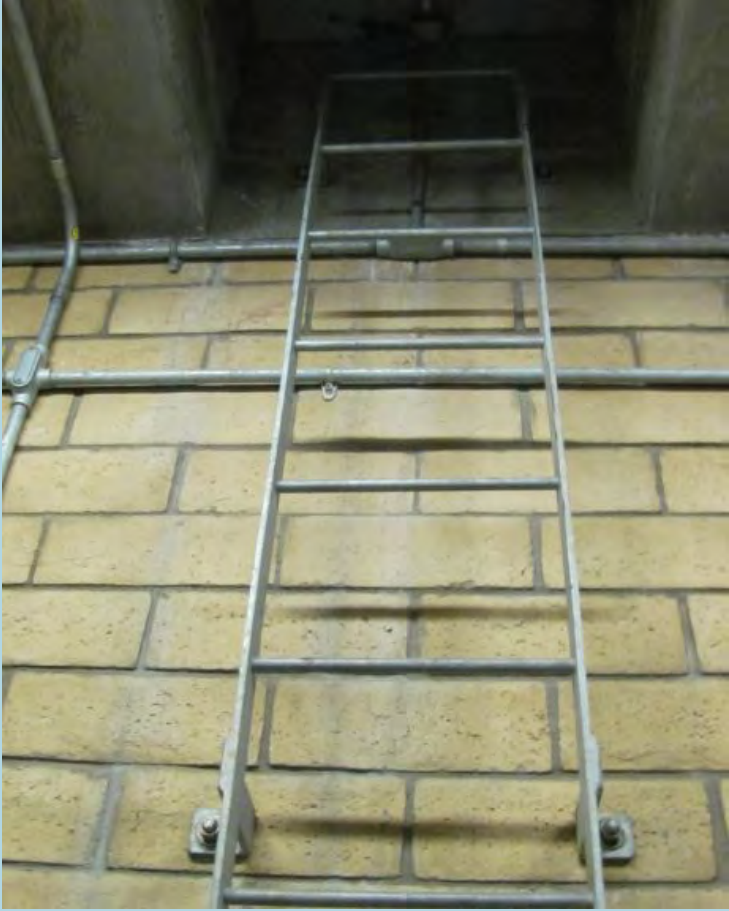
H Reservoir Civil/Site and Corrosion Observations		Photo
Ladders	Stainless steel interior ladder located in pump station room contains concrete landing prior to first step. Ladder in good condition (Photo 8).	<p>Photo 8</p>

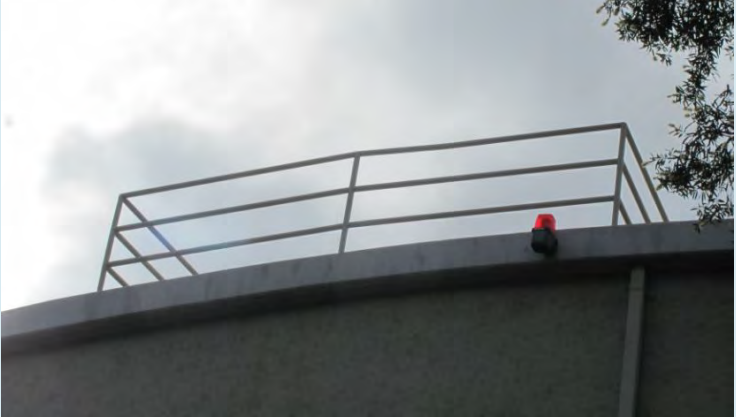
H Reservoir Civil/Site and Corrosion Observations		Photo
Handrails, and Guardrails	<p>There are a total of three guardrails located at H Reservoir. Two located on the roof and one on landing inside (Photo 9).</p> <p>There are a total of three stairways. Stairway on NE side of reservoir entrance is missing inner handrail but was observed to be in good condition overall (Photo 10).</p>	<p>Photo 9</p>

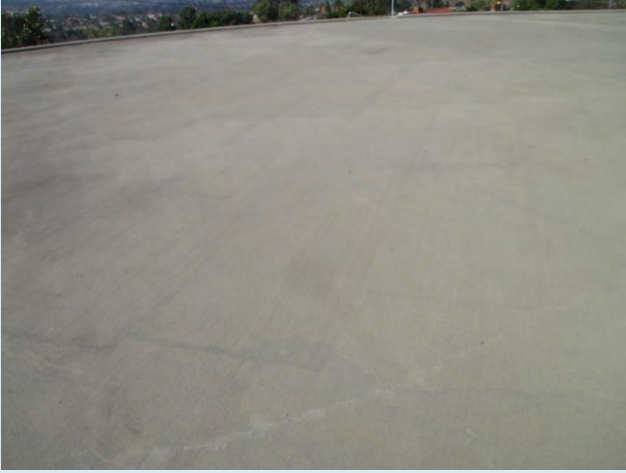
H Reservoir Structural Exterior Observations		Photo
Roof	Typical cracking on concrete roof, concentrated over column caps (Photo 1).	Photo 1

- The cracking on the roof deck appears to have been present since construction, but should be addressed to prevent long-term damage to the concrete and embedded steel reinforcing due to moisture infiltration.
- The cracking on the outside face of the roof deck appears to have been present since construction and is not a structural concern.
- The cracking of the shotcrete finish is not currently a structural concern, but should be monitored for indication of moisture seepage and corrosion of the embedded circumferential prestressed reinforcing. The cracking near the top of the wall is above the high water line, so the moisture staining at these locations may be an

- Repair the roof, as required, to prevent ponding and provide proper drainage.
- Seal all cracking on the roof concrete to prevent long-term damage to the concrete and embedded steel reinforcing due to moisture infiltration.
- Regularly monitor the cracking of the shotcrete finish for indication of moisture seepage and corrosion of the embedded circumferential prestressed reinforcing.
- Monitor all corrosion of the interior metal components.

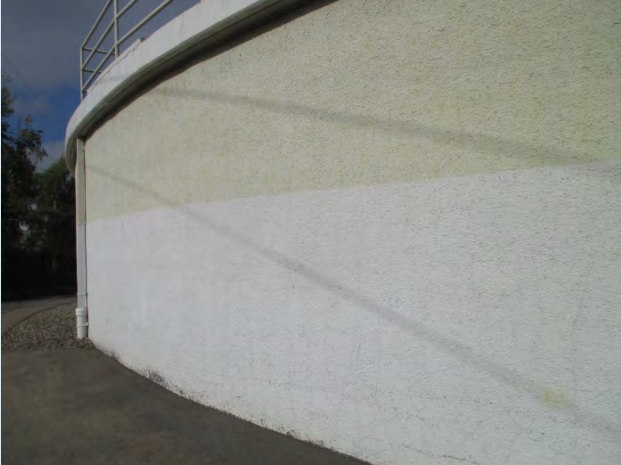
H Reservoir Structural Exterior Observations		Photo
Wall	Typical pattern cracking of shotcrete finish (approximately 12-inch grid) (Photo 5).	<p>Photo 5</p>

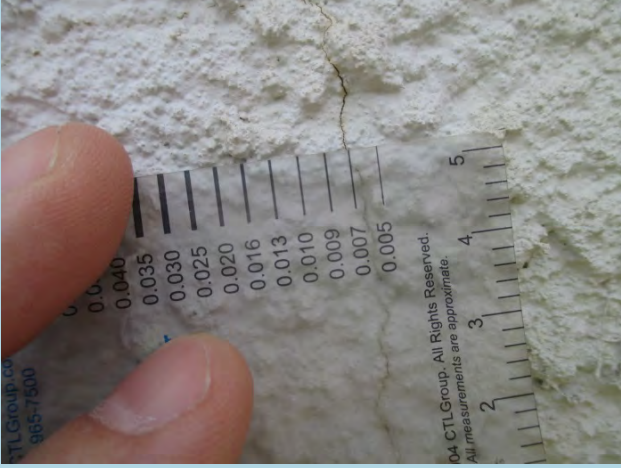
Wall	Typical crack width on shotcrete finish (Photo 6).	<p>Photo 6</p>

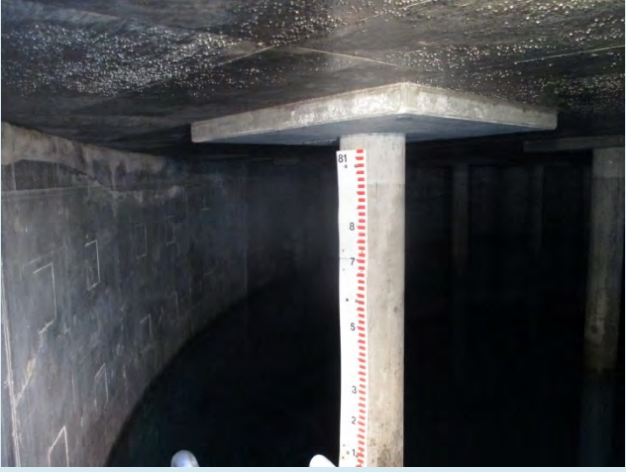
H Reservoir Structural Interior Observations		Photo
General	Typical condition at reservoir interior (Photo 1).	<p>Photo 1</p>

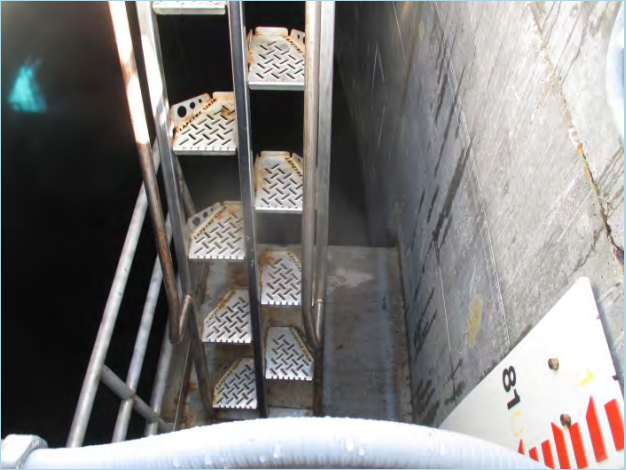
Access Stairs	Typical surface corrosion of interior metals (Photo 2).	<p>Photo 2</p>

- The minor corrosion of the interior metals is not currently a structural concern, but should be addressed to maintain long-term serviceability of the metal components.

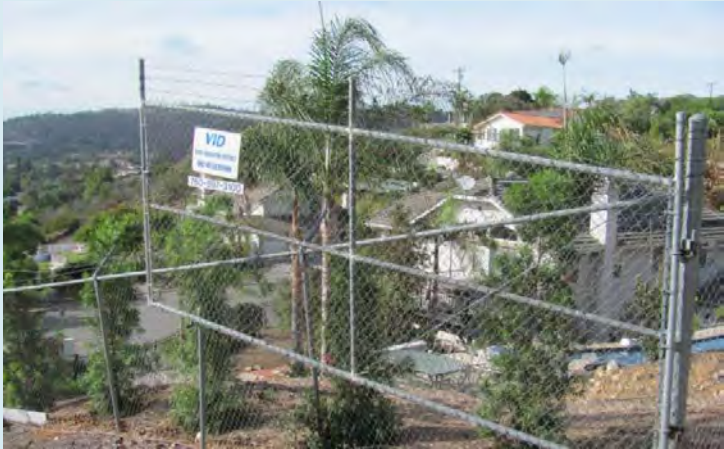
MD Reservoir Civil/Site and Corrosion Observations		Photo
Fence/Gate	Typical swing steel gate with barbed wire containing lock and signage located at entrance in good condition (Photo 1).	<p>Photo 1</p>

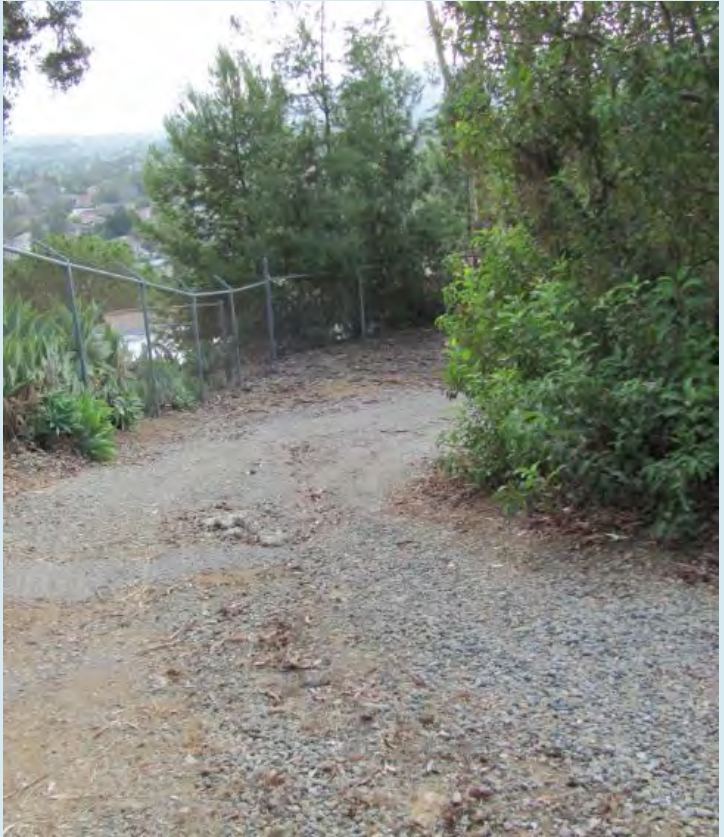
Access Road	<p>Reservoir is bounded by chain link fence. Overgrown shrub and bushes conflict with fence in certain areas. (Photo 2 and Photo 4).</p> <p>Paved access road leads up to entrance and gravel surrounding reservoir (Photo 2).</p> <p>Major case of erosion NE of entrance causing hazardous slope for maintenance personnel.</p>	<p>Photo 2</p>

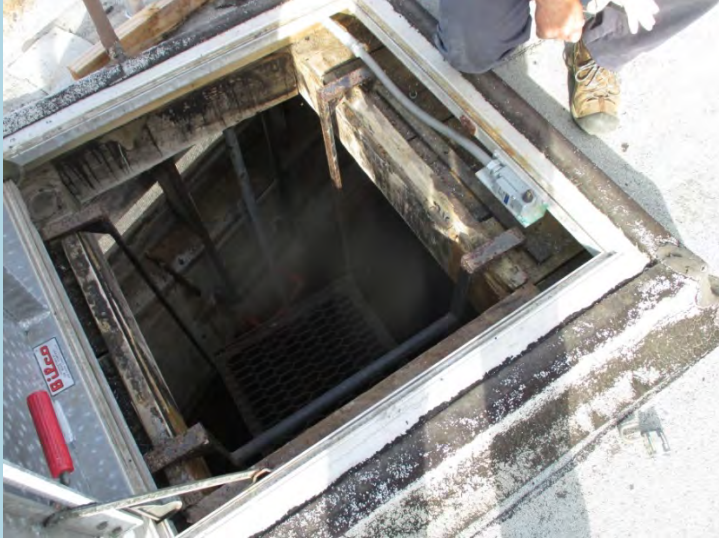
MD Reservoir Civil/Site and Corrosion Observations		Photo
Hatches	Roof hatch was observed to have surface rusting on the lock cover. Steel screws were found corroded (Photo 5).	Photo 5

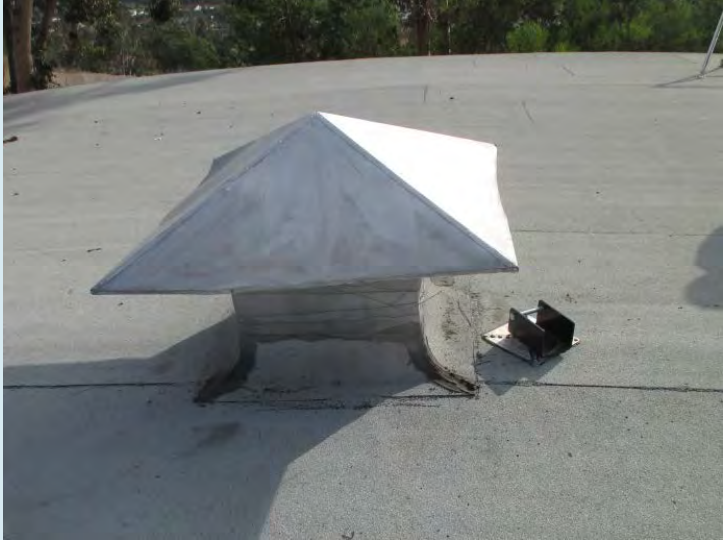
MD Reservoir Civil/Site and Corrosion Observations		Photo
Vents	<p>Center vent was found to be in good condition (Photo 6).</p> <p>New fine mesh bug screen had been added with temporary wire (Photo 7).</p> <p>Side vents are located around the perimeter every few feet apart. Vents have a mesh covering and wood frame. Wood frames had cases of chipping. Visible holes near side vents were stapled with mesh covering (Photo 8).</p>	<p>Photo 6</p>

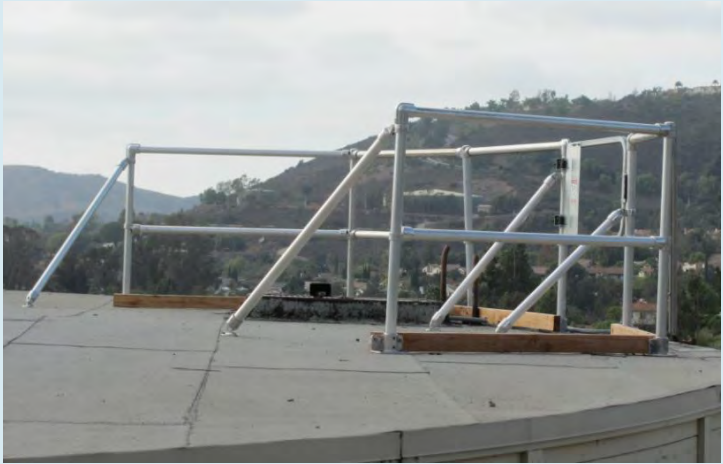
Handrails, and Guardrails	<p>There are a total of two guardrails located at MD Reservoir. Guardrails were found in good condition (Photo 10).</p>	<p>Photo 10</p>

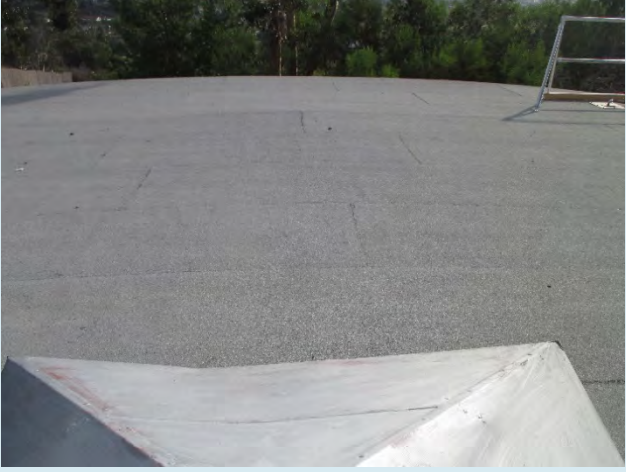
MD Reservoir Structural Exterior Observations		Photo
Roof	Visible sagging of the roof paneling between the supports with evidence of ponding along the roof edge. Minor vertical deflection of the roof system felt while walking the roof (Photo 1).	<p>Photo 1</p>

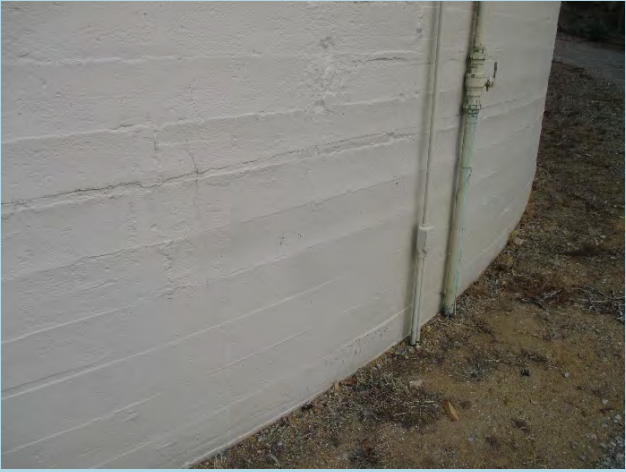
Wall	Typical full-height cracking in exterior face of concrete wall. This condition was observed along the entire perimeter of the reservoir at approximately 8-foot spacing. There does not appear to be any moisture seepage (Photo 2).	<p>Photo 2</p>

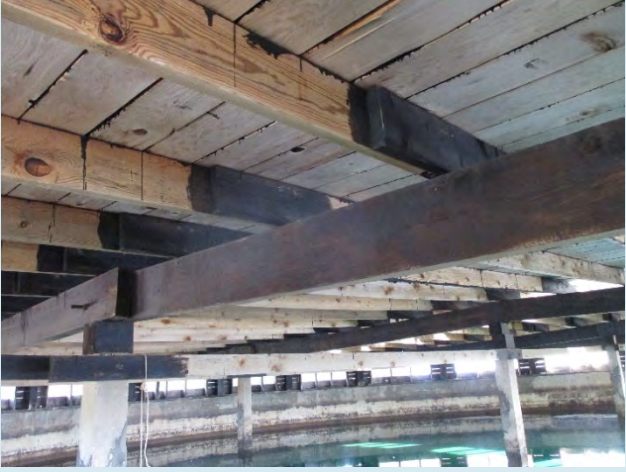
MD Reservoir Structural Interior Observations		Photo
Roof	Typical condition of interior roof framing and support (Photo 1).	Photo 1

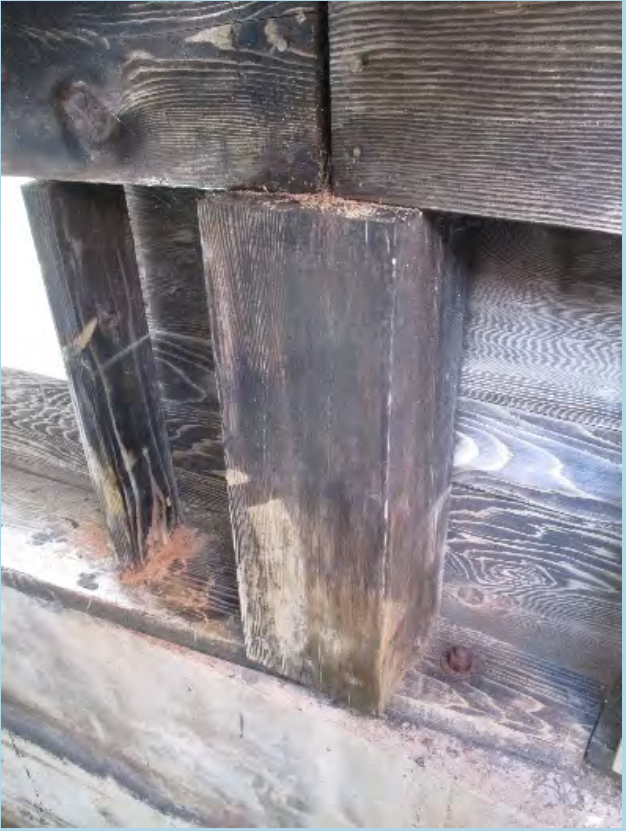
Roof/Wall	Typical condition of roof structure connection to reservoir wall (Photo 2).	Photo 2

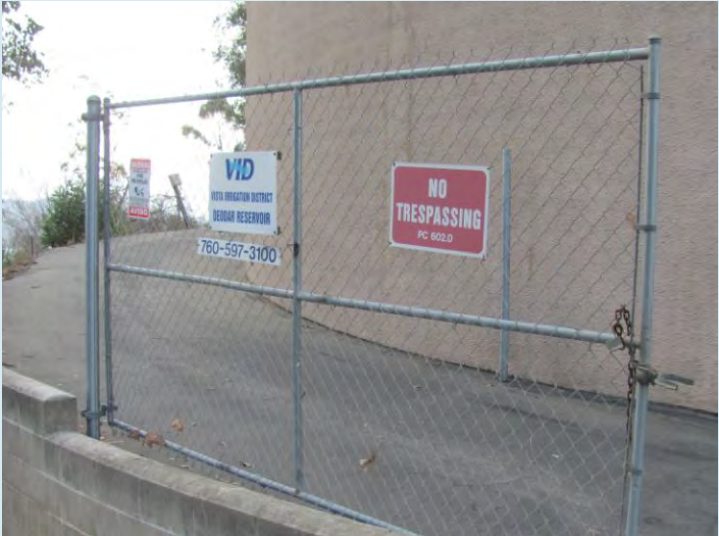
Deodar Reservoir Civil/Site and Corrosion Observations		Photo
Fence/Gate	Two typical swing steel gates containing lock and signage located at both the east and west side of the entrance. Gates observed to be in good condition (Photo 1 and Photo 2).	<p>Photo 1</p>

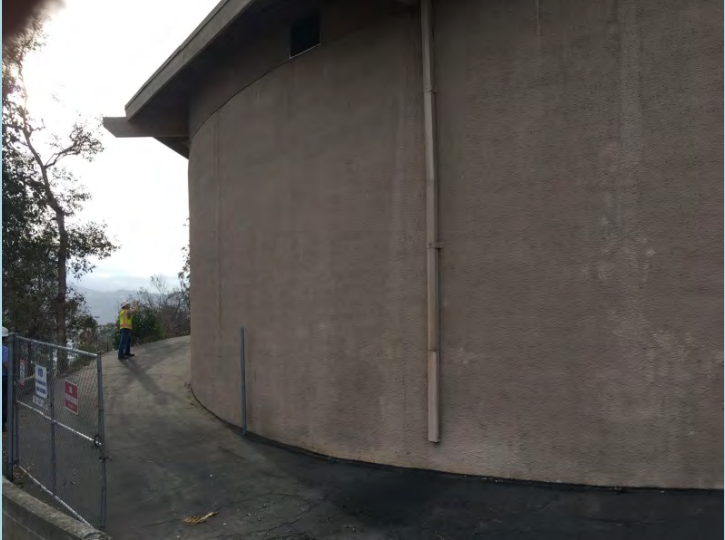
Deodar Reservoir Civil/Site and Corrosion Observations		Photo
Drainage	Roof drains surrounding reservoir. Good slope for runoff on North side of reservoir down to surrounding trees and vegetation (Photo 3).	<p>Photo 3</p>

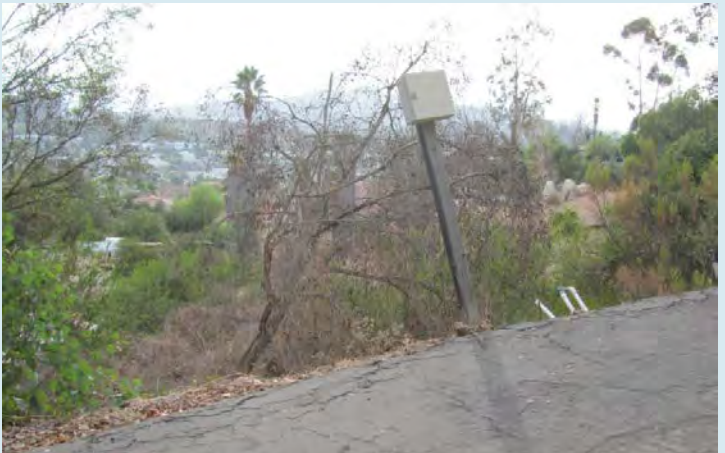
Trees and Vegetation	Trees and vegetation growth surrounding reservoir within distance does not conflict with operations. North end of reservoir consists of deep slope from end of pavement to adjacent landscape (Photo 4).	<p>Photo 4</p>

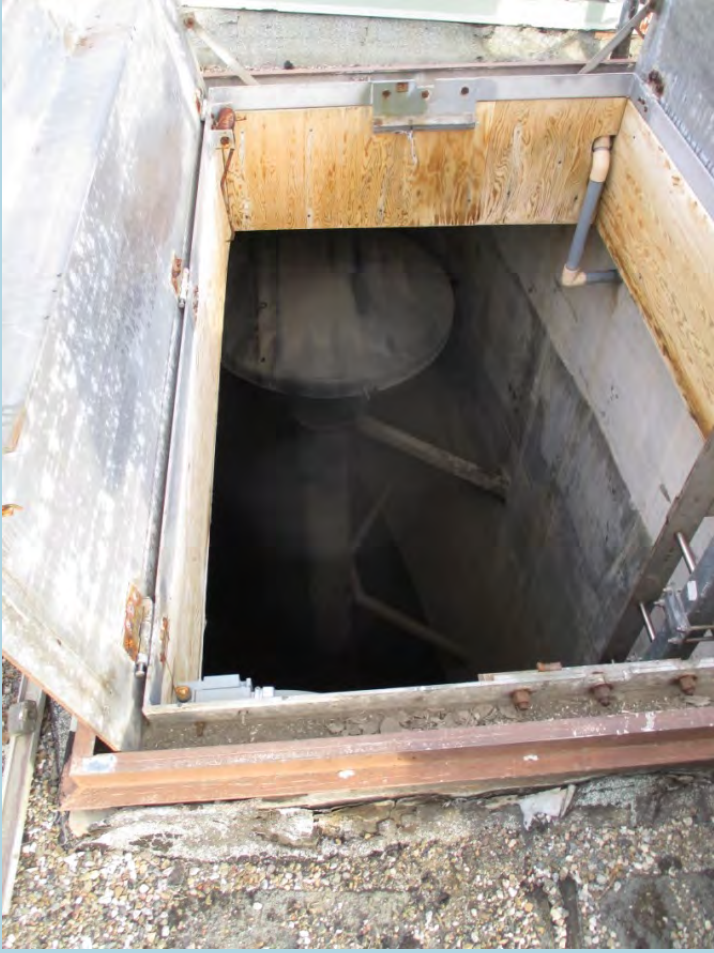
Deodar Reservoir Civil/Site and Corrosion Observations		Photo
Hatches	Roof hatch found to have corroded screws and hinges (Photo 5).	Photo 5

- Install new chain link security fence surrounding reservoir boundary.
- Appropriate signage shall be included with the installation of VID surrounding security fence.
- Replace corroded hinges and screws on roof hatch.
- Remove corrosion and repair coating on interior overflow structure.
- Install confined space signage on roof hatch. Use black text on signage to prevent fading.

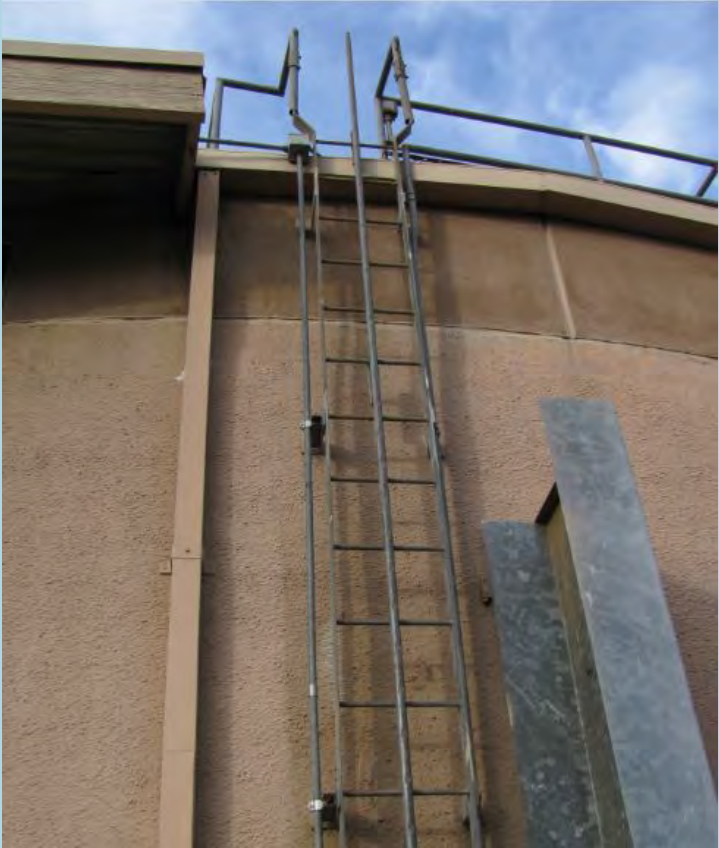
Deodar Reservoir Civil/Site and Corrosion Observations		Photo
Ladders	<p>Stainless steel external ladder located on NE side of reservoir entrance.</p> <p>Transition from ladder to guardrail is secure; gap between safety climb device and guardrail is narrow (Photo 8).</p> <p>Interior ladder was observed to be in good condition.</p>	<p>Photo 8</p>

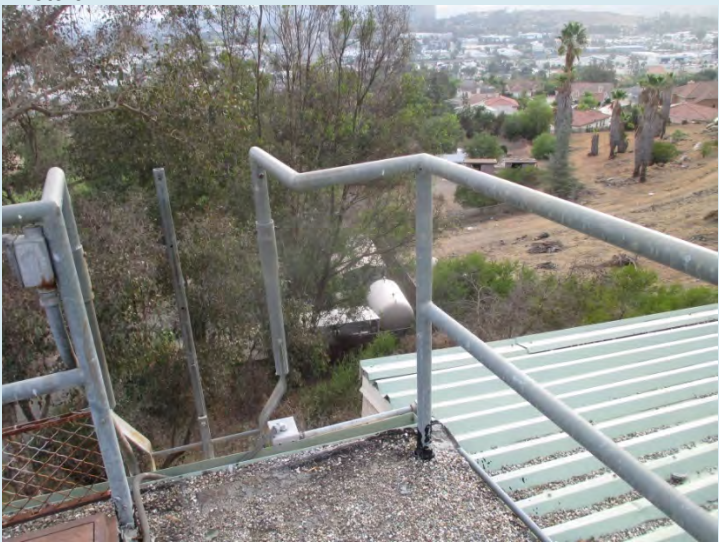
Handrails and Guardrails	<p>Guardrails were found to be in good condition (Photo 9).</p>	<p>Photo 9</p>

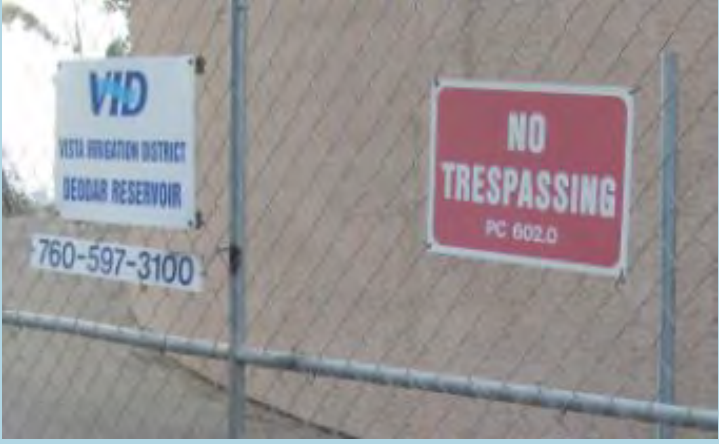
Deodar Reservoir Civil/Site and Corrosion Observations		Photo
Signage	Signage on site is includes only on the entrance and exit gate. Signage was observed to be in good condition (Photo 10).	Photo 10

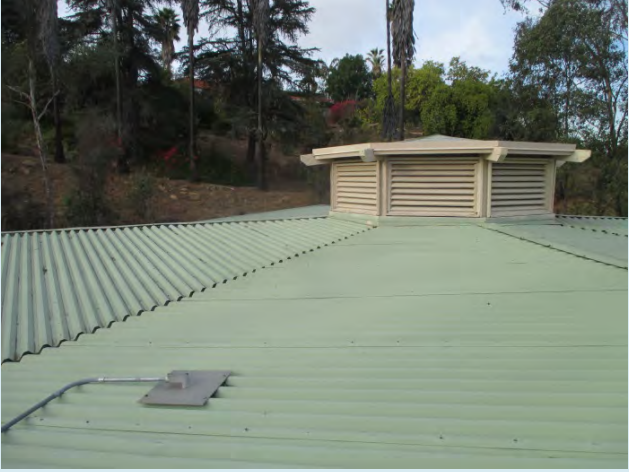
Deodar Reservoir Structural Exterior Observations		Photo
Roof	<p>General condition of reservoir roof.</p> <p>Deterioration of exposed wood at center vent (Photo 1).</p>	<p>Photo 1</p>

- The observed condition of the exposed wood at the center vent is expected of the age of its construction and does not appear to be affecting its function. All exposed wood should be recoated and, if necessary, replaced to ensure functionality of the vent structure.

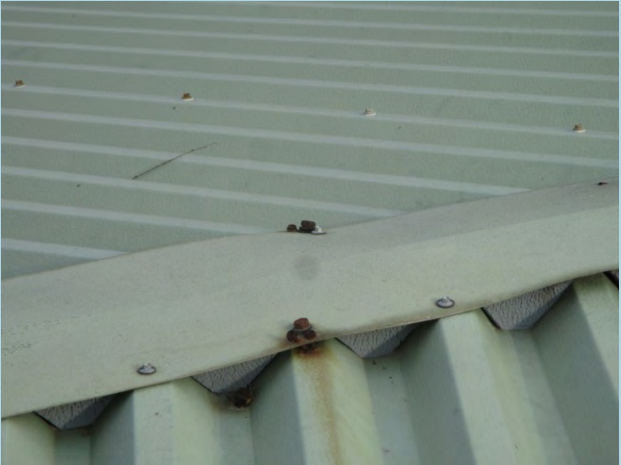
Roof	<p>Typical condition of roof deck. Some corroded fasteners. Evidence of damage due to thermal movement including missing and replaced fasteners. Missing foam insulation (Photo 2).</p>	<p>Photo 2</p>

- Damage due to thermal movement is typical of this type of roof deck. The deck connections to all supports should be routinely inspected and, if necessary, replaced, for safety and to ensure its functionality.

- Roof deck loading should be limited until all missing deck attachments are secured.
- All missing foam insulation should be replaced to restore weather-tightness of the reservoir.

- Replace all missing foam insulation to restore the weather-tightness of the reservoir.
- Reconfigure the roof drains to prevent accumulation of debris and moisture at the low points and deterioration of the roof system at these locations.
- Provide ventilation improvements for the reservoir to prevent accumulation of condensation and deterioration of the roof framing and its connections.
- Repair the corrosion of the stucco trim on the masonry wall to maintain long-term serviceability of the metal.
- Clean all staining of the exterior wall surface.

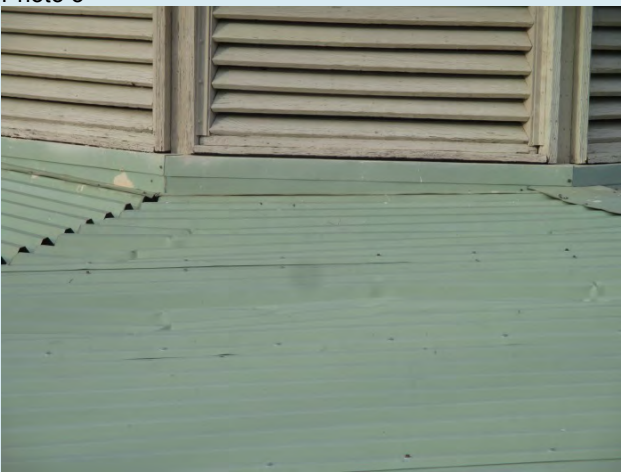
Roof	<p>Typical condition of roof deck near center vent.</p> <p>Isolated damage due to workers walking on deck at these locations (Photo 3).</p>	<p>Photo 3</p>

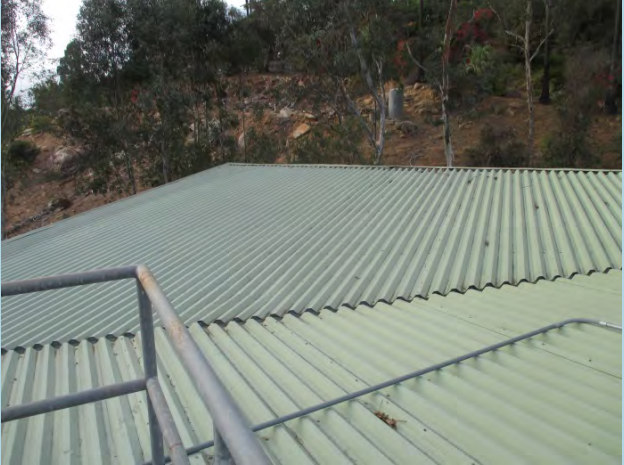
Deodar Reservoir Structural Exterior Observations		Photo
Roof Drains	<p>Up close inspection at the roof drains not possible at the time of inspection.</p> <p>Roof drains appear to be functioning properly, but design is similar to Pechstein Reservoir and similar issues likely occurring at this reservoir. See Section 4.3.2, Photo 3 for additional information (Photo 4).</p>	<p>Photo 4</p>

- Current design of the roof drains allows accumulation of debris and moisture at the low points, leading to deterioration of the roof system at these locations. Leaking of the gutters is also contributing to the active moisture and damage observed at the valley girders. The roof drains should be redesigned to prevent these conditions.

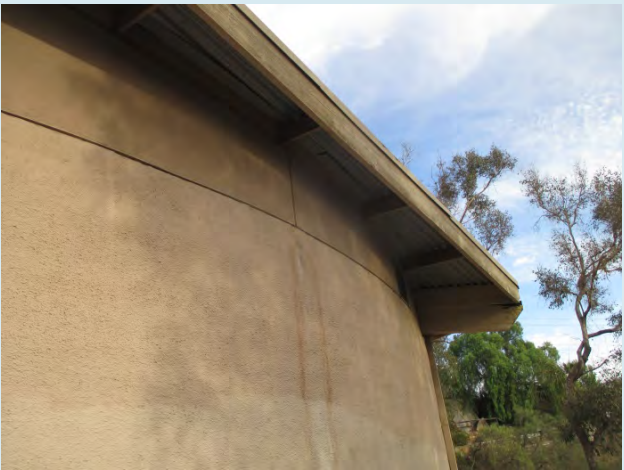
Roof/Wall	<p>Typical condition of wood framing at top of masonry wall.</p> <p>Active moisture with visible wood deterioration.</p> <p>Staining of concrete wall below joint in masonry wall stucco finish (Photo 5).</p>	<p>Photo 5</p>

- The major contributor to the deterioration of the roof framing is the lack of ventilation inside the reservoir. This lack of ventilation allows condensation to form on the roof components. The condensation accumulates as it travels from ridge to valley, causing progressively more severe damage with accumulation. The observed deterioration caused by this condition includes; deterioration of the rafters and valley girders with active moisture, algae growth, and staining (Section 11.4.2, Photos 5 – 6), corrosion and failure of wood connections at the interior of the

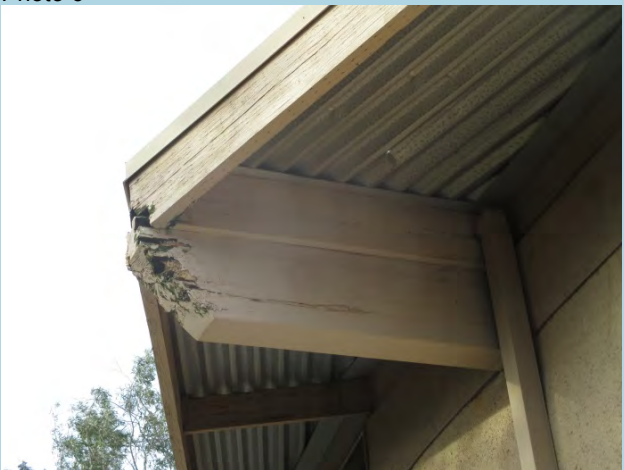
Roof	<p>Typical condition of valley girder.</p> <p>Deterioration and delamination of glu-lam beam with active moisture, algae growth, and staining visible (Photo 6).</p>	<p>Photo 6</p>

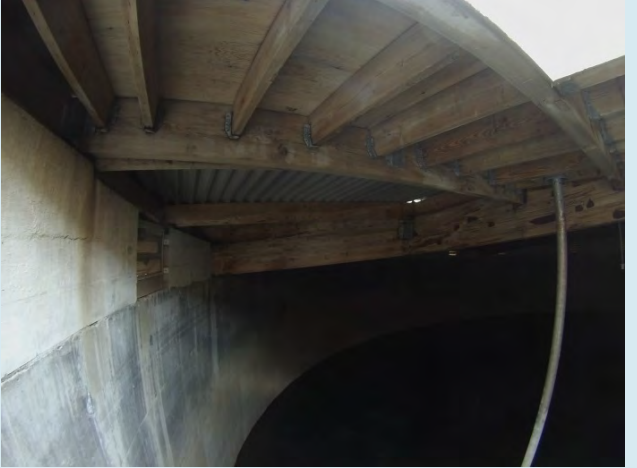
Deodar Reservoir Structural Interior Observations		Photo
Roof/Wall	<p>Typical condition of interior roof framing and support.</p> <p>Progressively more severe moisture accumulation (condensation) and corrosion of framing connections moving from ridge to valley.</p> <p>Light entering reservoir at locations of missing foam insulation (Photo 1).</p>	<p>Photo 1</p>

reservoir (Section 11.4.3, Photo 1, and as described by VID staff). Without improvements to the ventilation, the observed deterioration will continue.

- Monitor all corrosion of the interior metal components
