# GEOTECHNICAL INVESTIGATION

## VISTA IRRIGATION DISTRICT - E RESERVOIR AND PUMP STATION

2330 Edgehill Road  
Vista, California

SCST No. 180433P4  
Report No. 1R3

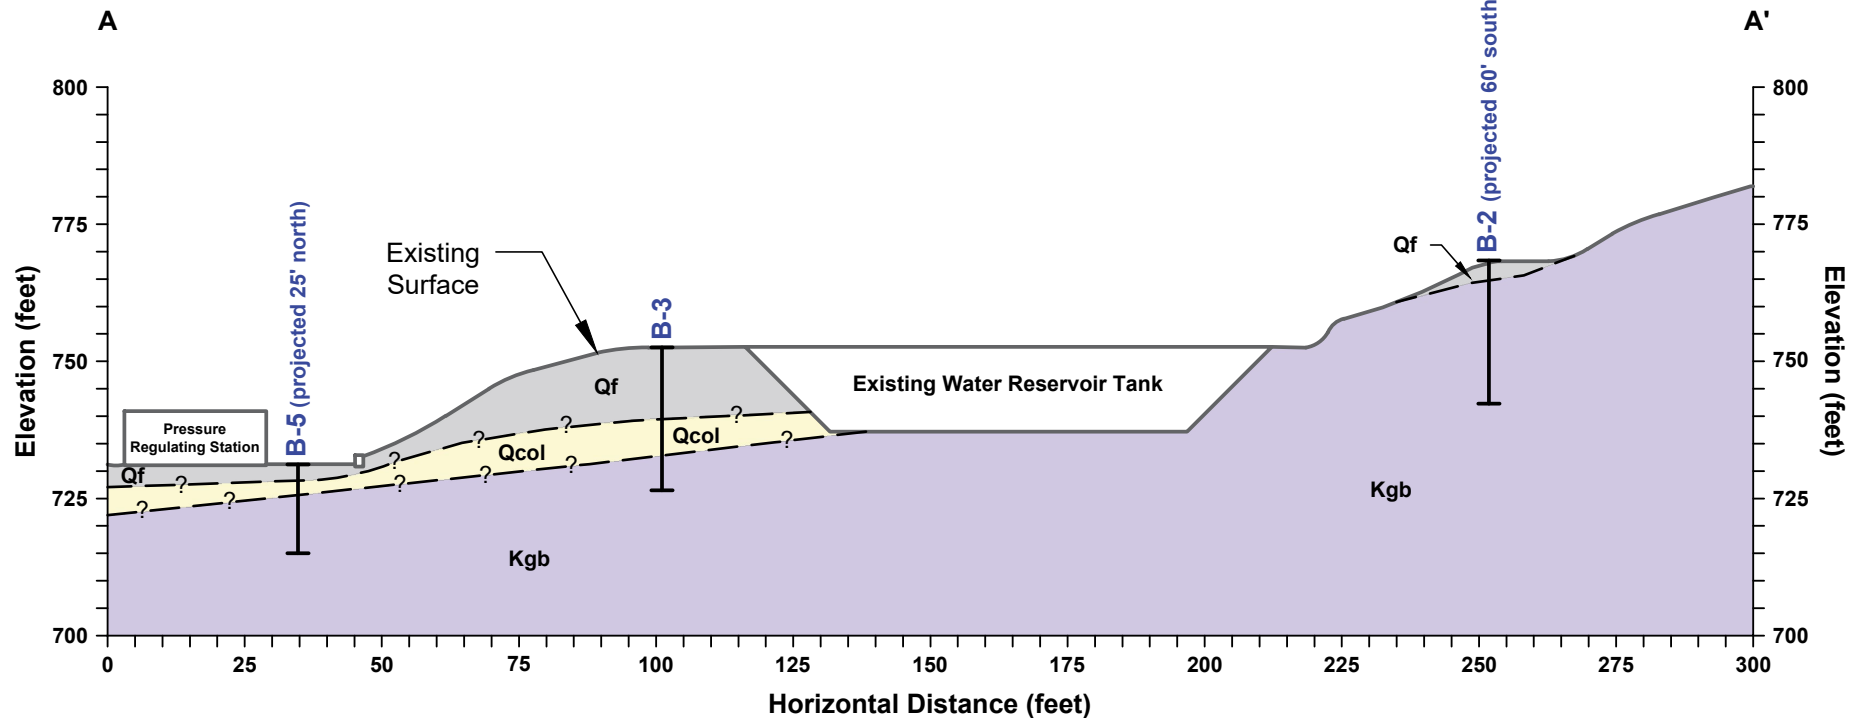
- B-5
Approximate Location of Boring

**GEOLOGIC CROSS-SECTION**  
 VID, E Reservoir Replacement and Pump Station  
 Vista, California

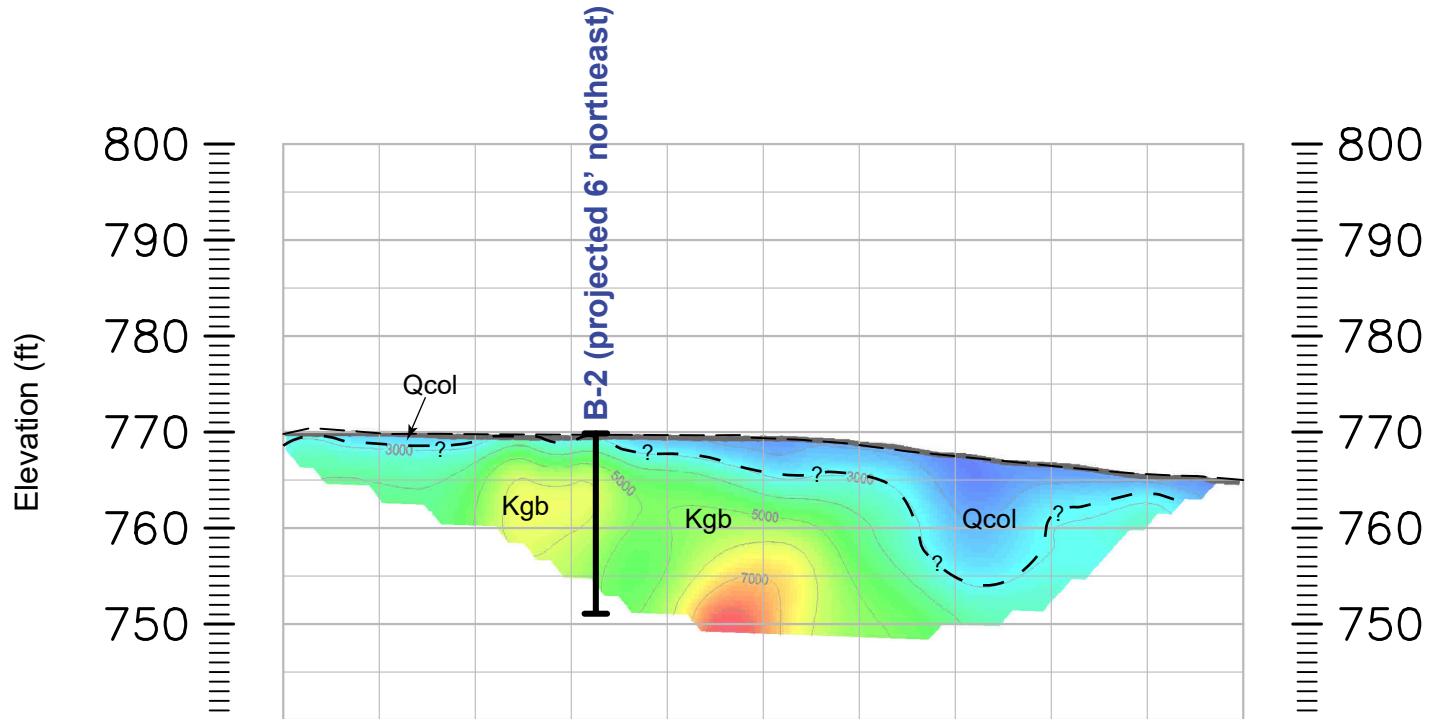
**TOMOGRAPHY PROFILE SL-1**  
VID, E Reservoir Replacement and Pump Station  
Vista, California

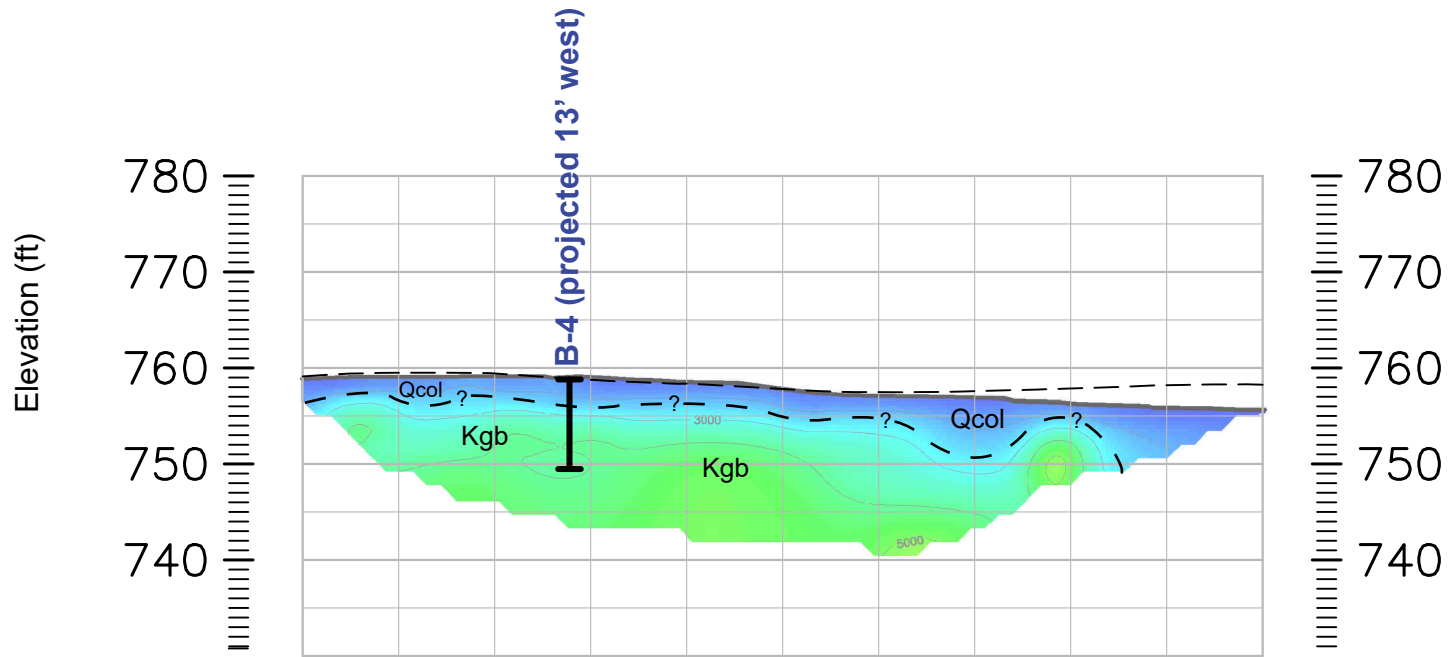
**TOMOGRAPHY PROFILE SL-2**  
 VID, E Reservoir Replacement and Pump Station  
 Vista, California

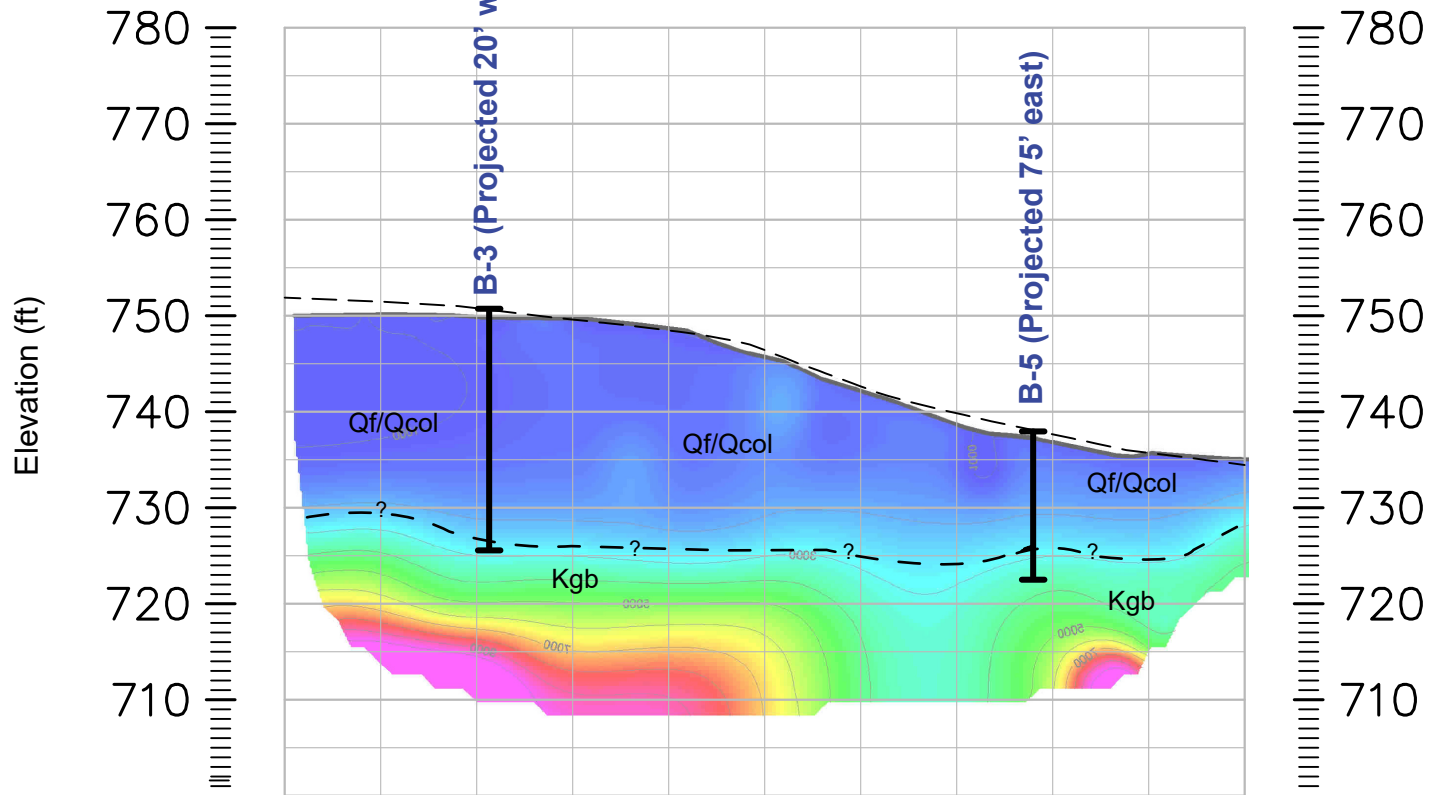
**TOMOGRAPHY PROFILE SL-3**  
VID, E Reservoir Replacement and Pump Station  
Vista, California

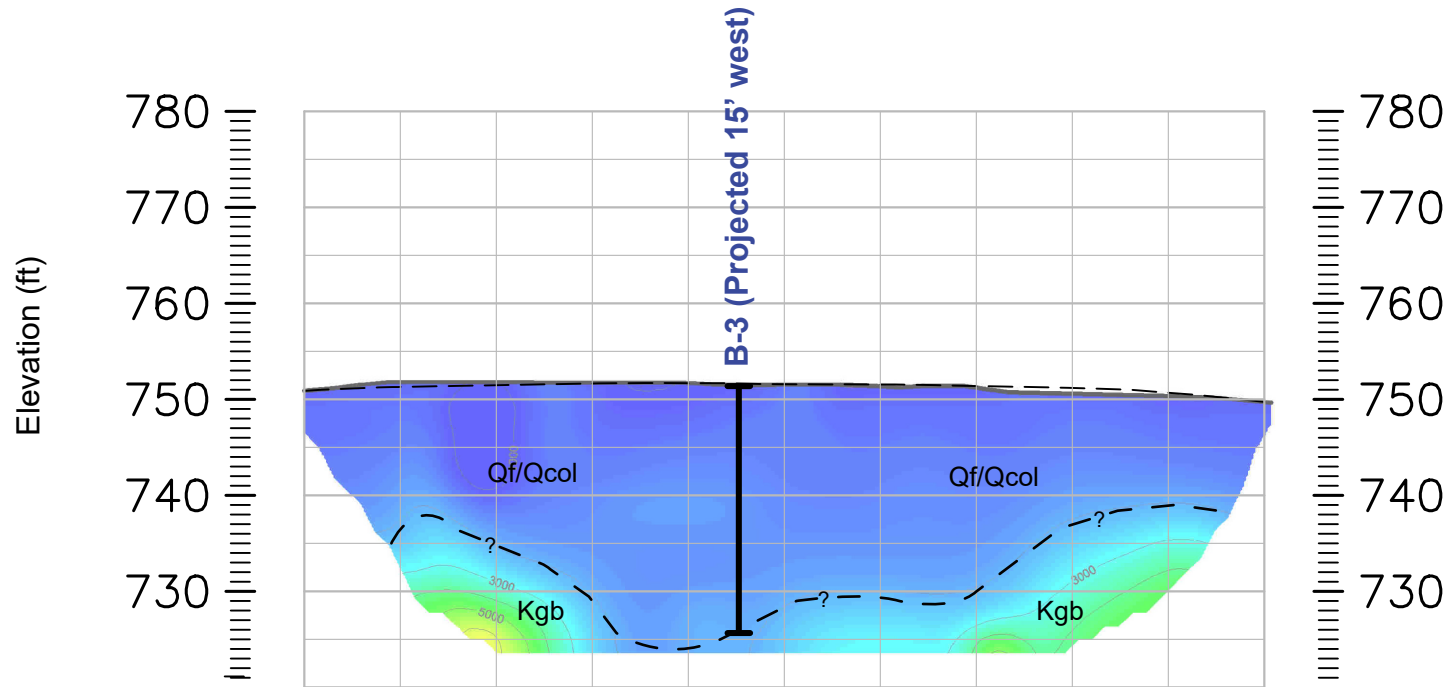
Figure:  
**8**

**TOMOGRAPHY PROFILE SL-4**  
VID, E Reservoir Replacement and Pump Station  
Vista, California

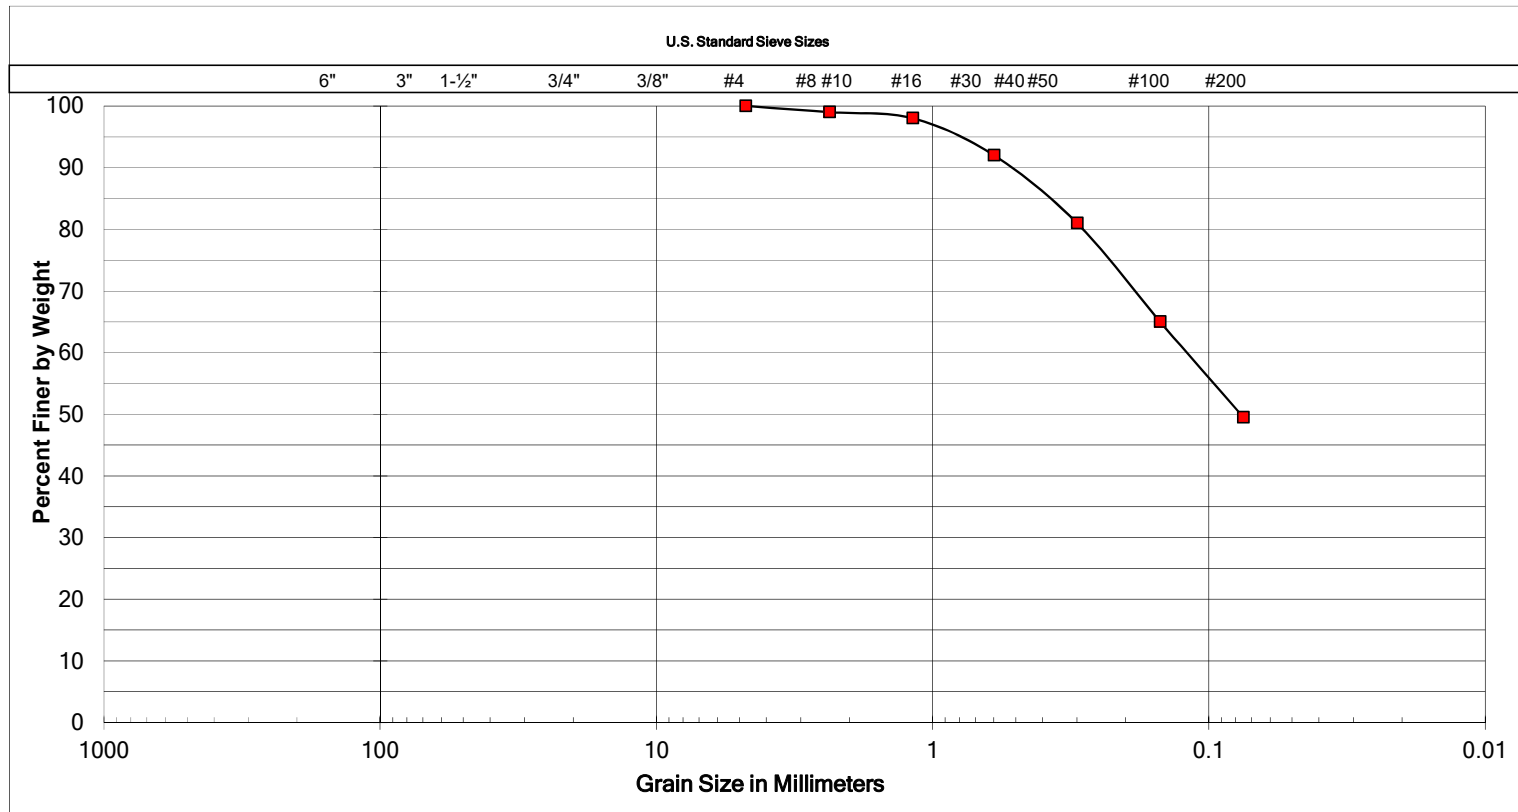
<b>SAMPLE LOCATION</b>
B-5 at 0 to 3 feet
<b>SAMPLE NUMBER</b>
37342

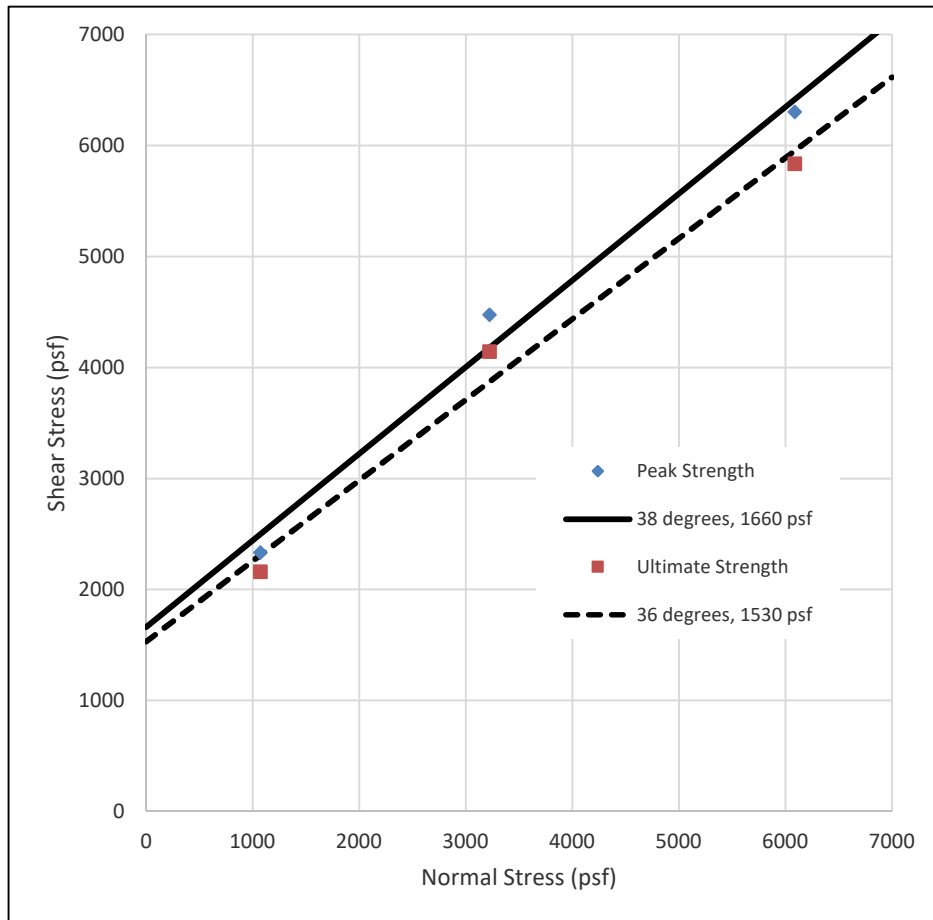
SAMPLE ID: B-3 at 19½ to 20 feet	Φ	Peak	Ultimate
		38 °	36 °
GABBRO (CLAYEY SAND)	c	1660 psf	1530 psf
NOTES: In Situ	γ <sub>d</sub>	Initial	Final
		117.5 pcf	117.5 pcf
Strain Rate: 0.003 in/min	w <sub>c</sub>	17.0 %	18.2 %
Sample was consolidated and drained	Saturation	100 %	100 %

- **DIRECT SHEAR:** The direct shear was evaluated on selected soil samples in accordance with ASTM D3080.
