2019

CONSUMER CONFIDENCE REPORT

Vista Irrigation District tests the drinking water quality for many constituents as required by State and Federal regulations. This report shows the results of our monitoring for the period of January 1, 2018 through December 31, 2018.

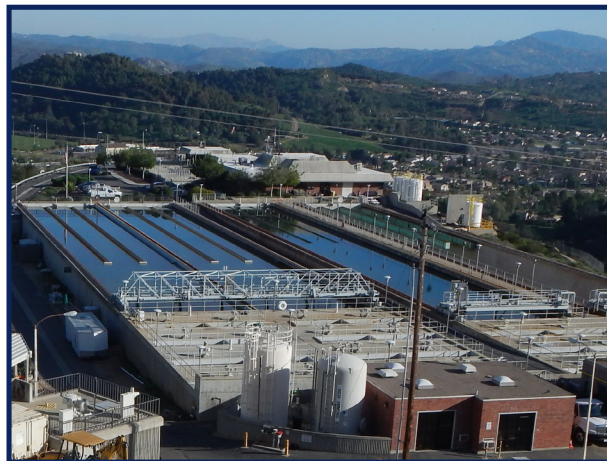
The 43-year old EVWTP recently received a major upgrade with the completion of the On-Site Chlorine Generation and Electrical System Upgrades Project. This project took three years to complete, and while it included many disinfection and electrical system improvements, its key objective was to replace the EVWTP's gaseous chlorine storage and disinfection system with an on-site chlorine generation system. Project elements included the demolition of gaseous chlorine storage and feed systems, installation of new sodium hypochlorite and chlorine dioxide generation systems, electrical system upgrades and upsizing emergency power generators capable of managing the demands of the redesigned EVWTP. The two newly installed emergency power generators can fully operate the EVWTP during a power outage, thus increasing water supply reliability.

The Escondido-Vista Water Treatment Plant (EVWTP), jointly owned by the City of Escondido and Vista Irrigation District (District), was constructed in 1976 and has capacity to produce 75 million gallons of potable water per day. Water treatment at the EVWTP includes mechanical and chemical removal of impurities, followed by inactivation of pathogens (e.g. viruses, bacteria, etc.) through disinfection. The result is clear and healthful water, meeting all state and federal requirements.
